HORNBREKKA ON HÖFÐASTRÖND

A 19TH CENTURY FARM

Preliminary results from an archaeological excavation

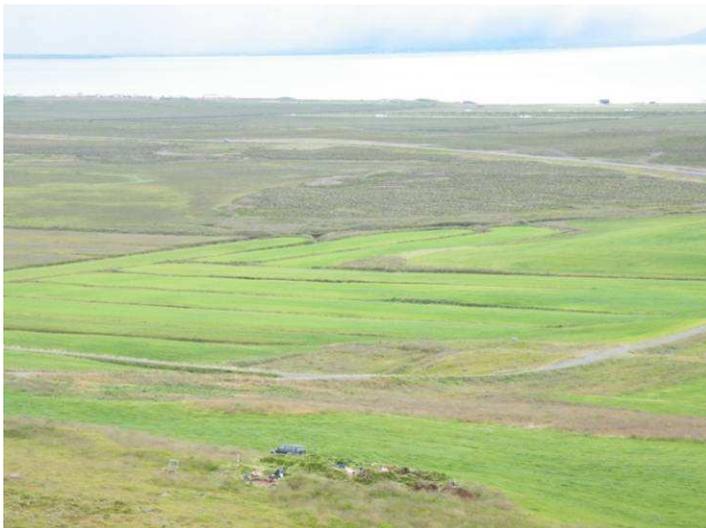
Fig 2: An overview of Hornbrekka, the farm ruin is at the bottom of the photograph. Looking SW

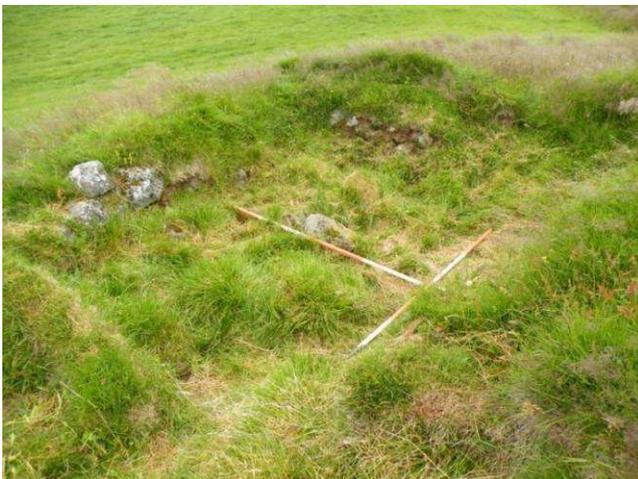
Fig 9: The NW room before excavation. Looking NW

A preliminary assessment trench was excavated in the north western room in 2001. The trench revealed thick occupation deposits and a variety of 19th-century artefacts (Milek 2001). Three occupation phases of the room were excavated in 2009, groups 001, 082 and 143, and one post-abandonment phase, group 155. The post abandonment group included

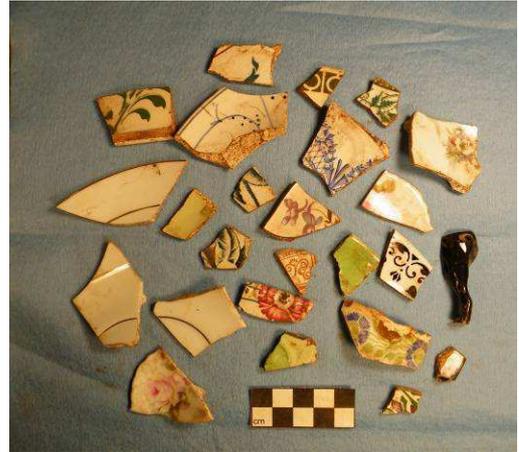
Fig 12: Selection of ceramics from context 088. Finds group <286>

However, a variety of ceramics (Fig 12) were retrieved from the blocking (context 088) between the storage

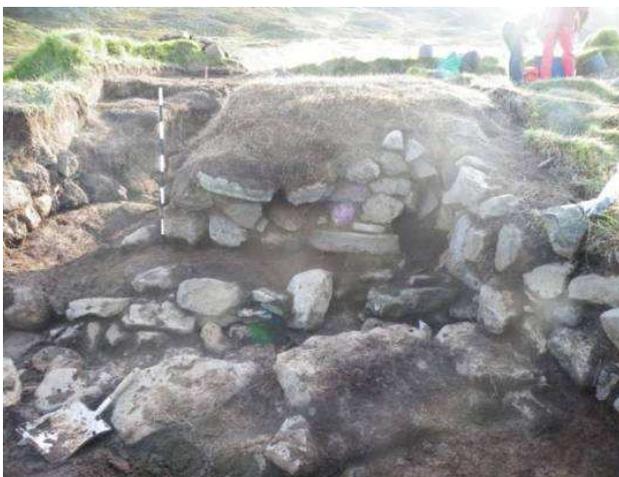
Fig 16: Wall 122. Looking N.

The eastern wall of the byre (context 122, Fig 16 and 17), which lay between it and the kitchen, also belongs to this occupation phase. The earlier phase of the room (group 143) was larger as the separating wall between the byre and the kitchen was much narrower. The new phase of this wall was built up against the old core, both to the west and to the north, on the side of corridor 099. New stone facing was constructed and the area between the old facing and the new was filled with turf debris, soil and rubbish (ash, glass and ceramic fragments and some bone refuse). A large flat stone, laid on its edge, was also inside the wall, probably to secure support for the earlier stone phasing (see Fig 17).

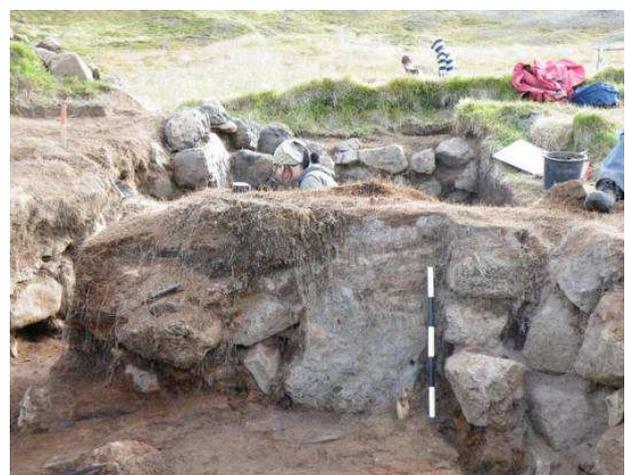
Fig 17: Wall 122 during excavation. Looking N

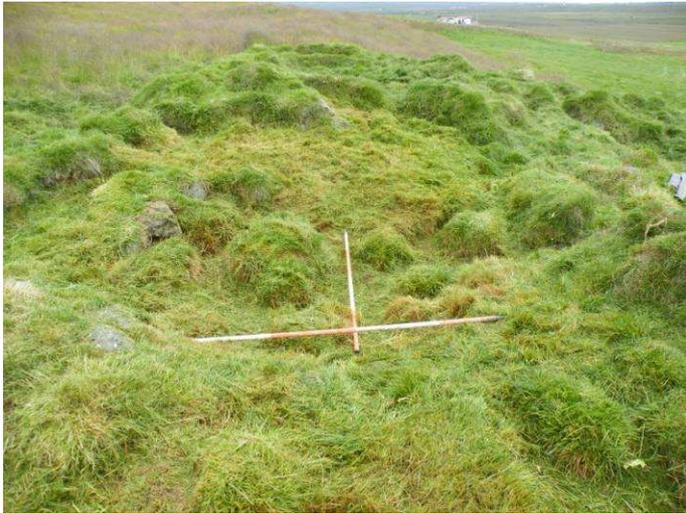
Fig 20: The north-east room prior to excavation. Looking S.

The north-eastern room in the ruin was partially excavated. The room extends further to the south than the limit of excavation so an arbitrary section was drawn through it. The excavated deposits from this room belonged to three different groups, two occupation phases (groups 003 and 097) and a post-abandonment phase (group 158). The post-abandonment phase of the kitchen

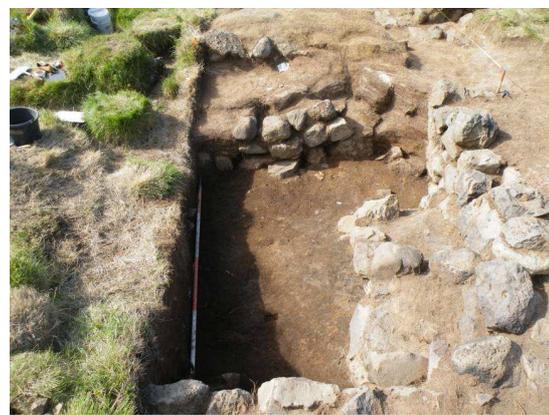
Fig 24: Latest phase of kitchen under excavation. Looking W.

The latest occupation phase of the kitchen included a series of floor deposits. The floors were mostly very compact and contained high percentages of ash, both wood ash and peat ash (contexts 053, 055, 062, 063, 069-073, 075, 077, 078, 079). In the north-eastern corner of the room there was a substantial double stove (group 024), built of local basalt stones with a cut feature (group 113) in front and below the western half where the embers will have been stowed away overnight. In this phase a row of stones had been added to the stove on its western side, an addition that is contemporary with the blocking of the passage

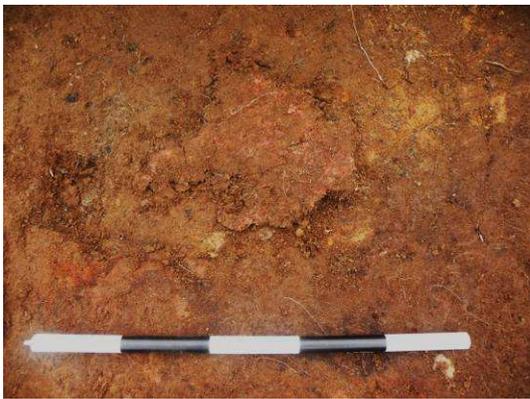
Fig 25: Piece of reddish wool in situ in floor deposit 053

The kitchen floor deposits from this occupation phase contained a wealth of artefacts, ceramic sherds from various vessels, mostly whiteware, vessel glass and window glass. They also contained a variety of iron objects, most of which are still unidentified. A high number of nails were retrieved from the floors, most notably from contexts 077 (40 nails) and 078 (17 nails). The artefact assemblage also included a possible knife with a bone handle (find 231) and a wooden object with a metal coating that is possibly a handle of a kitchen utensil (find 257). A large piece of reddish wool (Fig 25) was retrieved from one of the floors (context 053, find 172), a piece of wool was found in context 063 (find 199), and a small fragment of textile came from context 078 (find 250).

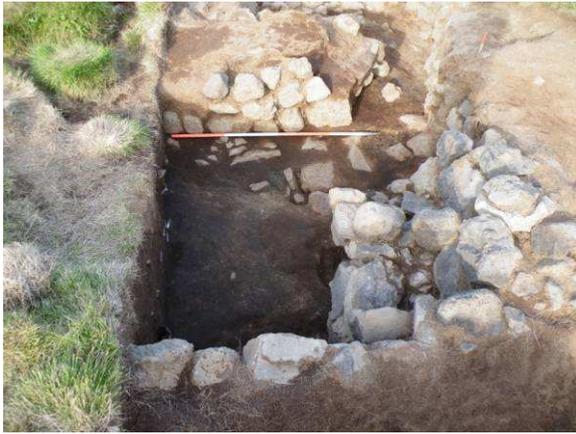
Fig 29: The kitchen on the last day of excavation

The earliest deposit in this occupation phase is the lowest floor (context 138), below which a deposit rich in turf that continues below the stove (group 024) was revealed. That deposit was left unexcavated as it was decided not to dismantle the stove at this stage in the excavation. It is noteworthy that when Nanna Jónsdóttir and Páll Gunnlaugsson moved to the farm in 1868

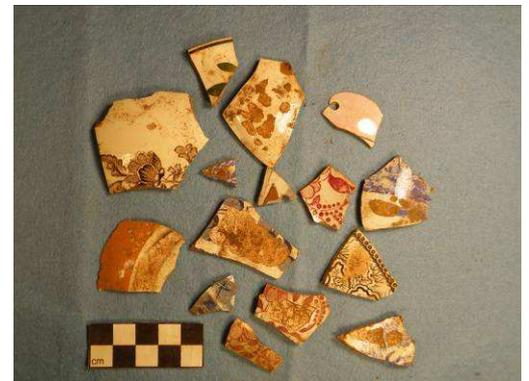
Fig 32: A selection of ceramics from one of the latest contexts (014) in the midden.
Finds group <062>.

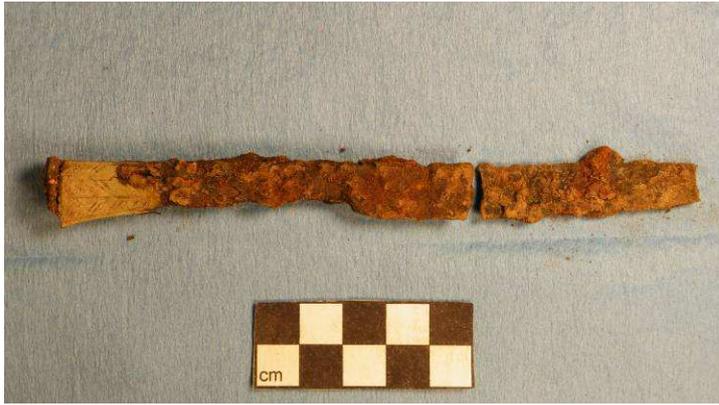
Fig 33 : Knife <265> found in the lowest context (074) in the midden.

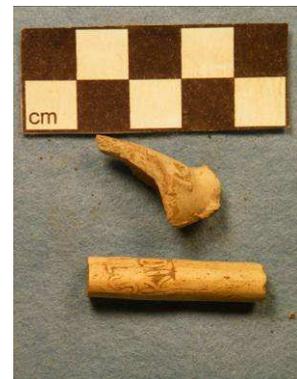
Fig 34: Clay pipe <184> from Stubbekøbing

date from late 17th/early 18th century to late 19th century. The lowest deposit in the midden context 076 contained a piece of German Frecken stoneware which dates roughly to late 17th or early 18th century. A variety of glass sherds were also found, both from vessels, green and clear, and window glass. A substantial amount of iron objects came from the midden: nails, fragments of tools, a couple of knives (e.g. see Fig 33) and many more objects, which are still unidentified. The clearest dating evidence came from the second lowest deposit in the midden (context 067). The deposit contained a fragment of a clay pipe which had a stamp from its manufacturer (Fig 34). The pipe originated in Stubbekøbing in Denmark and was in production from 1767- c. 1800 (Davey 1980).
