**EVALUATION OF ARCHAEOLOGICAL FEATURES AT
BREKKA AND DAÐASTAÐIR, NÚPASVEIT IN
ÖXAFJARÐARHREPPUR**

Evaluation report

Oscar Aldred

FS286-05151

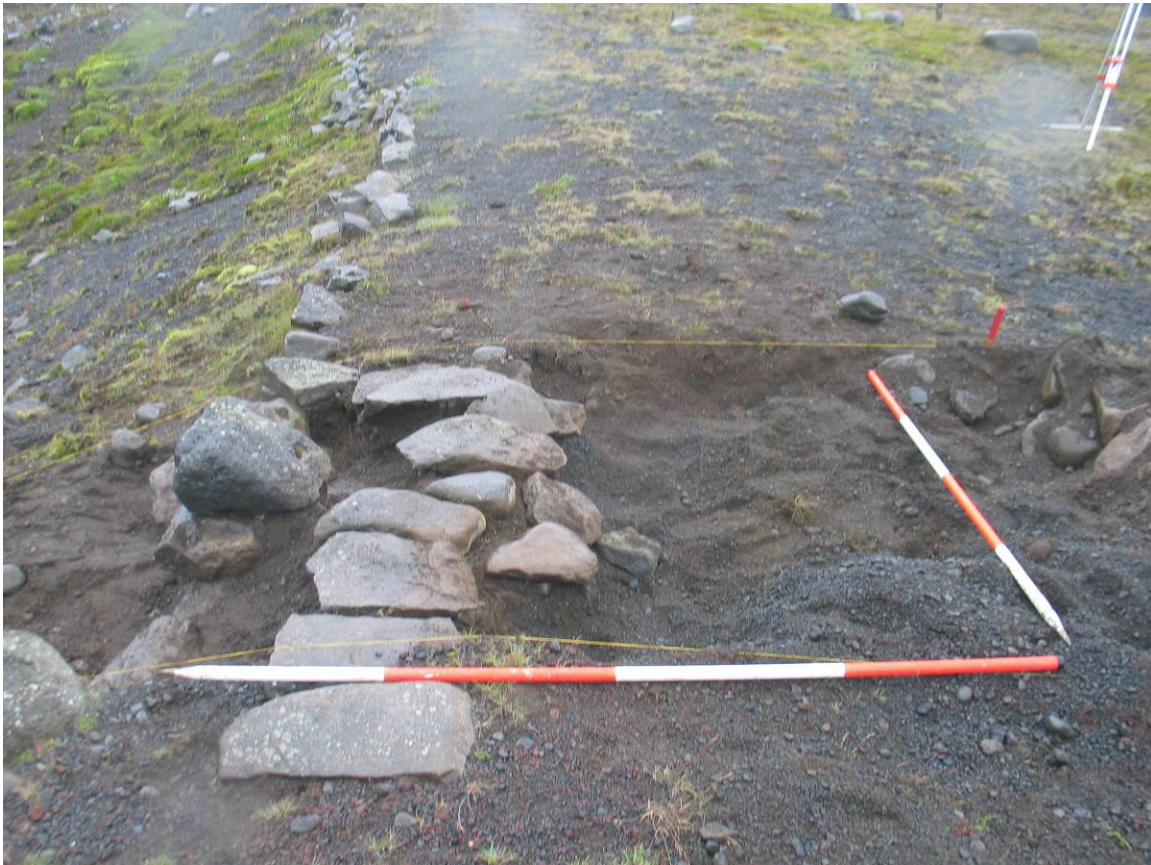
Figure 1 Looking north, the two stone revetment for the track.

The results of the excavation identified a stone constructed revetment [5], to support the northern edge of the slope. This was constructed 2-4 stones high, along two rows of stones, at an approximate depth of 0.5m. The stone construction sat over a colluvial windblown matrix. Other windblown and gravel deposits sat over the stones [1, 3]. Against the southern edge of the stone revetment a natural looking gravel deposit [4] comprising large stones sat within a fine gravel natural accumulation; this was incidently the surface deposits seen all around the site beyond the proximity of the road.

The stone revetment was visible either side of the trench, and probably has a similar construction. Towards the south, as it approached the present road downslope, severe erosion and destruction has occurred. Otherwise near to the trench further upslope it was relatively well preserved on the surface.

The stone revetment which is part of an old track was well preserved as a visible feature on the surface though excavation revealed that it was actually 2 rows of stones.
