Field Report

Barbuda Historical Ecology Project 2009
Antigua & Barbuda National Parks Dept and
City University of New York
March 11, 2009

Barbuda Historical Ecology Project 2009
Survey and Mapping for the Highland House, Barbuda
George Hambrecht
Cory look
Anthropology Department
Brooklyn College and CUNY Graduate Center

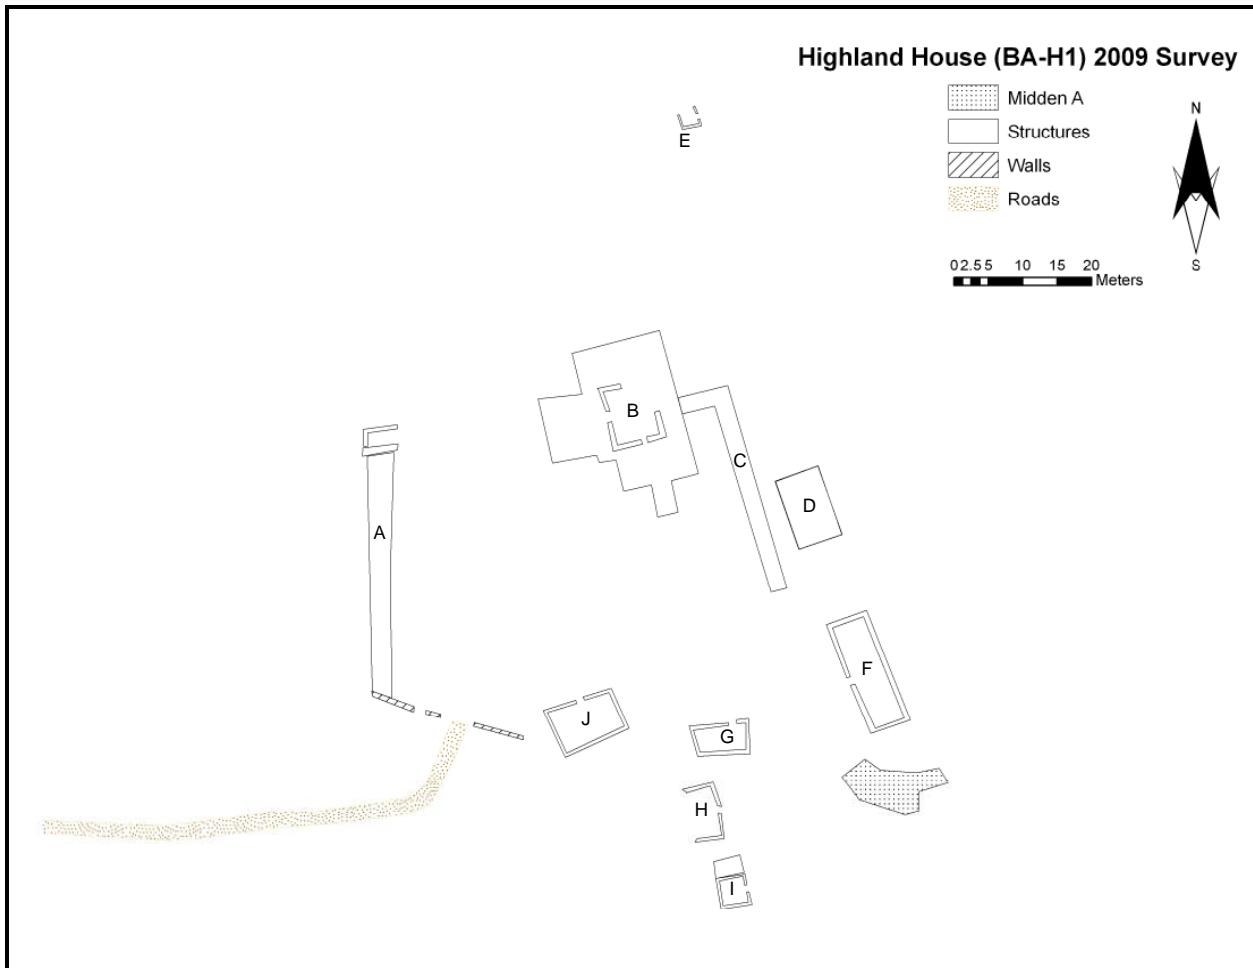
Table 1

Description	Watters 1982 Map Code	Hambrecht 2009 Map Code
Cistern and Spillway	2	A
Main House	1	B
Walkway to Main House	-	C
"Garden" House	-	D
Structure at edge of escarpment	-	E
Structure	9	F
Structure	7	G
Structure	6	H
Structure	8	I
Structure	5	J
Stone Drain	4	K
Wall	-	L
Homefield	-	M

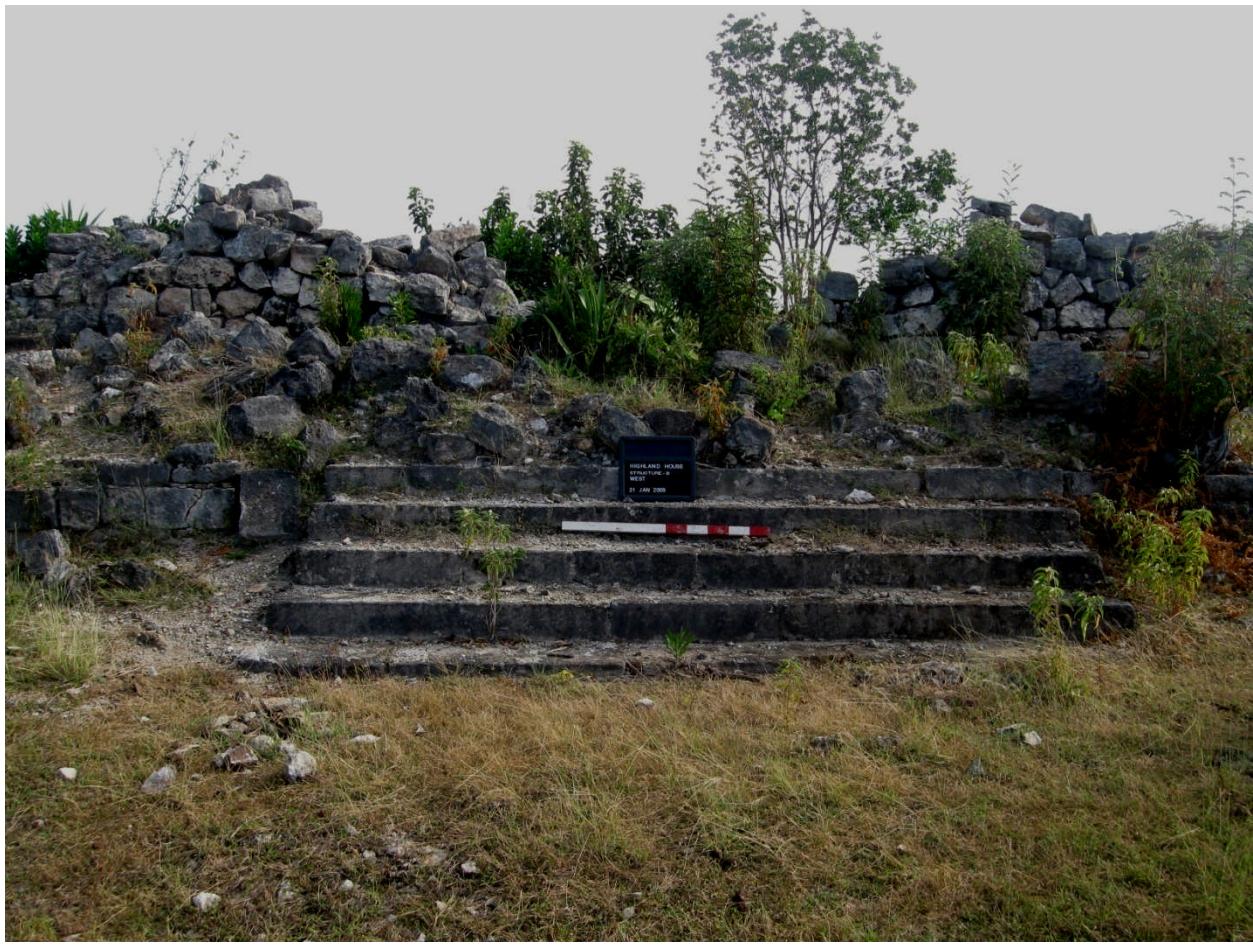
Figure 2. Main House (Structure B) – West Stairs

The whole house structure itself is very strongly built with walls in excess of a foot and half thick. The quality of the masonry in some cases is high as can be evidenced from the pictures of the western stairs (figure 2). The walls of the Main House itself seem to be of a rougher quality (figure 3).

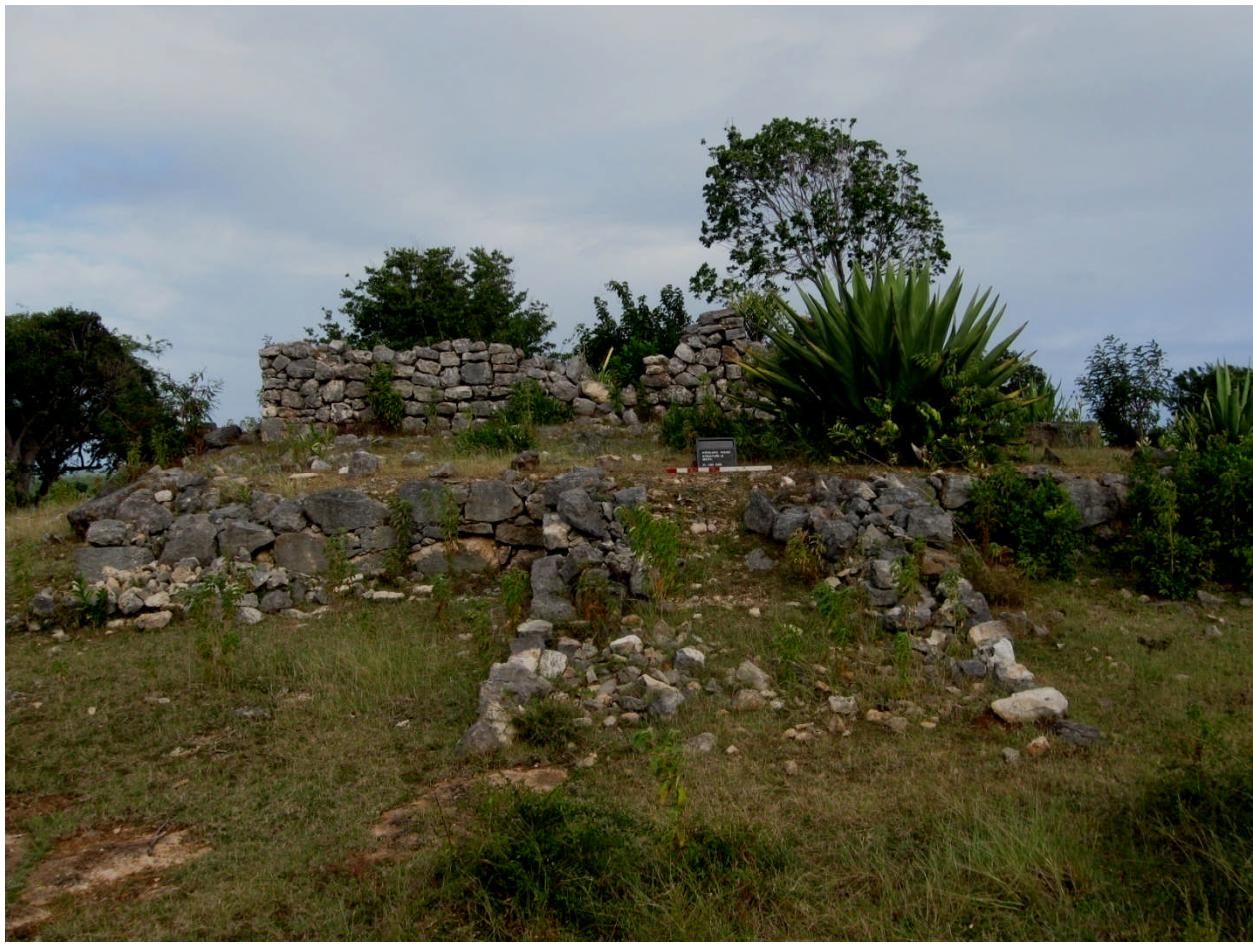
Figure 3. Main House (Structure B) – North Stairs to main house platform

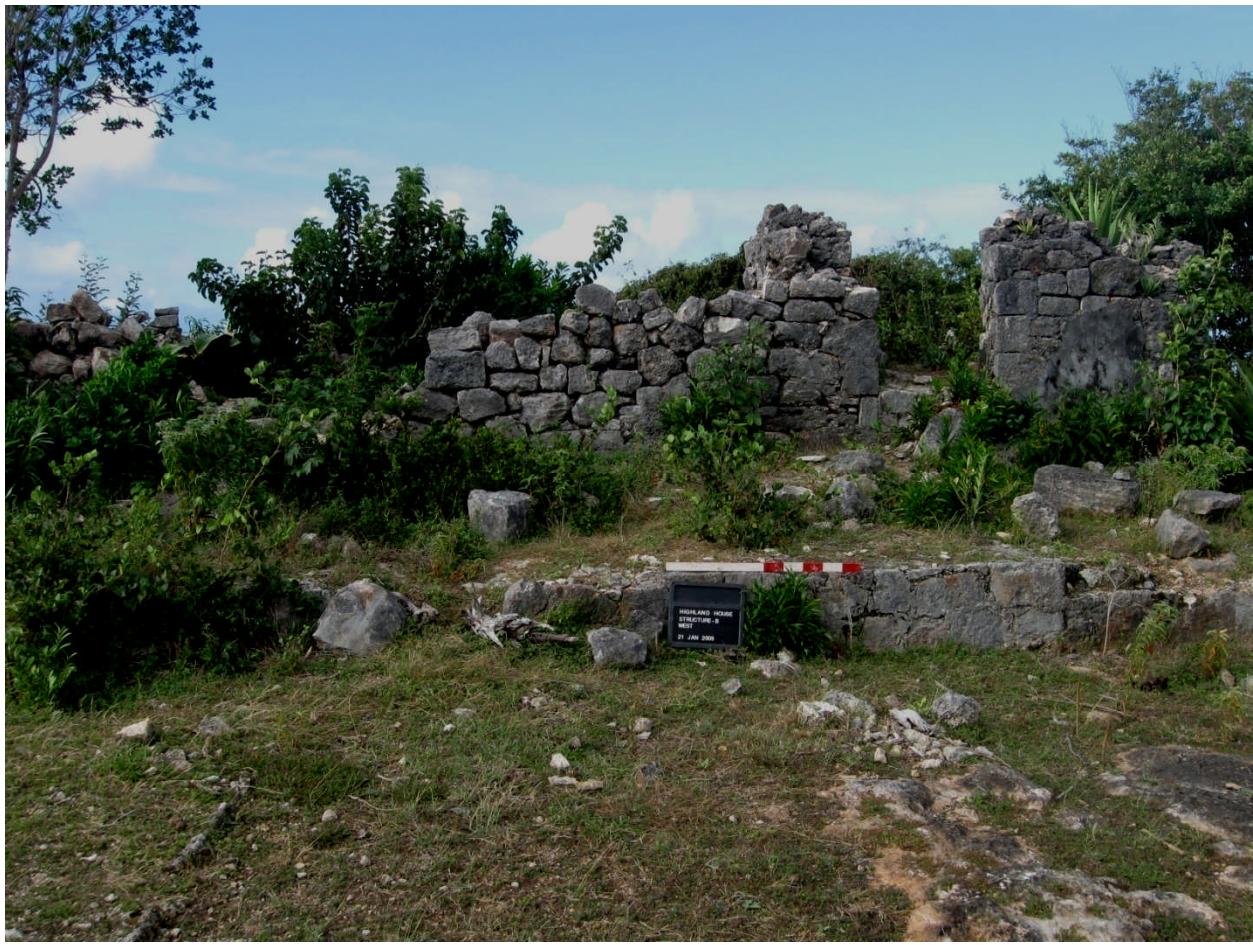
Figure 4. Main House (Structure B) – Eastern Stairs, Entrance, and main house platform. The line of stones on the left of the picture leading up to the platform is part of the walkway (Structure C).

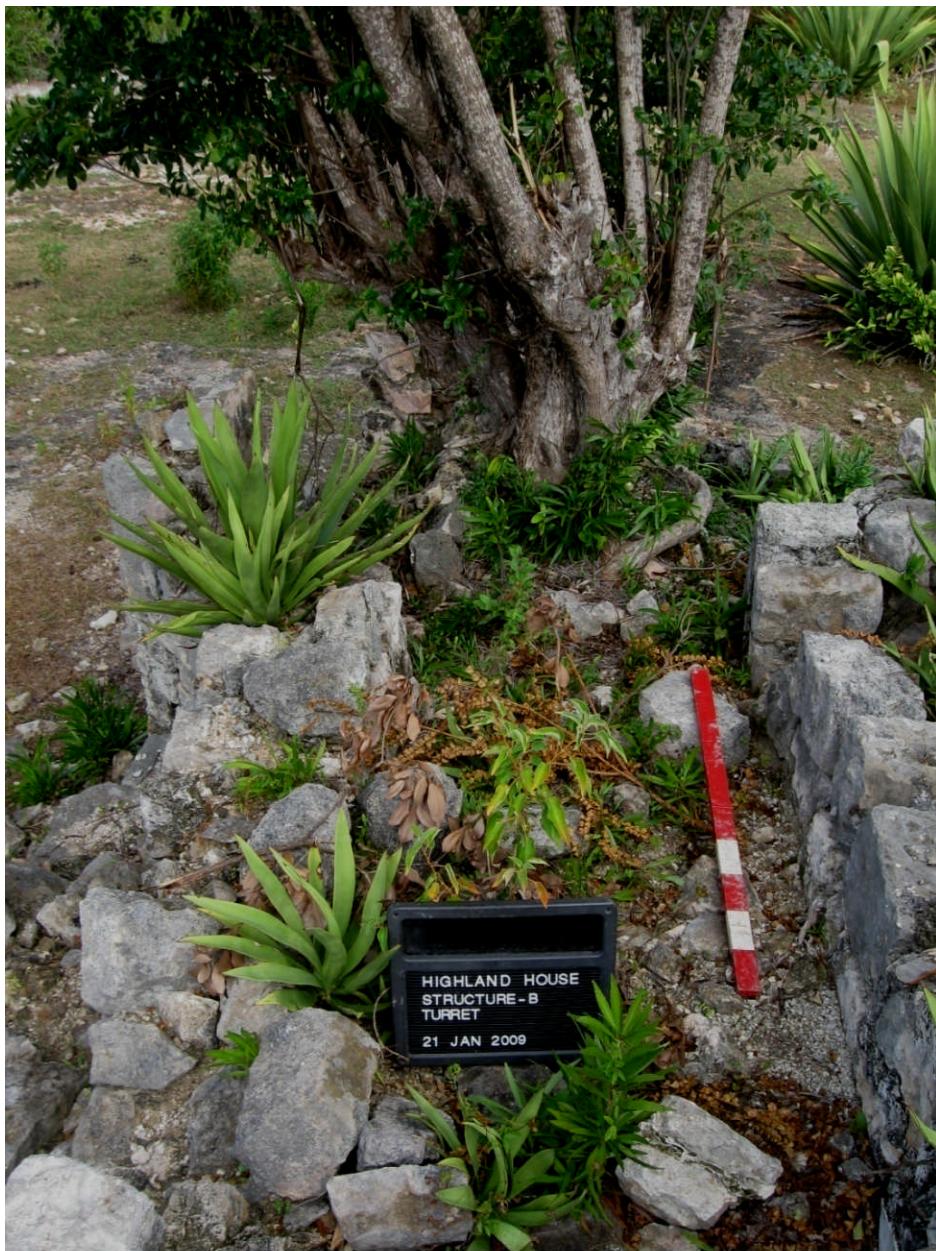
Figure 5. Main House (Structure B) – the “passage” down to the “turret” on the north side of the house.

A curious element of the Main House is on the northwest corner of the building. A passage leads from the northern “foyer” to the north ending in an octagonal stone structure (figures 5+6). There is a tree growing out of this structure whose roots have furthered the erosion of the structure and warped its original shape. This structure has been informally dubbed the “turret” as that was what it suggested when first observed. Calvin Gore, of the Barbuda Council and an invaluable source of information on all things Barbudan pointed out on the inside of this structure there is a reddish deposit that he usually associated with standing water. He suggested that this structure was a small cistern or even fish tank. Another possibility is that it was in fact a turret and what we see is the base of what was a tower for observing the northern end of the island. A further possibility is that it is a decorative feature.

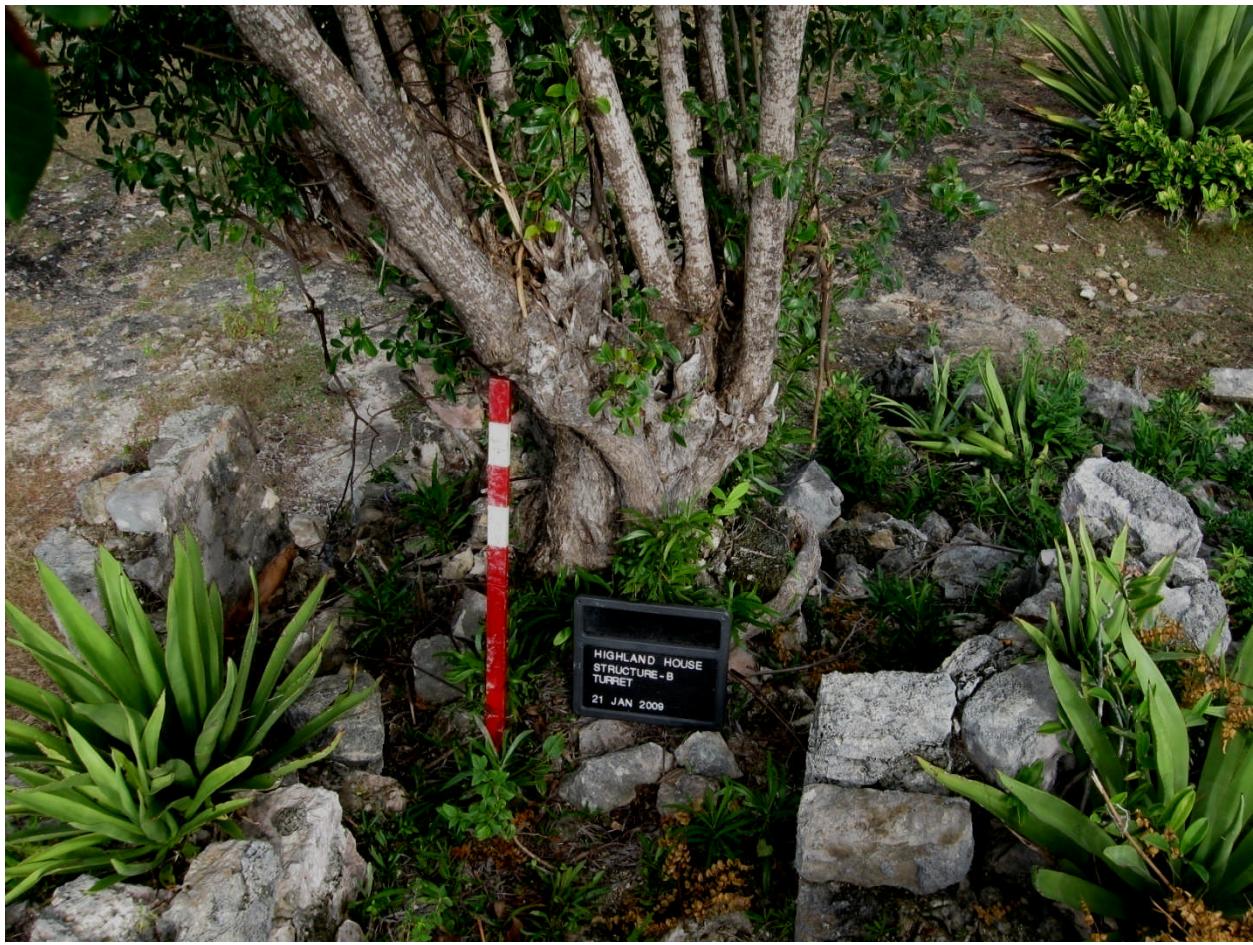
Figure 6. Main House (Structure B) – the octagonal “turret” on the north side of the main house.

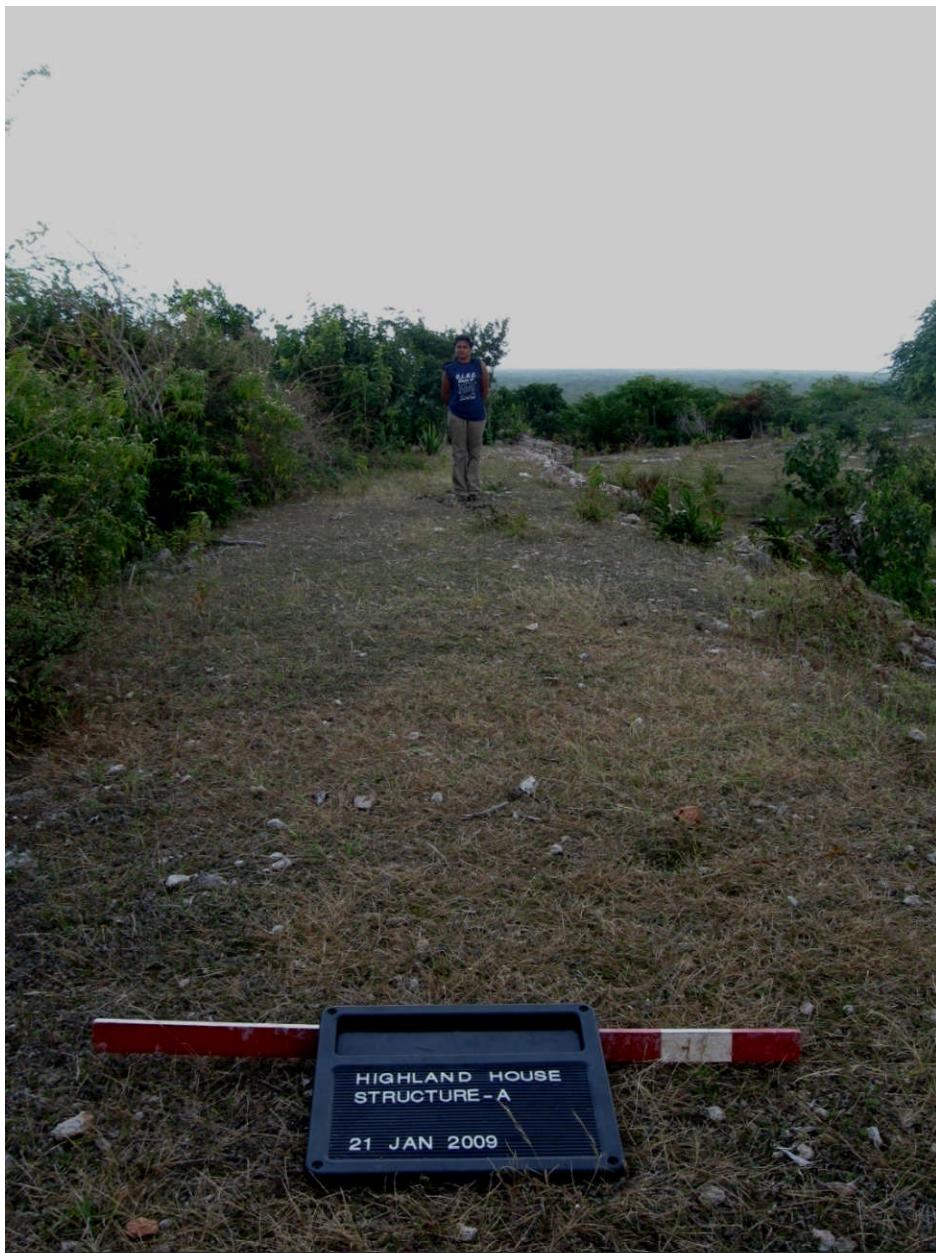
Figure 7. The Spillway going north, at a slight downgrade, toward the cistern. Structure A is the spillway leading at a slight downhill angle, to the north, into a cistern. Historic documents mention the presence of a cistern at Highland House, and the lack of freshwater anywhere near the house would have made storage a necessity (Watters and Nicholson 1982). The spillway has eroded significantly but it still clearly leads into the cistern which was built of good quality masonry.

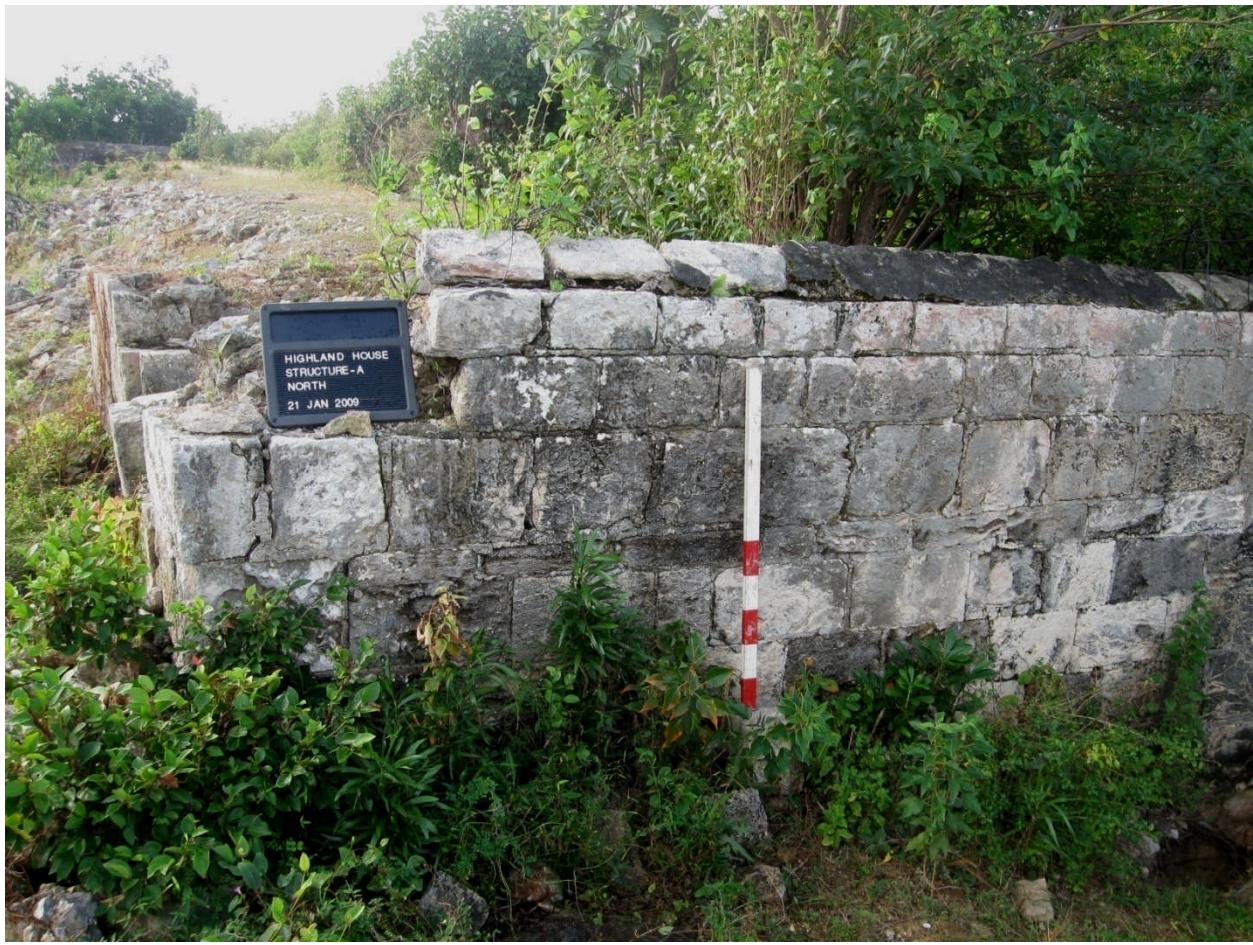
Figure 8. Cistern (Structure A) – north side with view of the spillway

There are stairs leading into the cistern from the eastern side of the structure and on the opposite side there is an overflow drain (figure 9). The cistern is currently filled with rubble, dirt, and vegetation. The spillway also functioned as the western boundary wall of the complex itself. The wall (structure L) ends at the southern end of the spillway and directly abuts it.

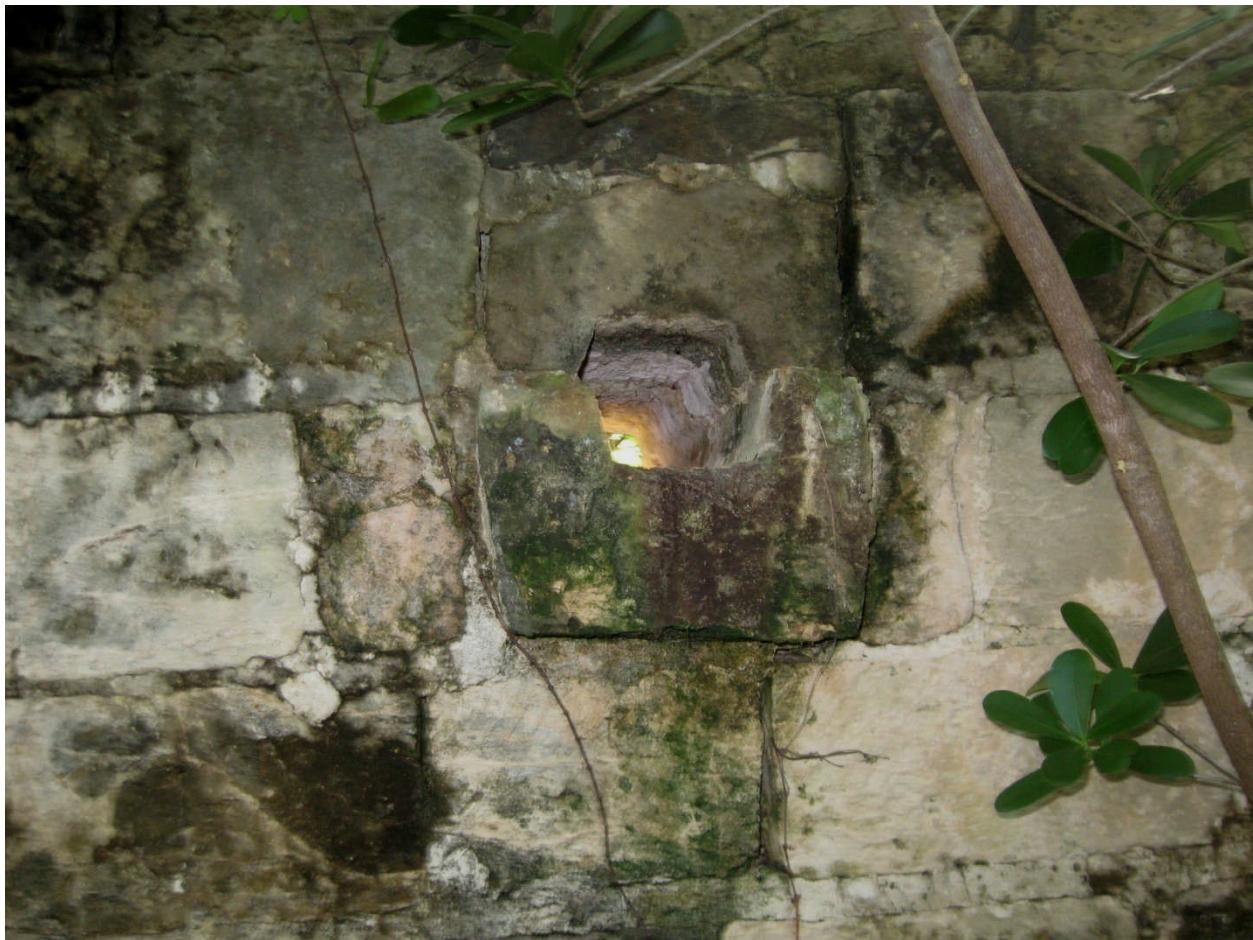
Figure 9. Cistern (Structure A) – overflow drain on the western wall of the cistern.

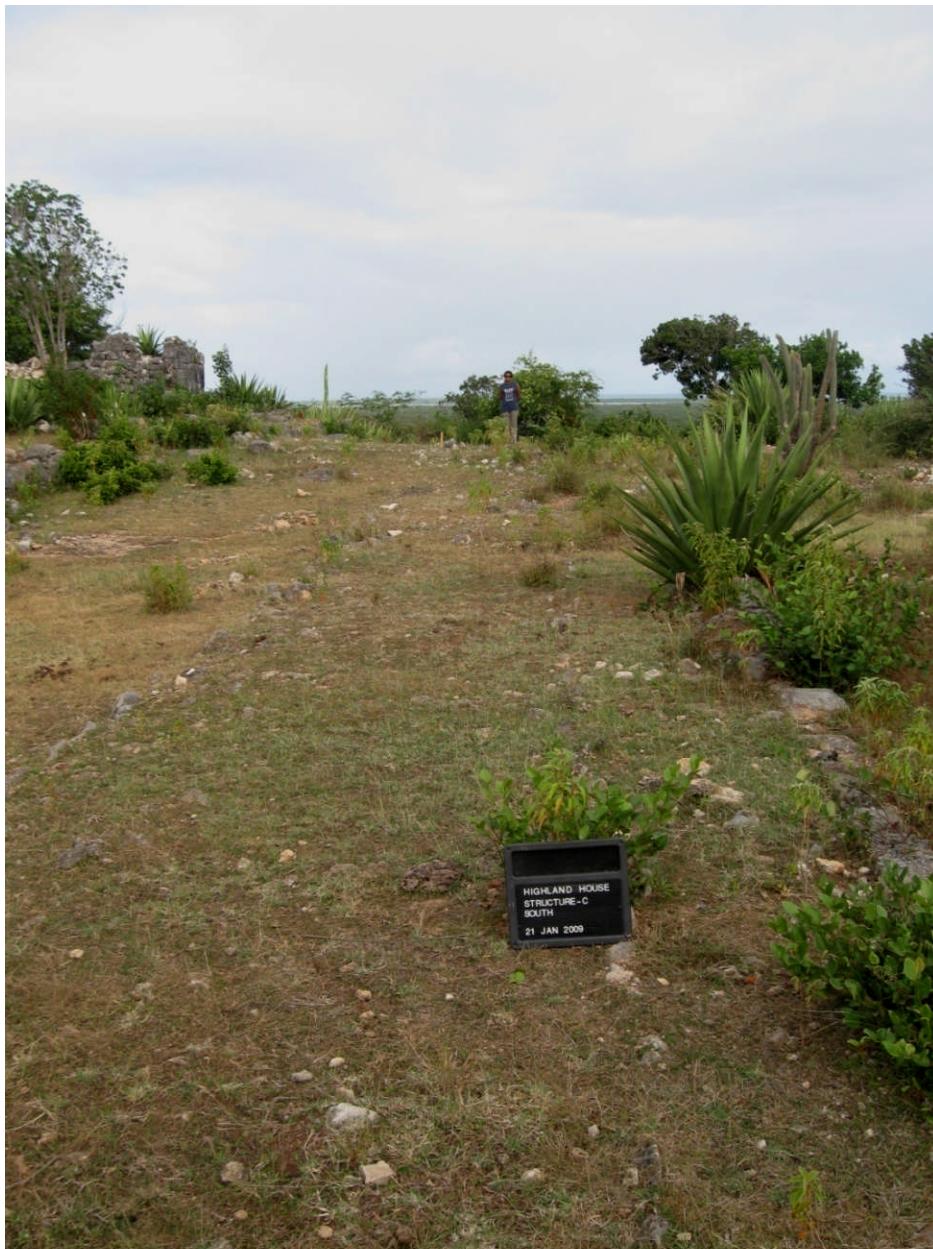
Structure C is the walkway mentioned before that connects the southern area of the complex containing the many outbuildings with the main house (figure 10).

Whether this walkway was a decorative landscape element or had some more specific use is uncertain. Considering that the main entrance seems to have been in the south this walkway might have been a formal approach to the main house. More research on Georgian approaches to landscape in such a peculiar context as this must be undertaken before the whole complex can be understood as a landscape/architectural statement.

Figure 10. The Walkway leading from the south to the eastern entrance of the main house.

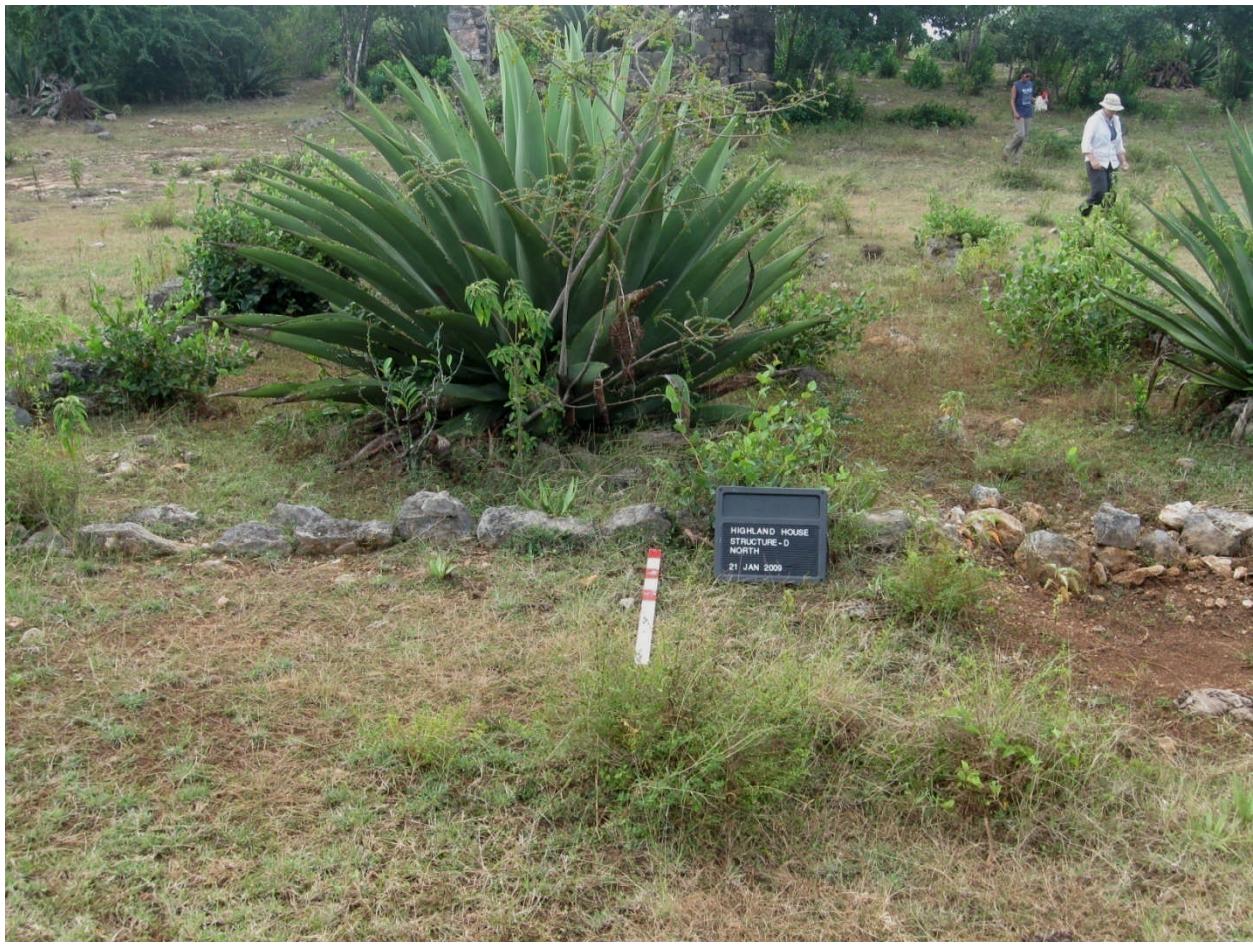
Figure 11. Structure D – north end

Structure D is more enigmatic than the rest (figure 11). It consists of a low rectangular foundation with very little masonry left intact. The quality of the stonework also seems much more haphazard. This might be one of the more temporary structures associated with the sub-leasees Byam and Martin, though there are other possibly more relevant similarities in some of the other out-buildings. Regardless this large structure (in terms of area) seems to have been of less permanence than the rest, unless it was dismantled and its masonry used for the other buildings at some time. Another possibility is that it was a garden element, possibly recreational and decorative in use.

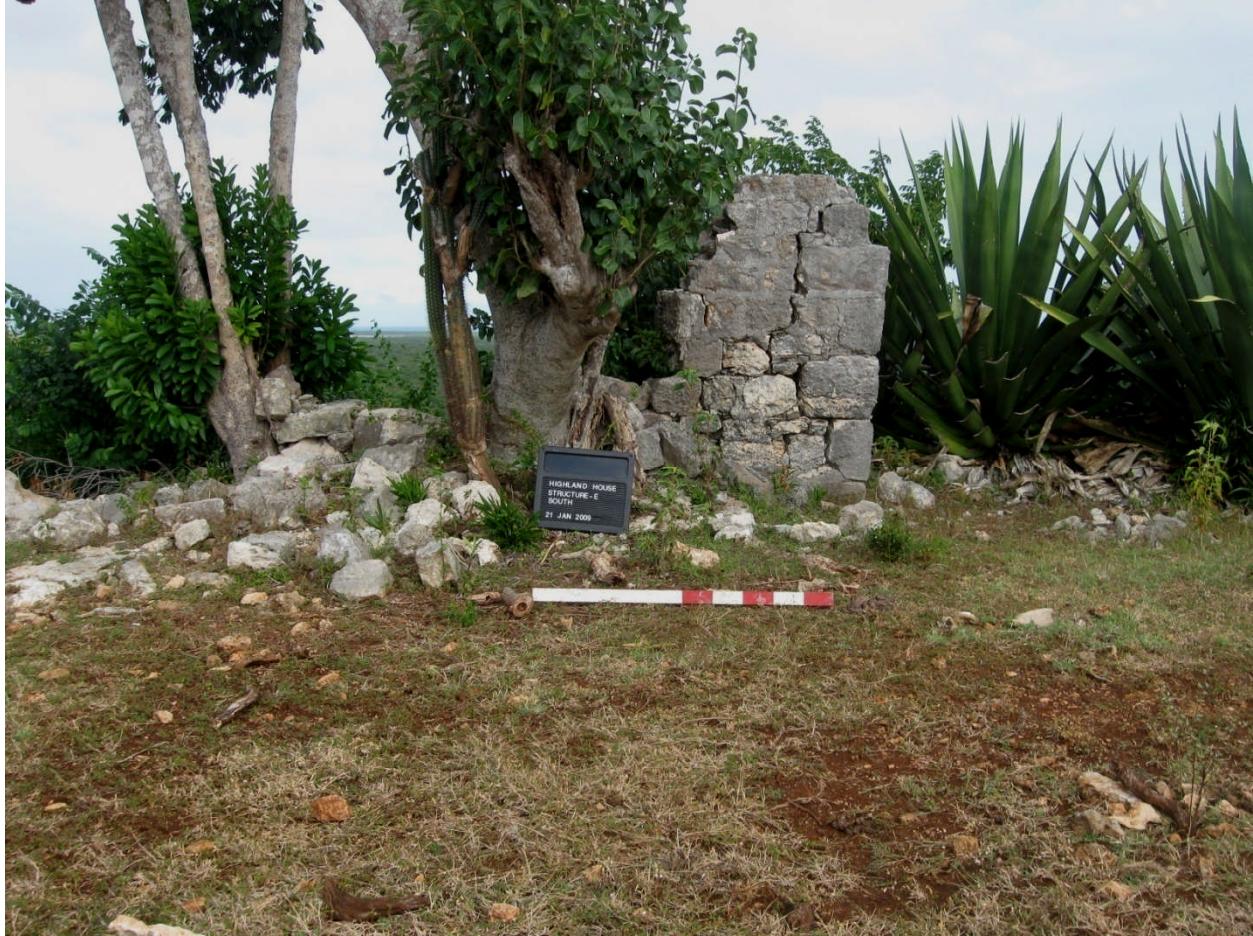
Structure E lies right on the edge of the escarpment (figure 12). Much of the northern end of the building has toppled off the escarpment leaving barely two walls intact. Initially it was thought that this building might have served as a watch tower considering its excellent view shed from the edge of the plateau. Yet there are many places from which to achieve this view, not least from the Main House itself. Another possibility that came to mind was that this might have been a privy. The drop off of the escarpment is fairly severe and at least during the rainy season any waste would have been washed further down the hill. It would have been a convenient place to get rid of human waste, close to the houses yet

with a good drop off from the escarpment that would have kept the waste at least somewhat distant. While no specific privy-like architectural elements (such as stone toilet holes) are present, much of the north side of the building has collapsed. The size and quality of the whole complex, as well as some of the more specific kitchen related elements suggest that the Codringtons might have invested in such a well built and solid privy. Finally Calvin Gore told the author that some of the best midden material associated with the site actually lies on the slope below the edge of the escarpment, suggesting that household trash was thrown over the side of the escarpment. This might also suggest that Structure E was a privy.

Figure 12. Structure E – southern end.
Structure F

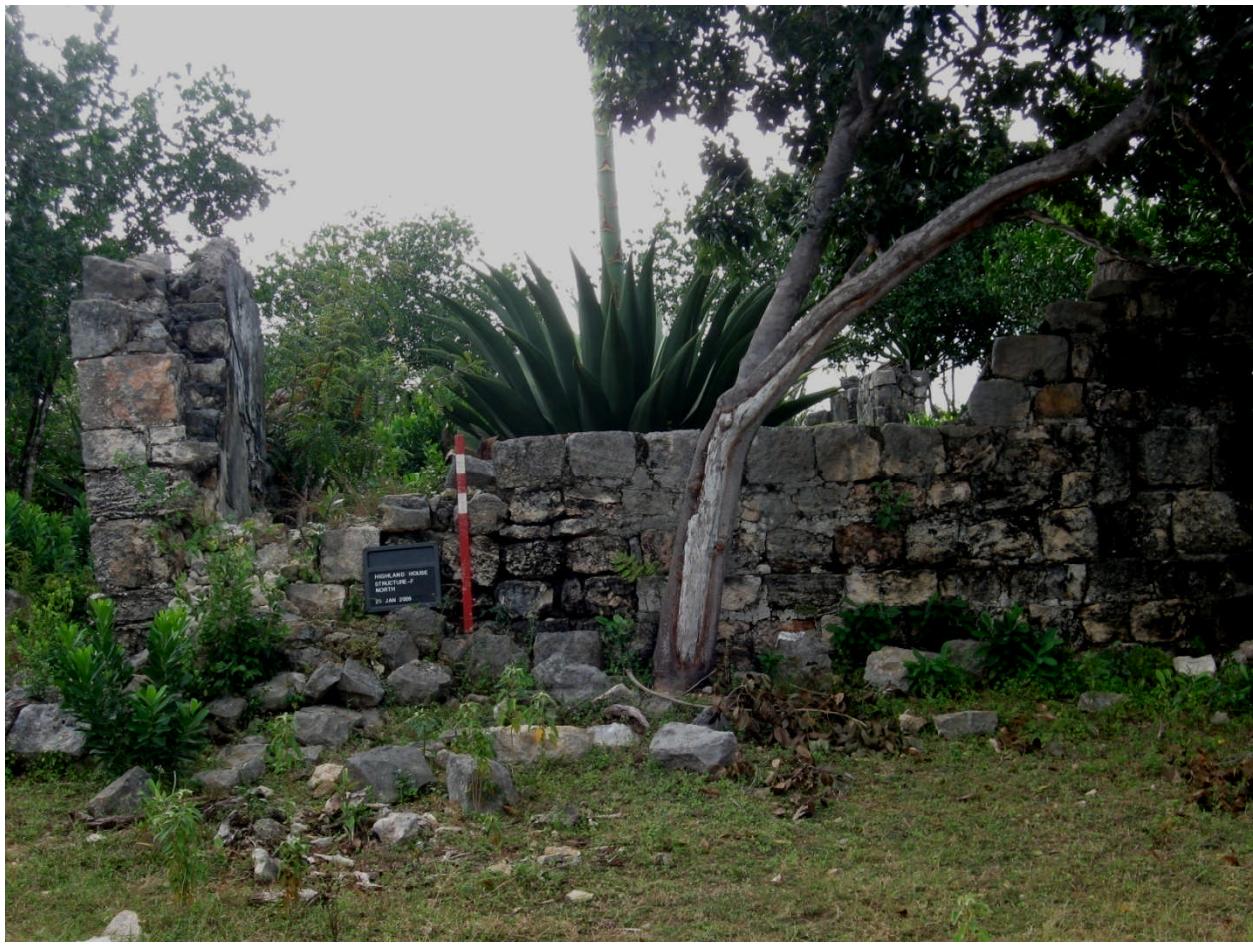
Figure 13. Structure F – north wall.

Structure F is a large building built of high-quality stonework (figure 13). It has a number of patches of plaster still on its internal walls. It is not possible to do anything other than speculate on its use. It had a number of widows on each side as well as an entrance on its southwestern corner.

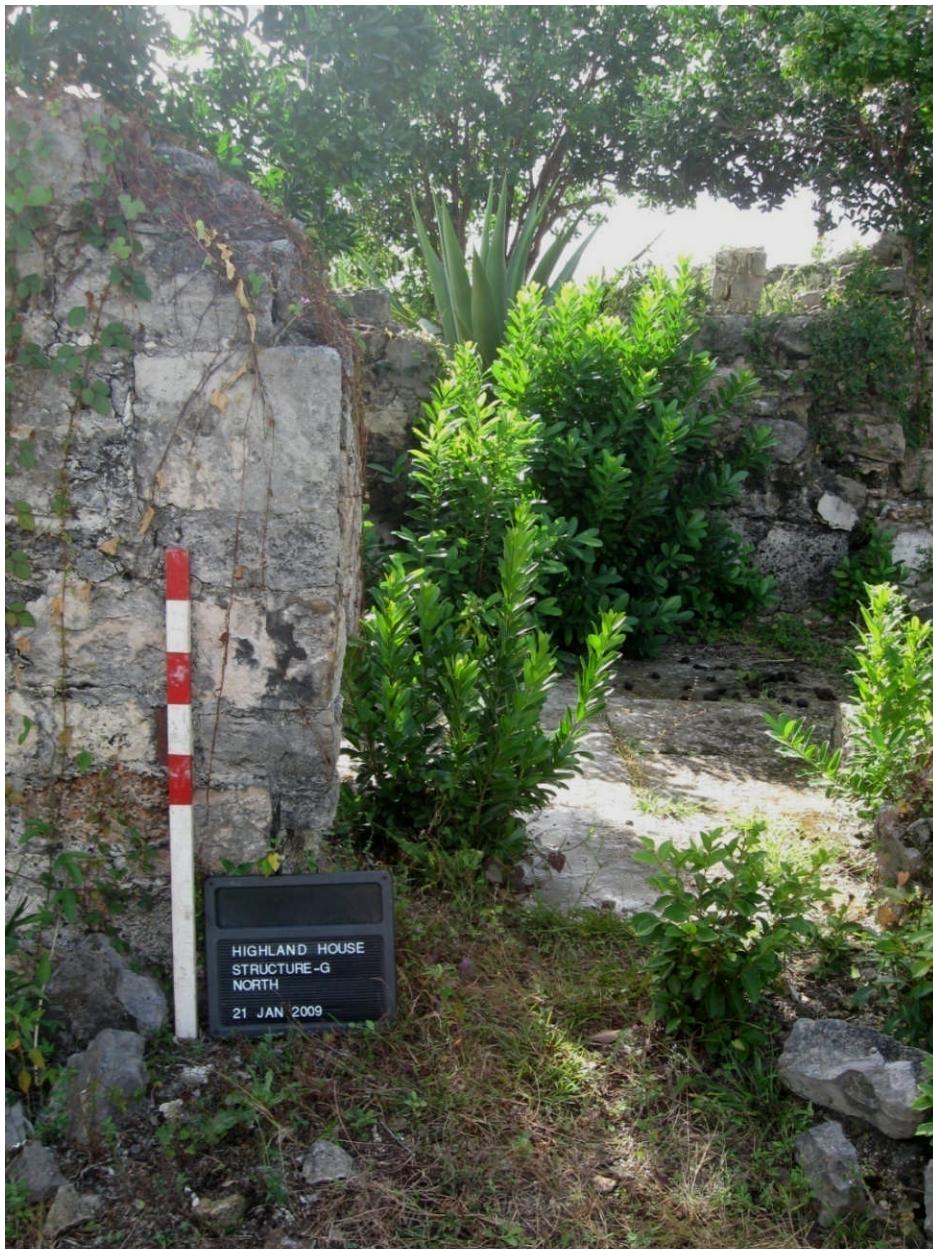
Figure 14.

Structure G is a smaller building also made of good quality stonework (figure 14). It had been cleared of most of the rubble and vegetation within it exposing a high quality flagstone floor (figure 15). This structure also shows evidence of a number of alterations throughout its life. A doorway on its eastern side as well as one on its northwestern corner were filled in half-way, creating windows. It also shows evidence of possible partitioning. Its relatively small size and the alterations made to it might suggest that this building contained administrative offices.

Structure G – north wall and entrance.

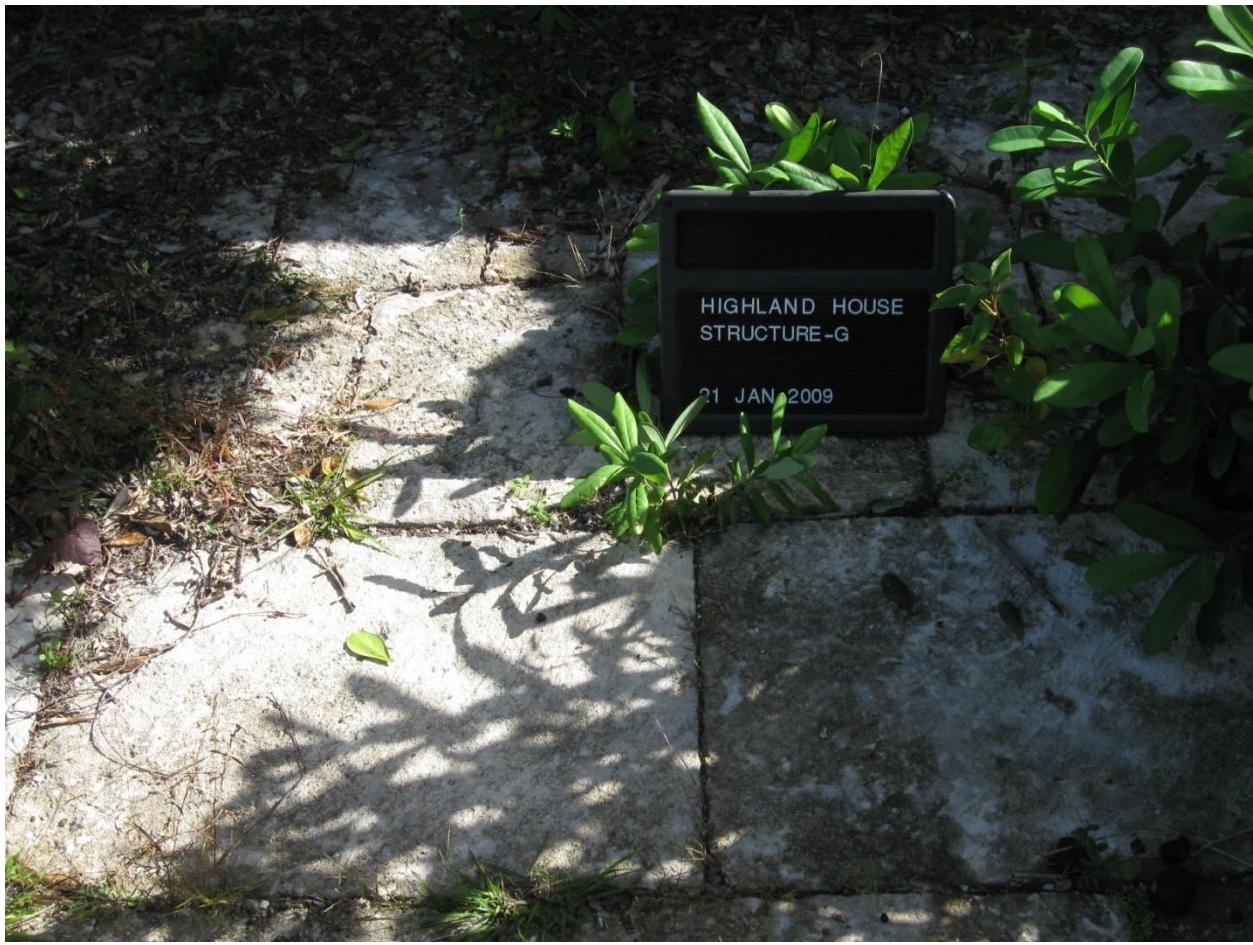
Figure 15. Structure G – flagstone floor

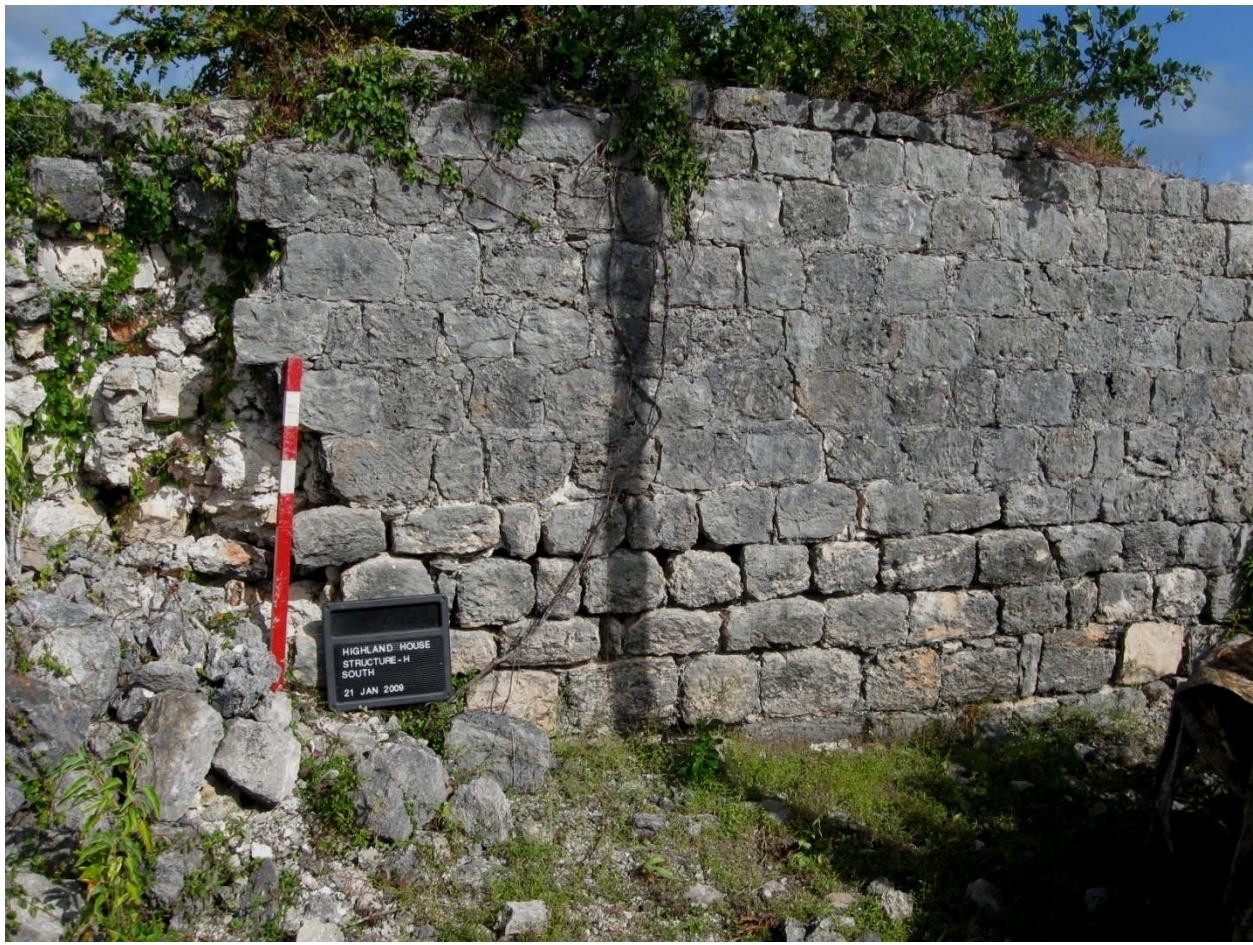
Structure H is another structure constructed of high quality fitted masonry(figure 16). The walls of this structure survive to the greatest height of any of the buildings. Again the purpose of this building is unknown.

Figure 16. Structure H – south wall.

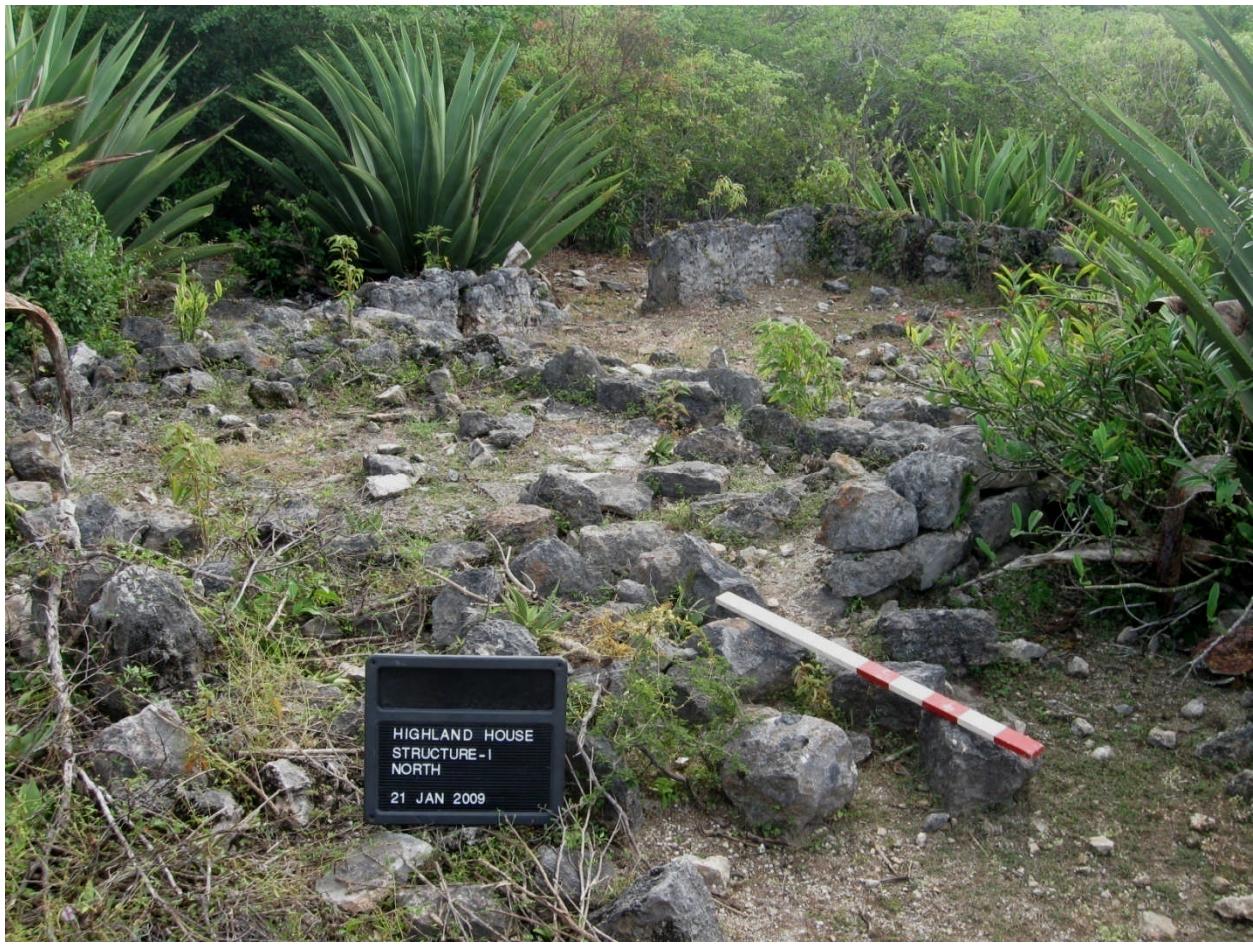
Structure I is a building divided down the middle into two parts (figure 17). The northern part might have had high, complete, stone walls. The southern portion has foundation walls that rise to about 30-40 cm and then taper in. The inside of these walls have insets where presumably wooden structural beams were laid (figure 18). This structure might have been a small stone room with a projecting tented room to the south. Historical documents and letters mention two timber structures that might have been built by the sub-lessee Byam. This structure is a good candidate for one of these.

Figure 17. Structure I – north end.
