Field Report

Barbuda Historical Ecology Project 2009
Antigua & Barbuda National Parks Dept and
City University of New York
March 11, 2009

Barbuda Historical Ecology Project 2009
Survey and Mapping for the Highland House, Barbuda
George Hambrecht
Cory look
Anthropology Department
Brooklyn College and CUNY Graduate Center

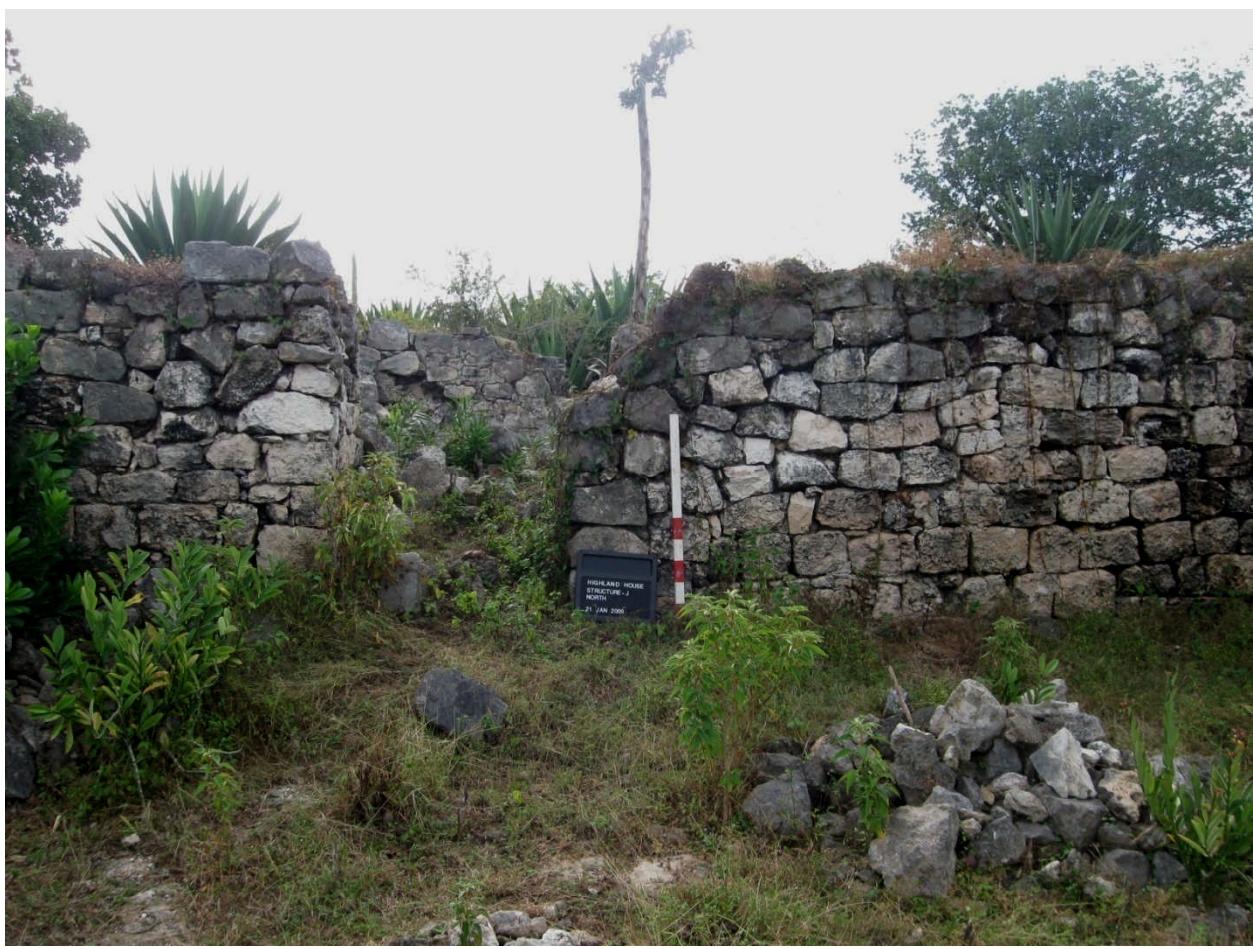
Structure J is a two room building with access to the outside from both rooms as well as a doorway between the two (structure 19). The stonework of this building seems a bit rougher than the other buildings and there are some interesting indications that this might have been a kitchen or washing building. Inside of the western room there is a large stone basin as well as a length of stone gutter. Directly outside of the building on the south side from the basin lies structure K (figure 21). This is a long stone drain that leads from Structure J downhill away from the building running roughly southwest, outside the complex wall (figure 22, Structure L). Below where this drain ends there is a light but consistent spread of historic midden material, bone and ceramics, that has been labeled Midden B. A preliminary interpretation of this building and the drain is that this was either a wash-house or kitchen, or possibly both. The waste from the activities centered around the basin was thrown out into the drain so that the waste ran down the drain downhill away from the complex itself. It was not clear whether there was a direct connection through the wall from the basin to the drain.

Figure 19. Structure J – north wall and entrance.

Structure J and K (the possible kitchen/wash house and the stone drain) might also be a promising approach to excavation.

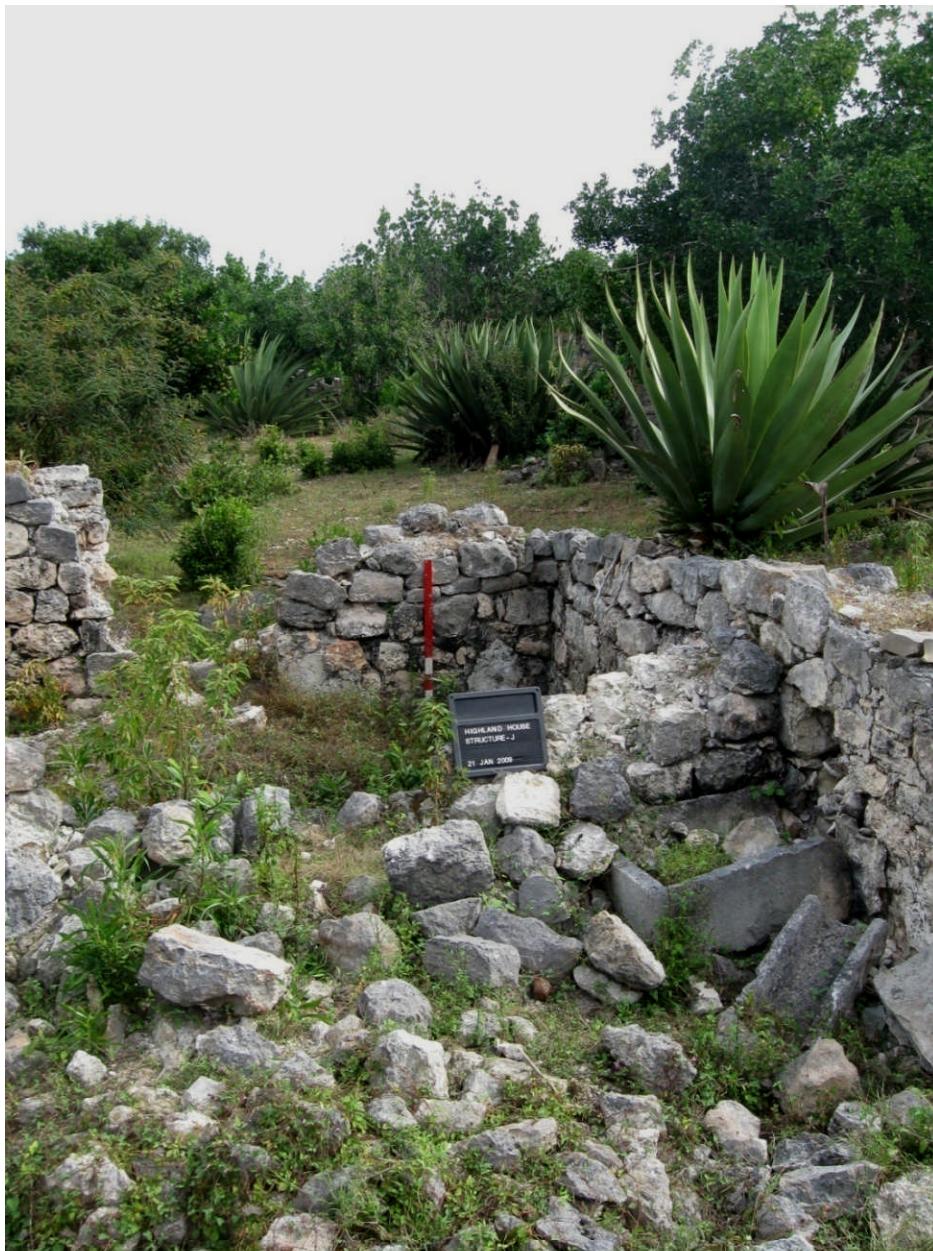
Figure 20. Structure J – looking east – note the partition, the large stone basin on the right and the length of stone trough below the basin.

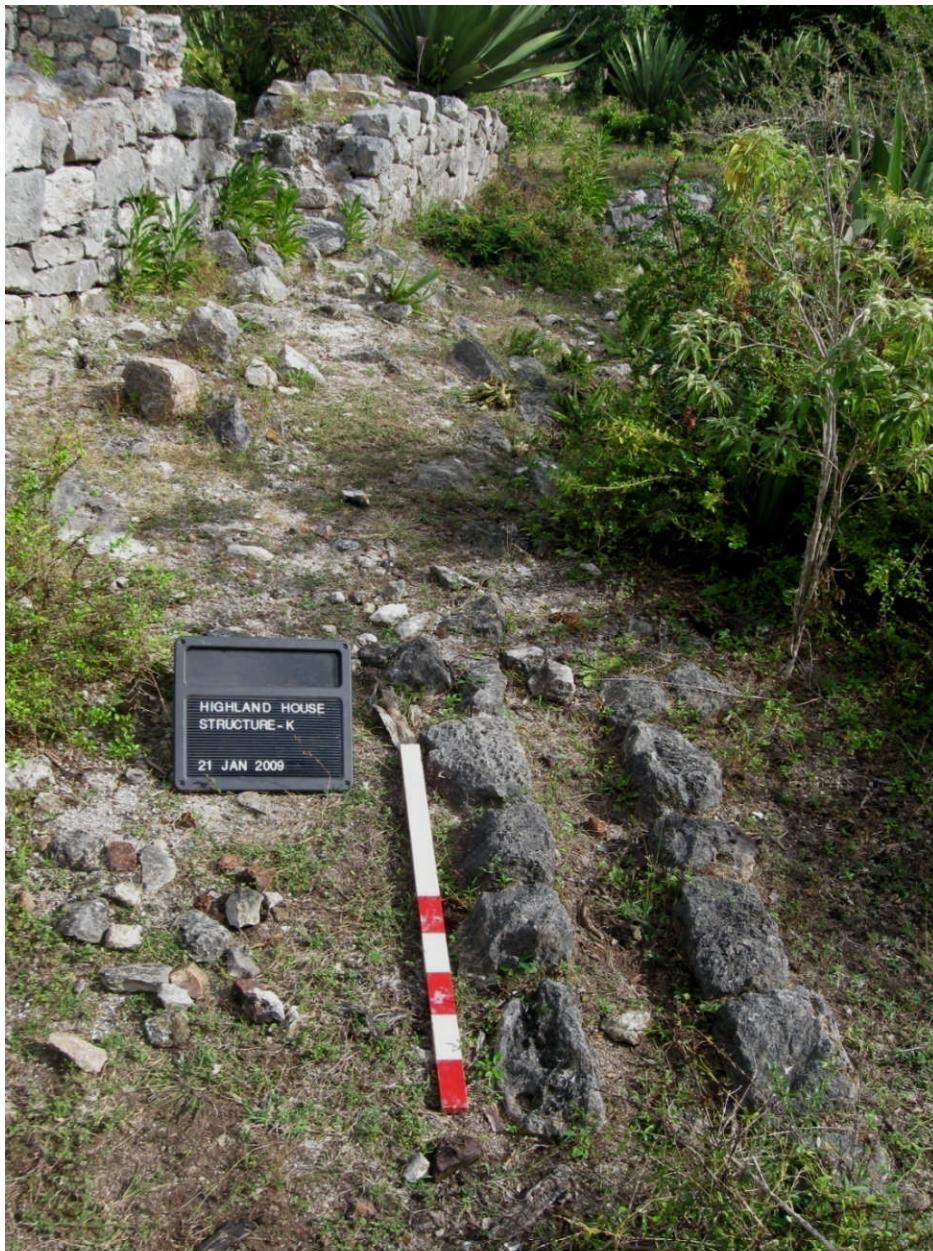
Figure 21. Structure K – the stone drain

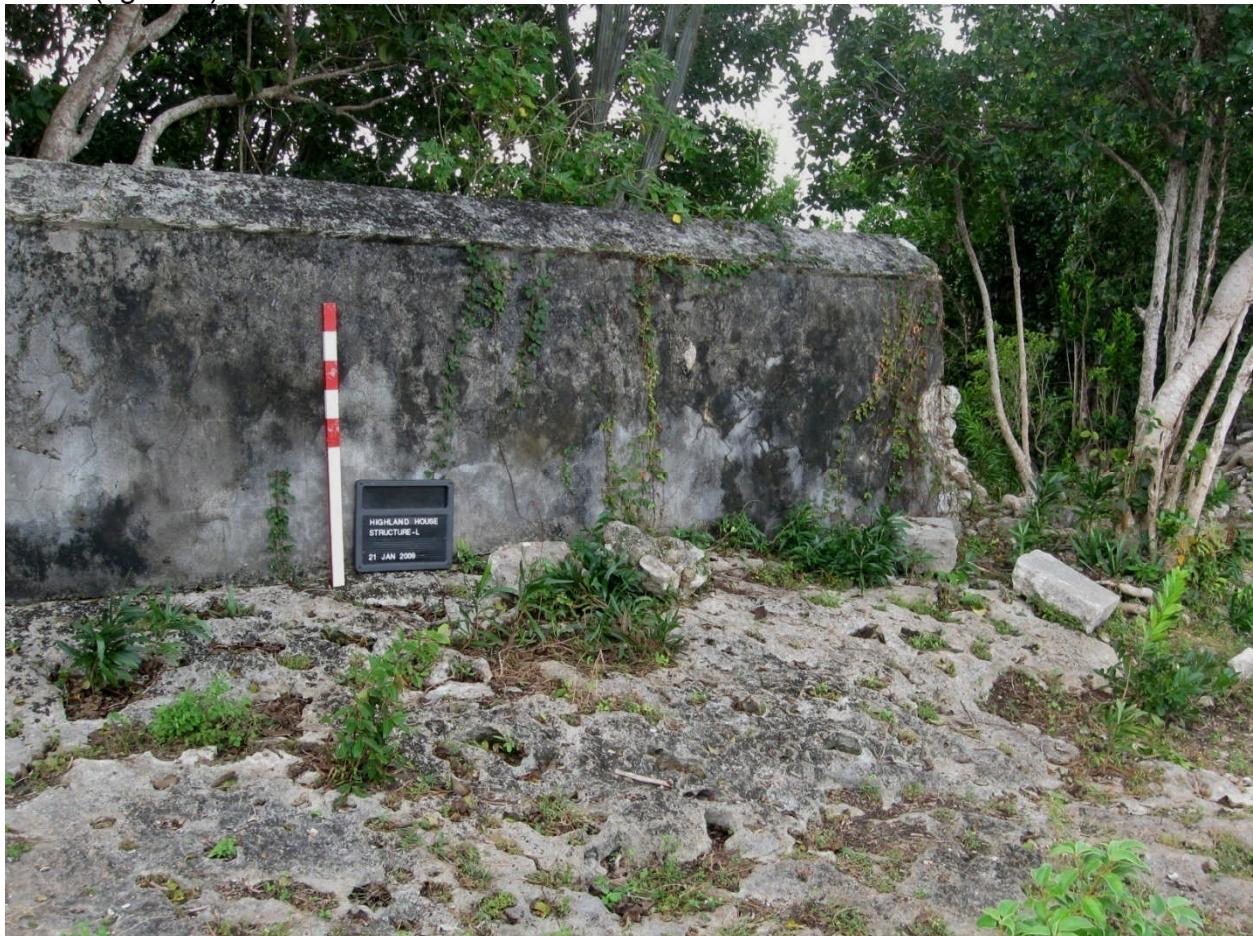
The wall around the complex is an interesting element. It does not completely encompass the complex. The wall ends at its western terminus abruptly, and in ruins. Calvin Gore has suggested that this was due to the stonework being removed for other buildings. This would be odd in that the western end is farthest away from the village of Codrington. It could be that the wall was deconstructed for buildings on the western side of the island, though these are few and far between. Another possibility is that the wall just stopped being built at this point.

Figure 22. The Wall – (Structure L)

This brings up the question of what purpose the wall served. Protection, from other colonial powers and their own slaves, would not have been served through a non-contiguous wall. Keeping animals out of their planted areas might have been one purpose. The wall could also have been a delineator between the Codrington's area of leisure and sport and the rest of the island and its farming and animal husbandry.

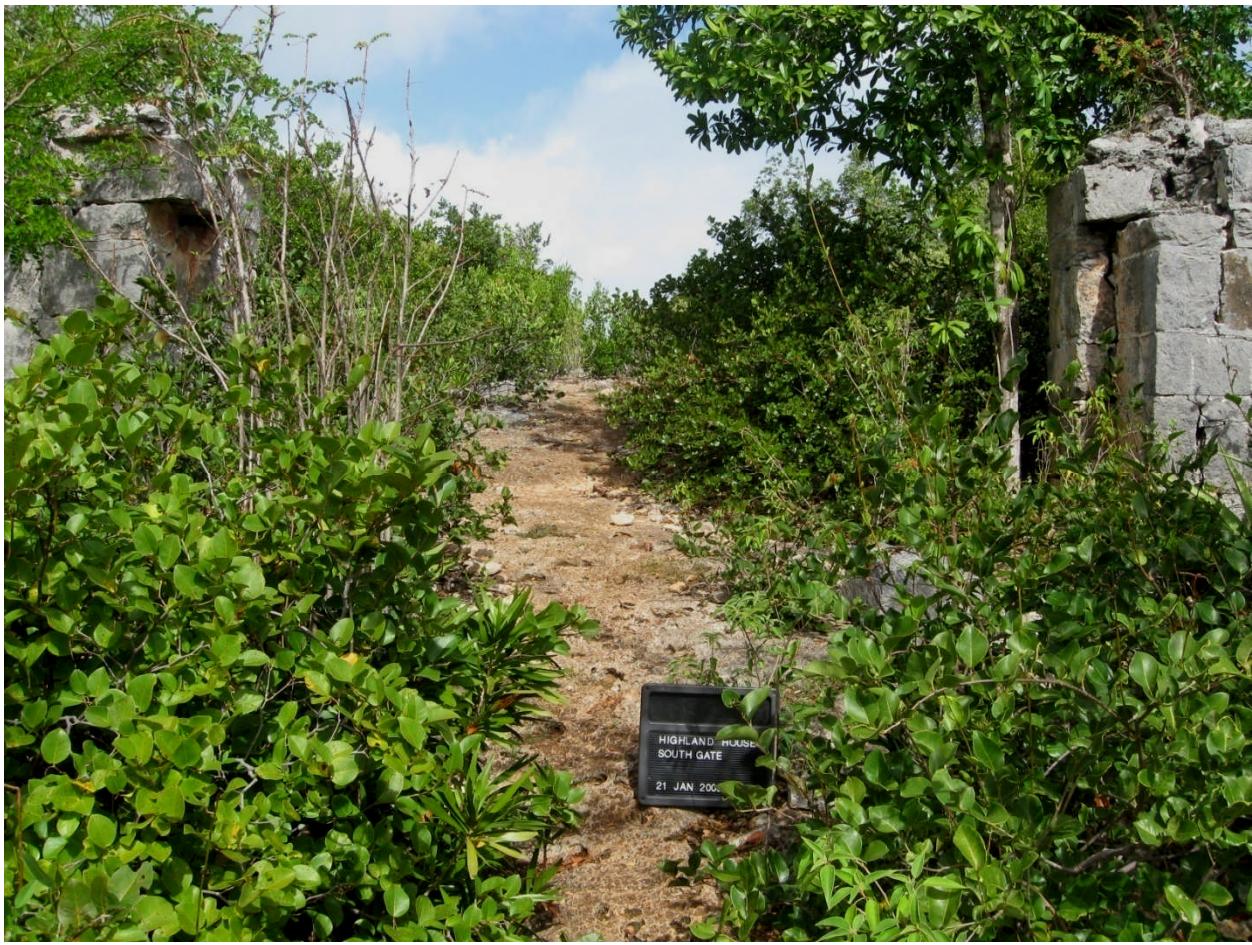
Figure 23. The South Gate

The southern gate of Highland House seems clearly to have been the main entrance to the complex. The approach would seem to have been from the south. The current approach from the west is modern and the opening in the wall one that was broken through, not an original gate.
