Norse Coastal Landscapes

Field report on surveys and excavations in the coastal area of Vatnahverfi Summer 2010

**The National Museum of Denmark,
Department of Danish Middle Age and Renaissance, Copenhagen, Jan. 2011**

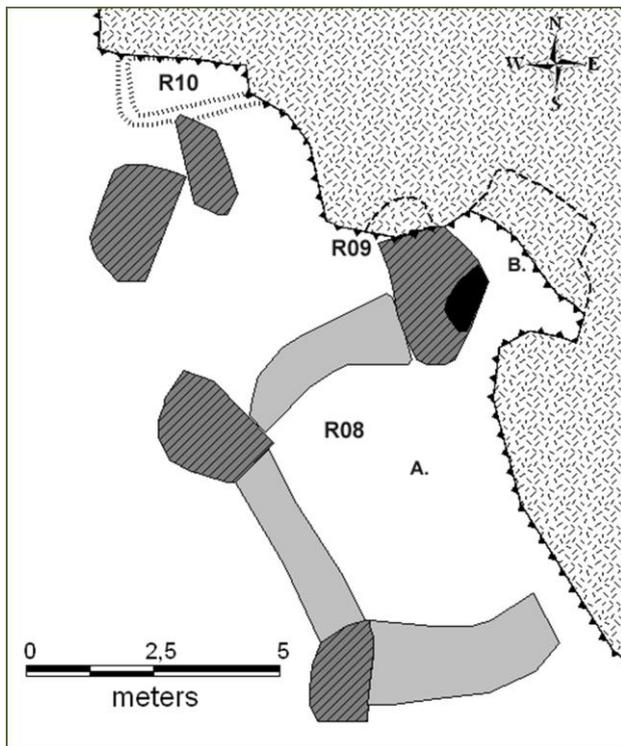
Fig.5 Ruin 08-10.

Ruin 08 (fig.5): This ruin is found some 600m up the valley, just north of the main cluster of structures (fig.3). The ruin is found in the edge of a boulder field just below a steeply ascending mountain side and exploiting several of these massive, naturally deposited boulders as part of the construction, hence giving the structure a rather uneven shape. The walls of the structure are either dry-stone build on top of these boulders to a height of c.50cm's (c.40cm's wide) or, in places, more collapsed turf-stone walls of c.40cm's height and c.100cm's in width. The structure is divided in two parts; a.) a c.8,5x5m large enclosure with an exit in the SE corner and with a entrance in the NE corner to b.) a smaller compartment or enclosure, c.3,5x3m, and halfway roofed by naturally deposited boulders. The structure is overgrown by willow, grass and buttercup.

Ruin 10 (fig.5&7): Just c.5m's NW of ruin 08 one finds another rather irregular ruin; in the edge of the boulder field and partially exploiting this for walls, there is a small and roughly trapezoid structure, ca.2,1x0,5-1,1m (inside dimensions). To the W and S, the walls partly consist of naturally deposited boulders, partly of build up stone/turf, while the E and N sides are made up of naturally deposited boulders. This room appears to have been dug c.50cm into the ground. No visible entrance could be found. It is probably to be interpreted as a sheep/goats shed used in connection with ruin 08-09.

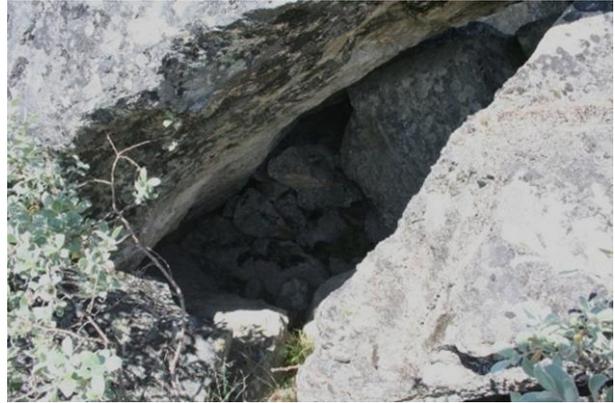
Ruin 09 (fig.5-6): Rather than an actual structure, this ruin is a small gap, ca.1,5x1m, under and between the naturally deposited boulders, in front and back of which there are traces of built up wall. This structure is most likely a *lambakró* (a small pen/shelter for separating lambs/kids from ewes/goats for higher milk production) associated with the use of ruin 08.

Fig.6 Ruin 09 seen from the SW (Photo: C.K. Madsen 2010).

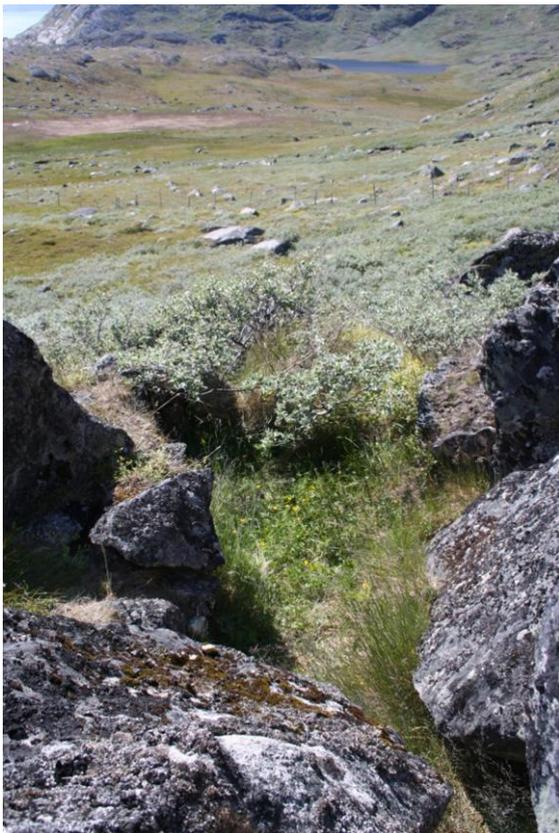
Fig.7 Ruin 10 seen from the E (Photo: C.K. Madsen 2010).

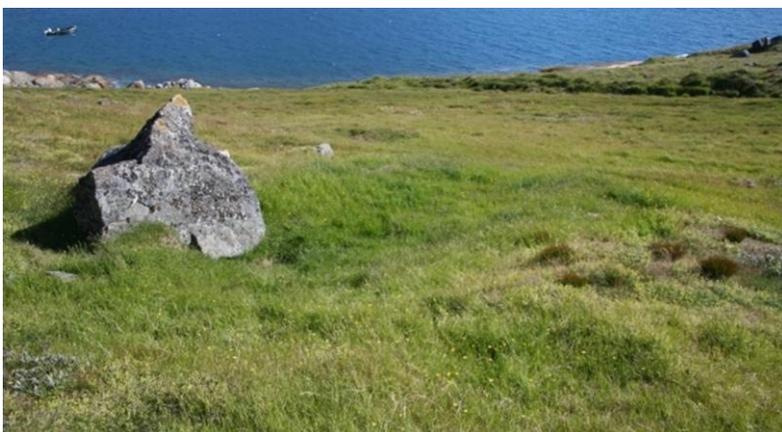
Ruin 11 (fig.8): Possible Norse turf/stone ruin, rectangular, c.8,2x6,5m, with a large, naturally deposited boulder in the NE corner, located some 250m W of the main cluster of buildings. The structure appears as a depression in the surface surrounded by collapsed turf walls about 1,5m wide and preserved to a height of c.50cm. The ruin is completely overgrown with lush grass. This, and a very distinct inside wall line in the northern gable, suggests these might be the remains of a more recent building?

Fig.8 Ruin 11 seen from the NNW (Photo: C.K. Madsen 2010).

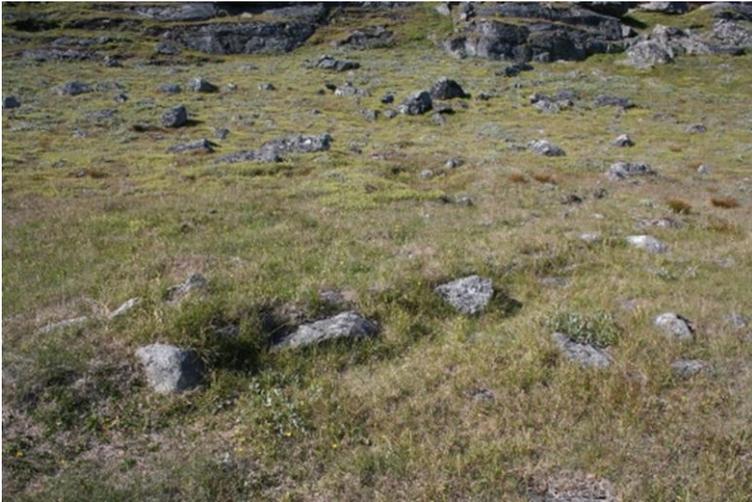
Fig.9 Ruin 12 seen from the SE, where a clearly visible stone/turf box wall or foundation is visible (Photo: C.K. Madsen 2010).

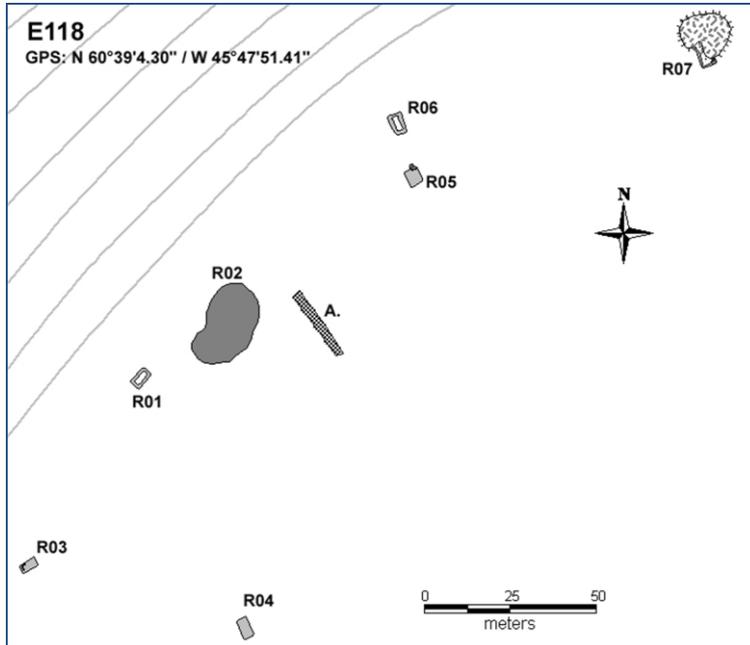
Fig.16 Survey plan of E118.

Ruin 03 (fig.16): Description after Berglund 1980: “ *The remains of a completely collapsed structure built in stone, outline c.4x6m (in the 2010 survey c.5,1x2,75m9) and orientated NE/SW. To the north a stretch of wall, c.1m wide and consisting of two, parallel rows of stones, is visible. The rest of the ruin spills over the terrain. Is situated on a elevation towards the transition to the mountain side. Vegetated by grass, willow and moss*”. Because of the limited amount of collapse, the structure was, however, probably not built in stone, but is rather a stone foundation for a stone/turf, economy building.

Ruin 04 (fig.16, 18): Description after Berglund 1980: “*The remains of a complete collapsed stone house lying on a small knoll between the coast and mountain side. Its outline is assessed to measure c.3,5x4-5m (in the 2010 survey c.5,85x3,2m), orientated E/W. The greater part of the building stones has fallen to the north*”. Again, these remains might only be from a stone foundation, as many of the surrounding stones appear rather natural. From the location of the ruin, it could be a skemma. The ruin is vegetated by juniper, willow, grass, and moss.

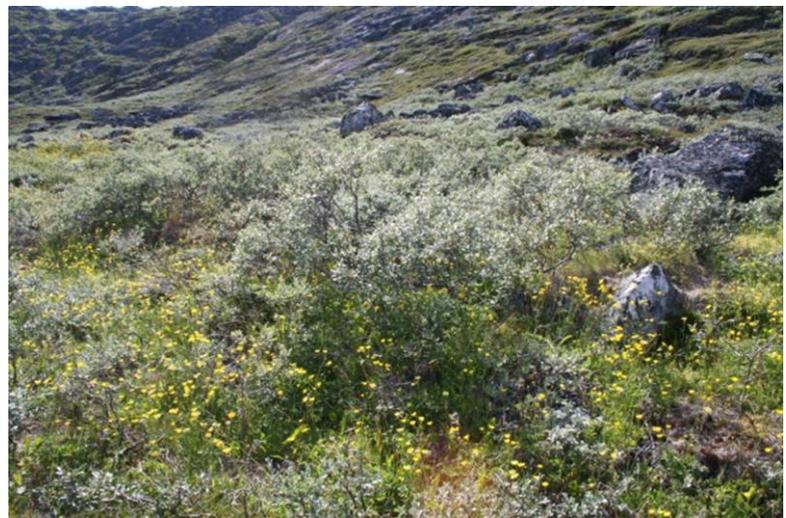
Many stones are visible on the surface and there are traces of several rooms – not parallel. By the northern side is a massive boulder, which has been part of the structure. To the south a midden area is visible”. It should be noted that because of the naturally stony surface, the structure is very hard to delimit. The mentioned rooms are also very seem very uncertain and were thus not recorded. The ruin does, however, distinguish itself much from the surrounding terrain by its distinct vegetation of dominated by buttercup and grass.

Fig.17 Ruin 01 seen from the E (Photo: T.B. Jensen 2010).

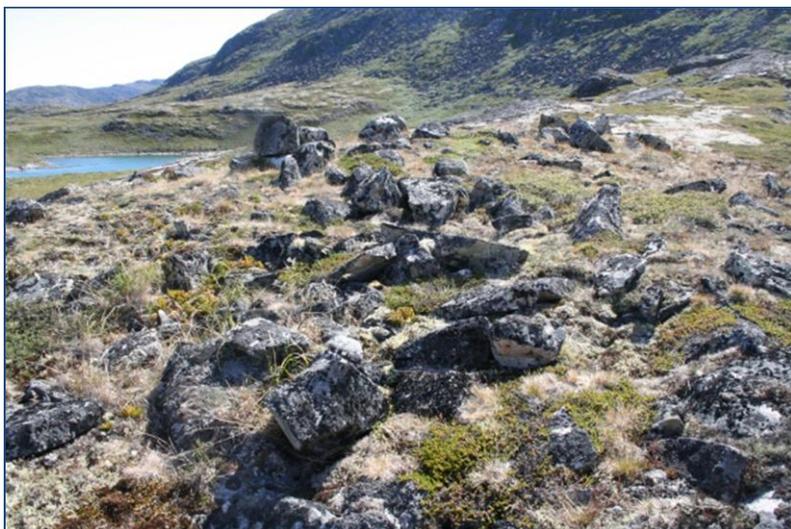
Fig.18 Ruin 04 seen from the E (Photo: T.B. Jensen 2010).

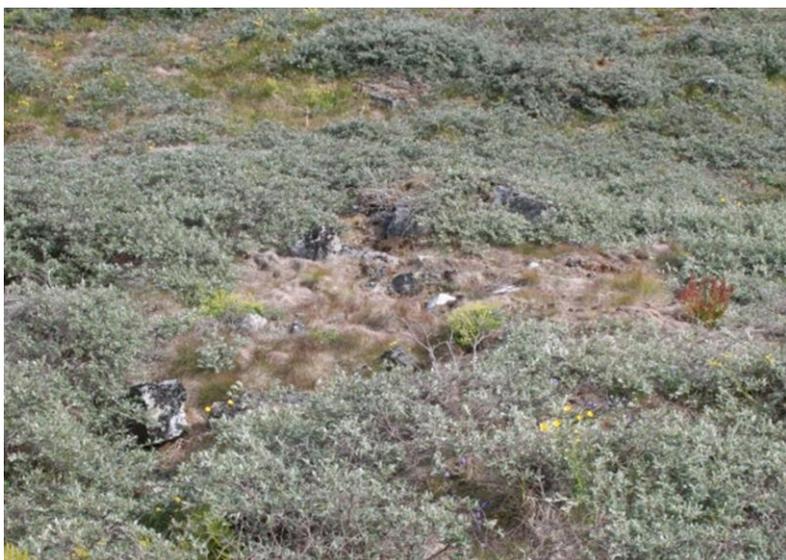
Fig.19 Ruin 06 seen from the S (Photo: T.B. Jensen 2010).

Ruin 06 (fig.16, 19): Description after Berglund 1980: “*The remains of a completely collapsed building, most probably erected in stone/turf and very indistinct, covers c.10x8m, but is hard to delimit, because it is densely overgrown by grass and willow*”. The ruin numbered 06 in the 2010 survey was, in fact, rather distinct on the inside, measuring c.6,4x4,1m, and build in stone and turf with walls c.60-80cm wide. Only to the north is the ruin hard to delimit, as it was here dug slightly into the slope. For this reason, this might be another ruin, albeit its position and orientation corresponds very well with the 1980 survey. The ruin is vegetated by grass, willow, and Alpine lady's mantle.

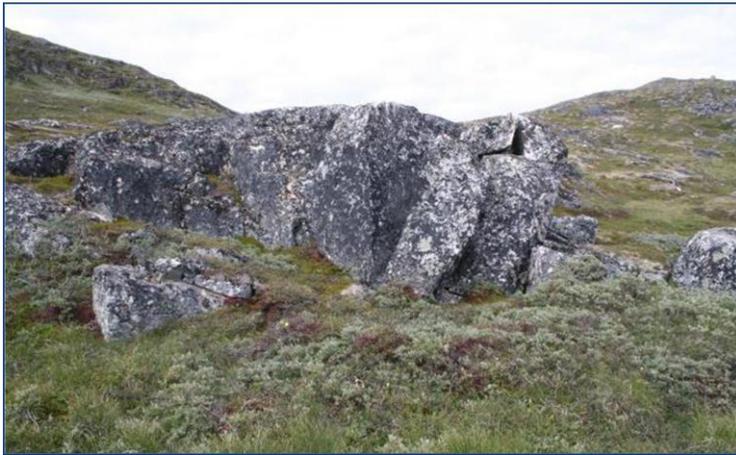
Fig.20 Ruin 07 seen from the S (Photo: T.B. Jensen 2010).

Ruin 07 (fig.16, 20-21): Description after Berglund 1980: “A small animal enclosure built against a cliff formation. The stacked stones are completely hidden under dense willow shrubs. The cliff formation is characteristic by supporting a lintel so that a framed opening appears. The enclosure measures c.7x3m and is orientated NNW/SSE”. The walls are c.50cm wide and rise up to 50cm above ground level.

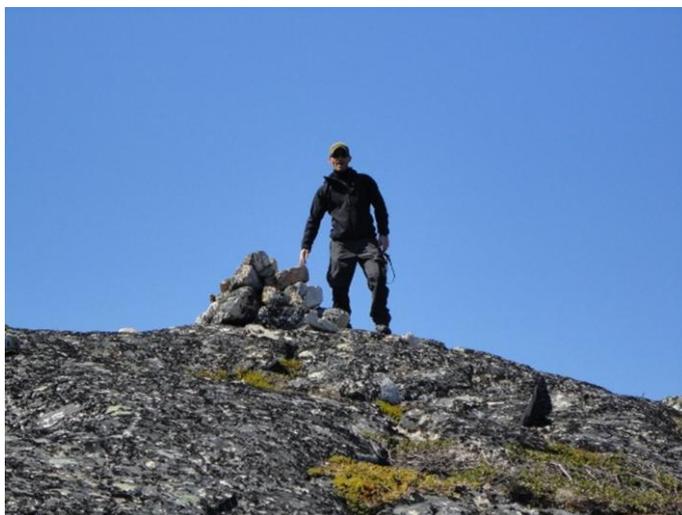
Fig. 23 GUIDE 87 and TBJ. This cairns has well located lichens up to 6 cm, suggesting a date pre 1400 A.D (Photo: P.B. Heide 2010).

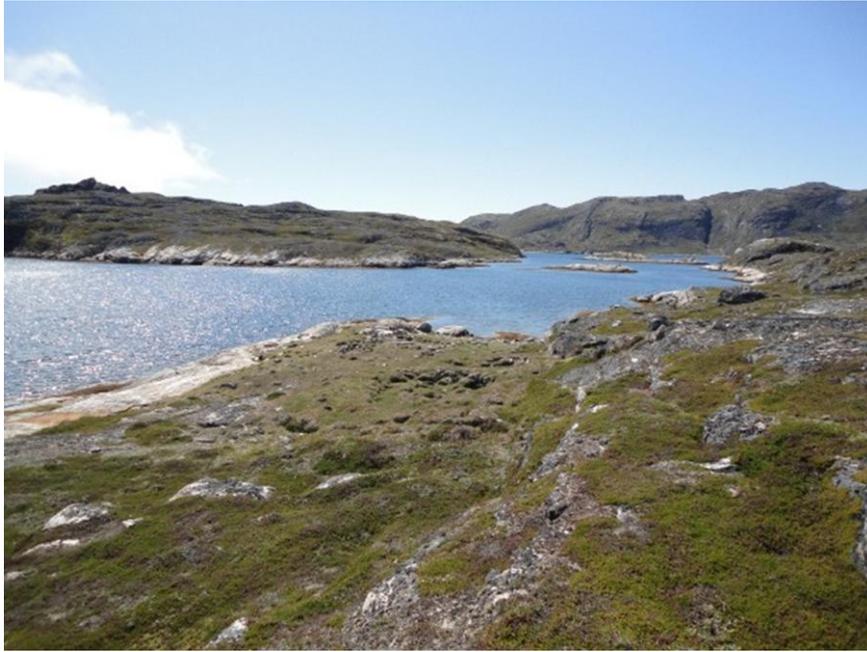
The island contains a number of cultural remains, including Inuit house remains, stone rings for drying nets, a small presumably Norse pen (see field notes 16.07.2010) and a number of cairns from a long period of time. On the south coast are the remains of three large Thule summer houses (fig.24), next to the small pen (GUIDE 86). The northern tip of the island was only inspected visually from afar.

Fig. 24 The Thule summer houses on the eastern side of the island Qimatulivissuaq. The small bay in the centre of the picture offers good landing for boats and kayaks. GUIDE 86, is on the low shelf to the right of the houses (Photo: P.B. Heide 2010).

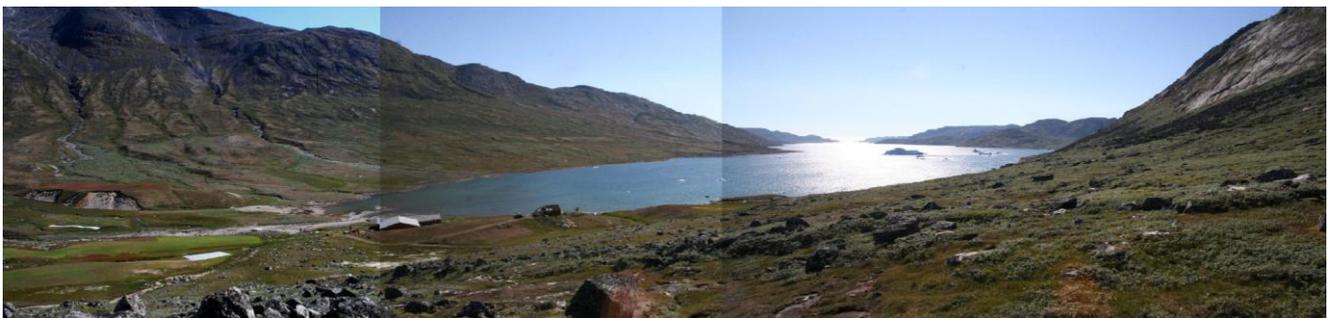
Fig.25 160% view, looking SW, of the bay with E182. The majority of the ruins are located on the north (right) side of the bay, just right of the modern sheep farm. As seen in the picture, the Kangerluarsorujuk is open right out to the arctic North Atlantic (Photo: C.K. Madsen 2010).

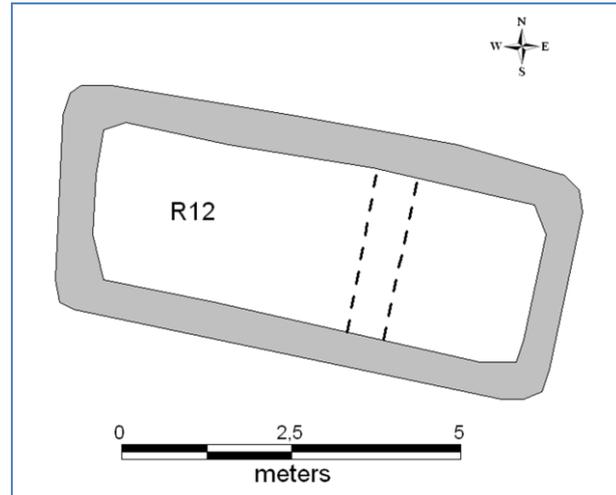
Fig.27 Survey plan of the new ruin 12

While spending an hour trying to locate ruin 04 of the 1980 survey, a new, likely Norse ruin was found. Incidentally, this ruin has almost the exact same dimensions as described for ruin 04 of the 1980 survey, but, however, differs very much in appearance and somewhat in location. This R12 is most probably a new ruin, rather than the ruin 04 of the 1980 survey, unless the latter has collapsed much during the 30 years between the two surveys:

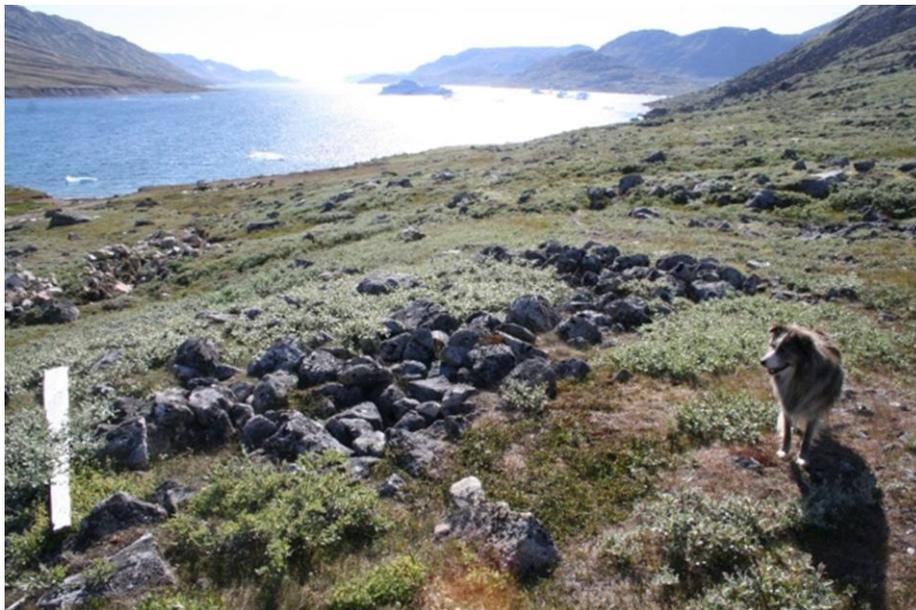
Fig.28 Ruin 12 seen towards the SW (Photo: C.K. Madsen 2010).

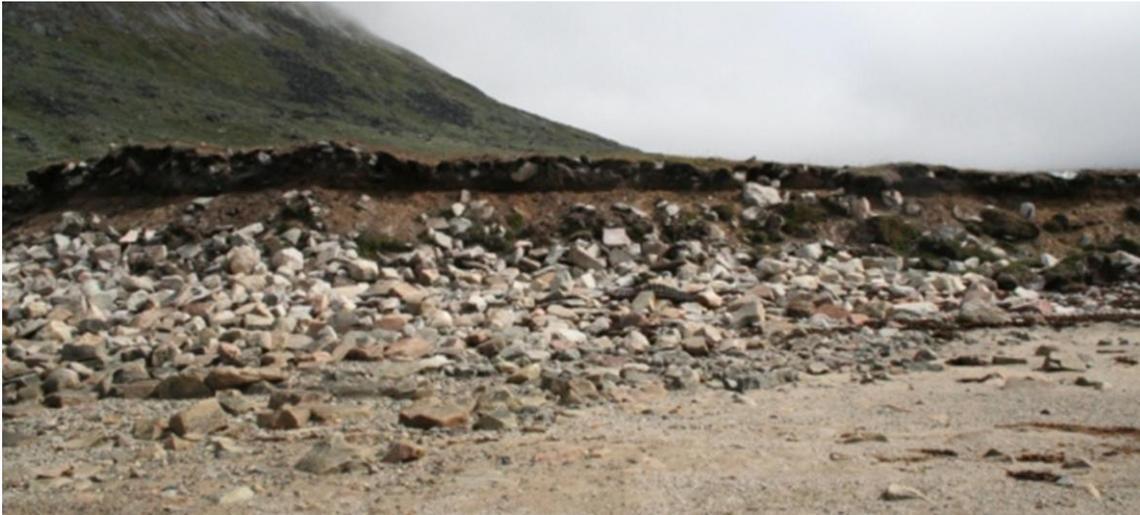
Excavations: As mentioned above, ruin 07 (fig.29-30), probably a staple complex of some sort, was selected for excavation; this ruin is found on a small, flat foreland elevated about 3-4m a.s.l. It is a turf/stone build ruin, rather indistinct and collapsed, measures c.18x9m and is orientated NNW/SSE. Several rooms and wall lines are discernable. In the north end of the ruin a platform of flat stones (probably reused Norse building stones) has been constructed in recent time, maybe a drying platform. With a c.15-20m wide, stony beach in front during low tide, but no beach at all during high tide, the fjord is constantly gnawing at this small plateau with ruin 07 and marked erosion had visibly occurred since the visit to the site in 2006. This erosion is exacerbated by the fact that the ruin group, as mentioned, lies directly exposed to the wind and ocean and, possibly, decreasing amounts of summer drift ice to work as wave barrier. On and just in front of the eroding side of the slope and ruin is a large quantity of fallen building stones, suggesting both that quite a bit of structure have already eroded and that stones formed a major part of the structure. On the slope one also finds pieces of charcoal and burned bone.

Fig.29 The eroding west side of ruin 07 after clean up. Many of the stones below the erosion front are collapse stone from the building (Photo: C.K. Madsen 2010).

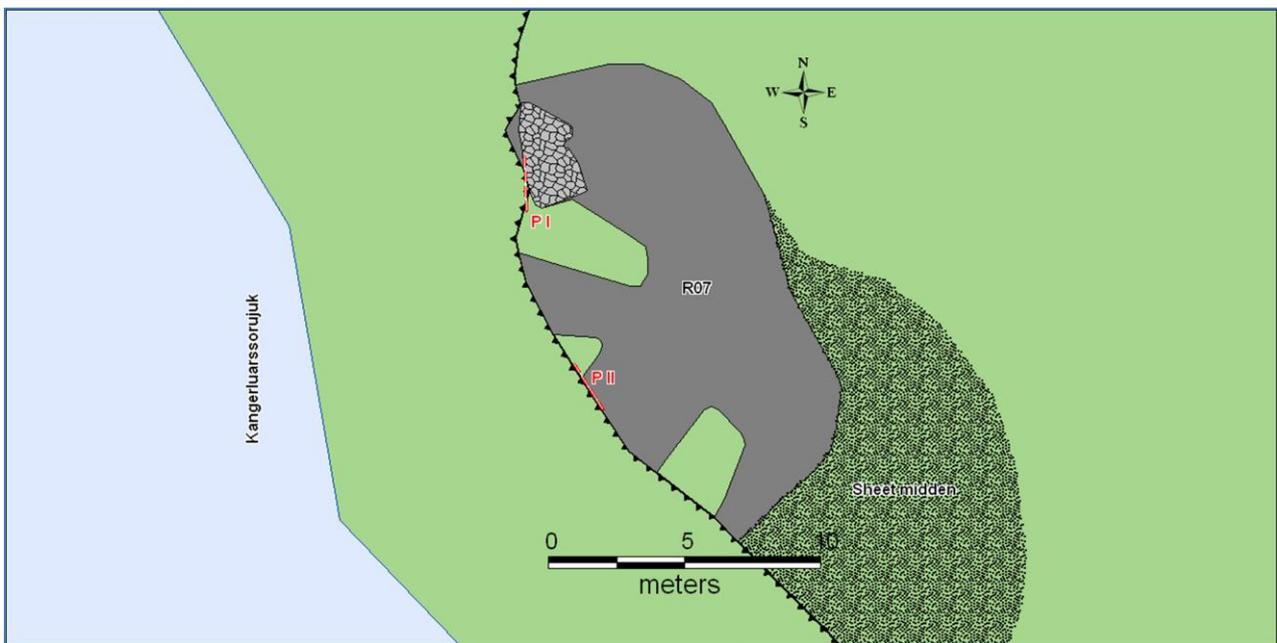
Fig. 30 The new survey plan of ruin 07. The black “barbed line” demarcates the erosion front and black area south of the ruin is sheet midden seen in the section.

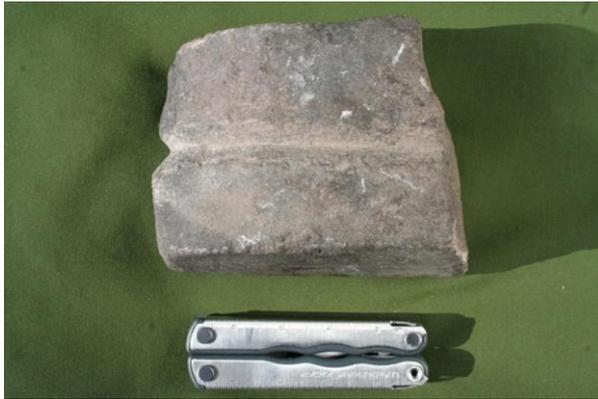
Fig.33 Grooved soapstone; net sinker?.

Visiting the farmer on the first day at the site, we were told that they had collected a number of soap stone artifacts from the beach below the erosion front. Kindly, they permitted us to photograph these, of which fig.33-36 display the more interesting pieces (soap stone fragment in fig.35 was found to have a runic mark):

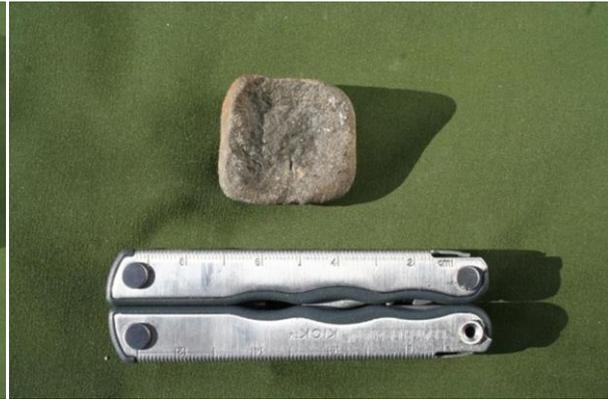
Fig.34 Bottom of soap stone vessel/lamp.

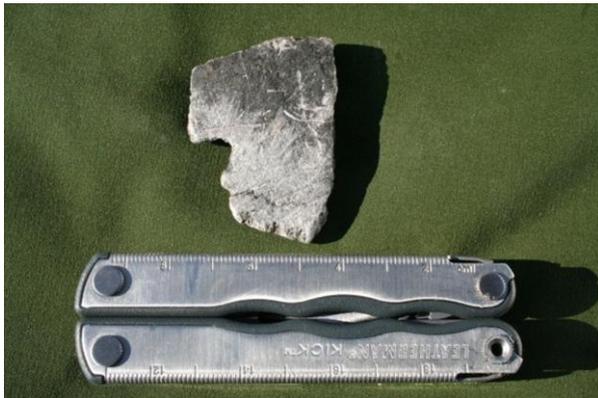
Fig.35 Drilled soapstone fragment with runic marks.

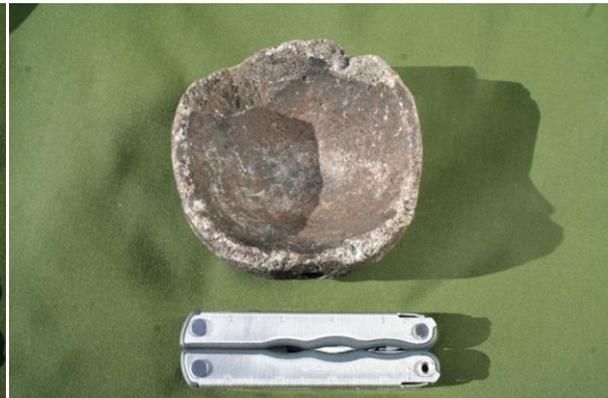
Fig.36 Bottom of soap stone vessel.

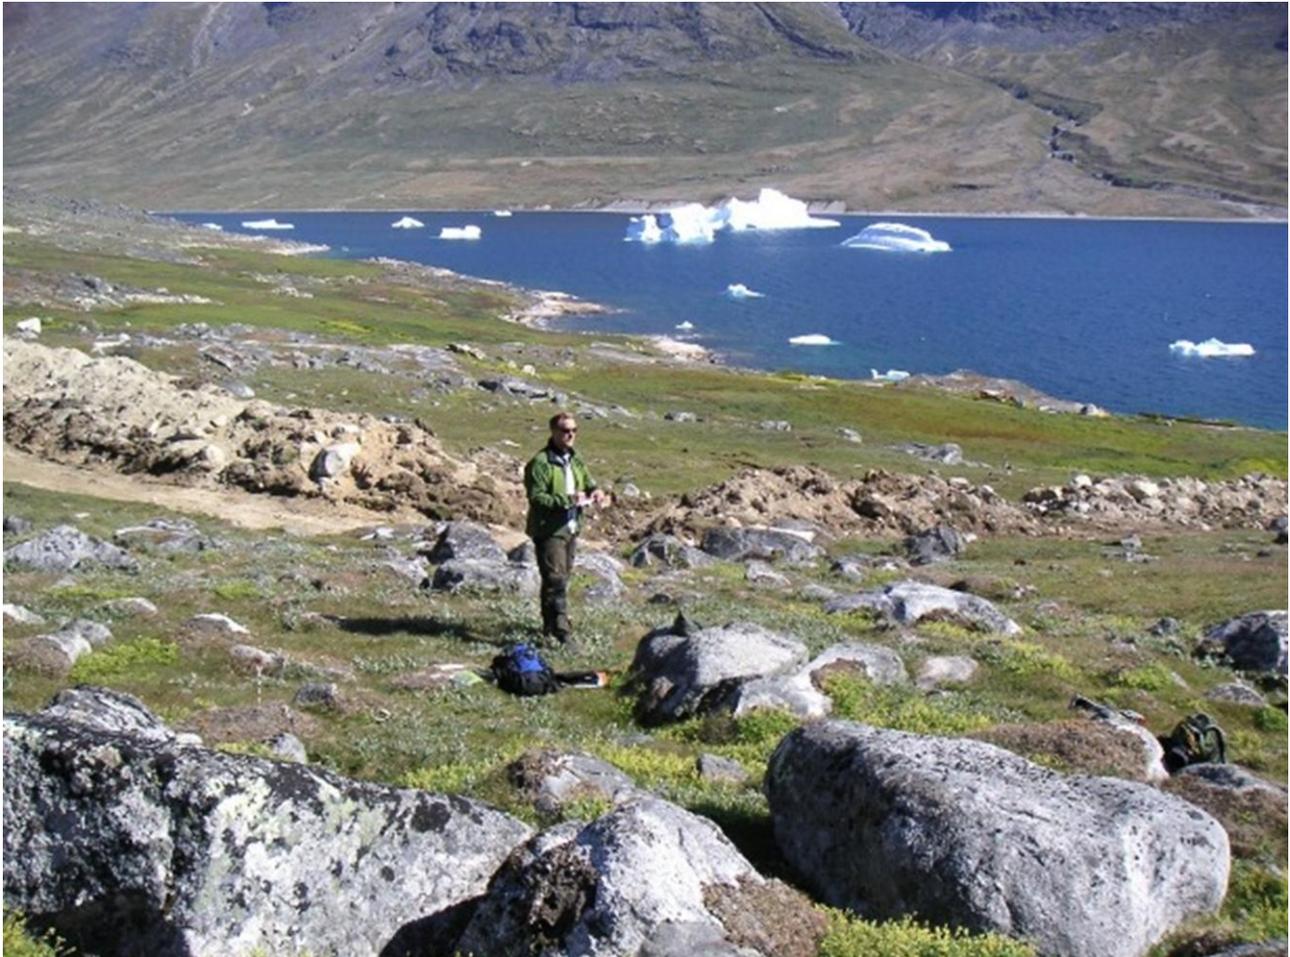
In relation to the excavation at E 182, a visual-phenomenological recording was done at E 331. The terrain between E 182 and E 331, as well as around the latter has undergone considerable transformation due to modern road building, and not much surface appears to be original.

Fig. 37 Poul doing a visual map and landscape room recording at E 331. Note the extensive roadwork in the middle ground. The survey setup can be seen on the ground (Photo: T.B. Jensen 2010).

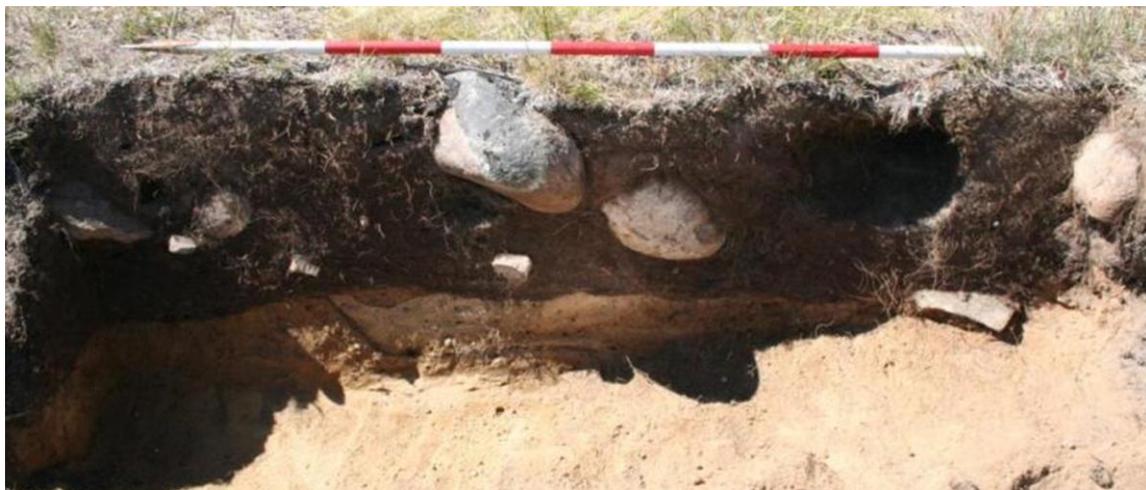
Fig.39 The excavated section E329 P I seen from the E (Photo:C.K. Madsen 2010).

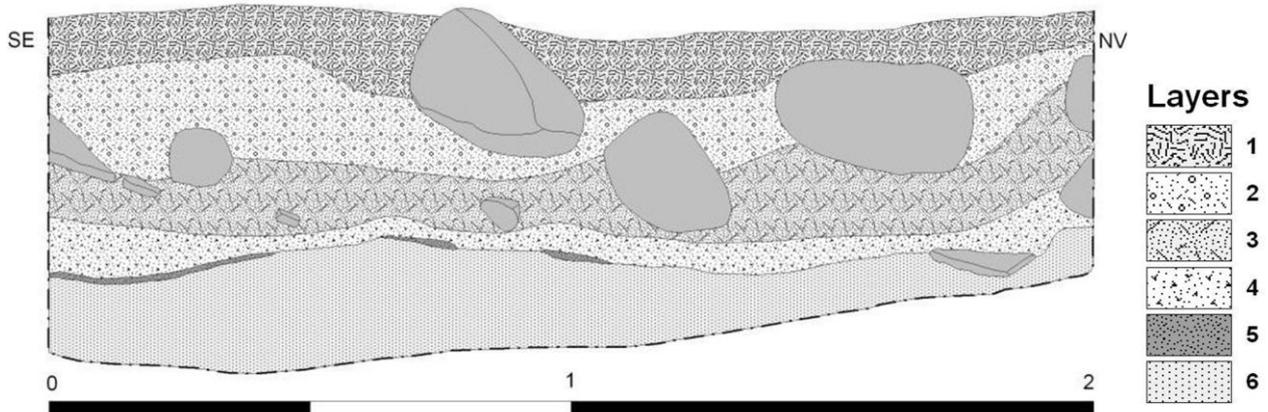
Fig.40 Scale drawing of 2m section E329 P I.

Layer	Description	Interpretation
1	Growth layer with roots	-
2	Homogenous grayish brown silt (decomposed turf) with a few specks of charcoal.	Collapse material
3	Heterogeneous grayish brown to brownish yellow silt and fine grained sand with some specks of charcoal.	Collapse material
4	Heterogeneous brownish grey silt with light grey and yellow turf lenses, many specks of charcoal and some burned/unburned bone.	Sheet midden?/Collapse?
5	Dark grayish brown stripe of compact gravel and silt.	Original vegetation surface w. podzol?
6	Yellow sand/gravel with a few stones	Subsoil

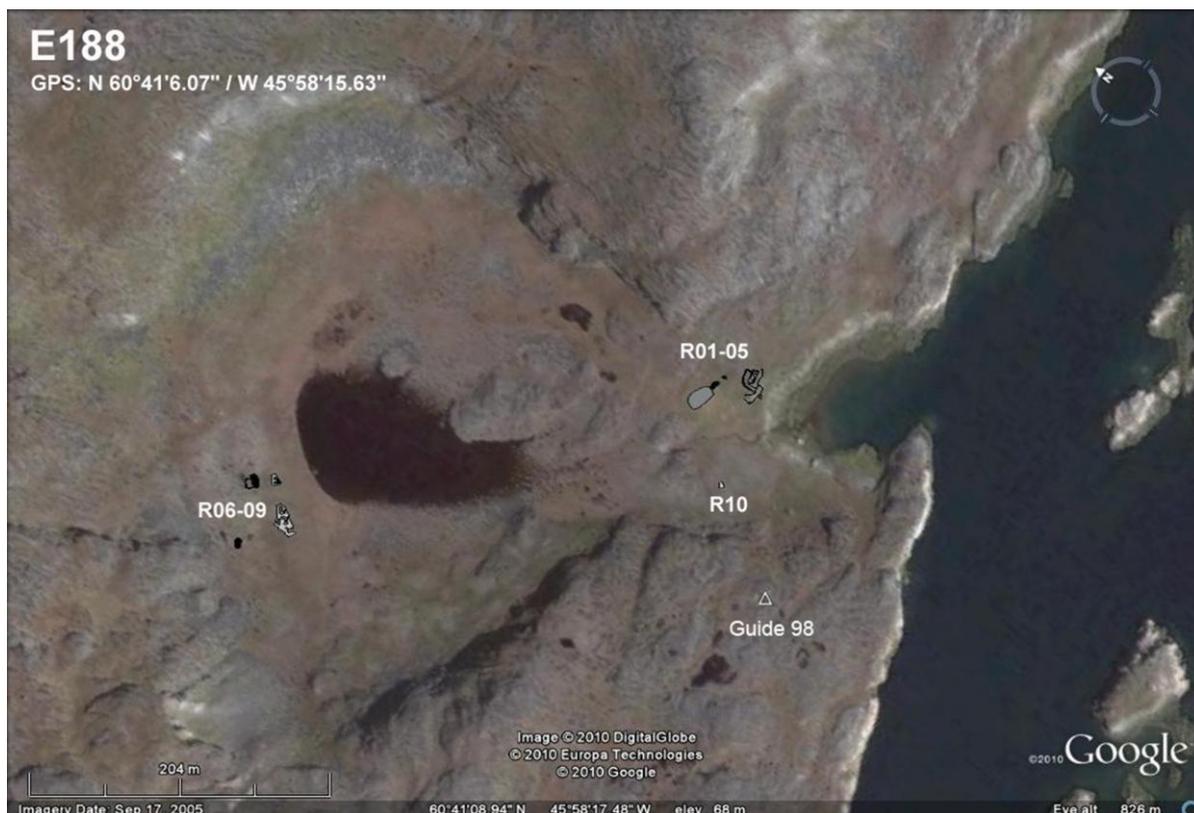
Fig.44 Survey plan of the 10 ruins at E188 on GoogleEarth© satellite imagery.

Site description: The ruin group is found by a small sheltered and shallow cove on the eastern side of the island of Akia and is divided in two clusters of ruins; one cluster (R01-05, 10) lies very close to the small cove, which provides excellent and sheltered landing (fig.45), and the well-preserved (fig.48) R05 is visible upon approaching the site from the fjord. The terrain sloping down to the cove is fairly green with patches of lush grass and flowers, but is otherwise mostly dominated by low heather vegetation. A single stream runs from the northwest, where a lowering in the terrain funnels one into a perfect, southern faced circus valley circled by steep slopes on all sides but the western; central in this valley is a shallow lake and between this and the fallen boulders at the foot of the steep slopes, is a belt of reasonably lush vegetation, changing from grassy meadow closest to the water to birch and willow shrub towards the higher ground. The circus valley is perfectly sheltered from the cold and misty coastal winds and on warm, sunny days, temperatures in the valley will soar. At the northwestern end of the lake, just above the wet meadow, is the second cluster of ruins (R06-09), 4 outhouses lying in close proximity.

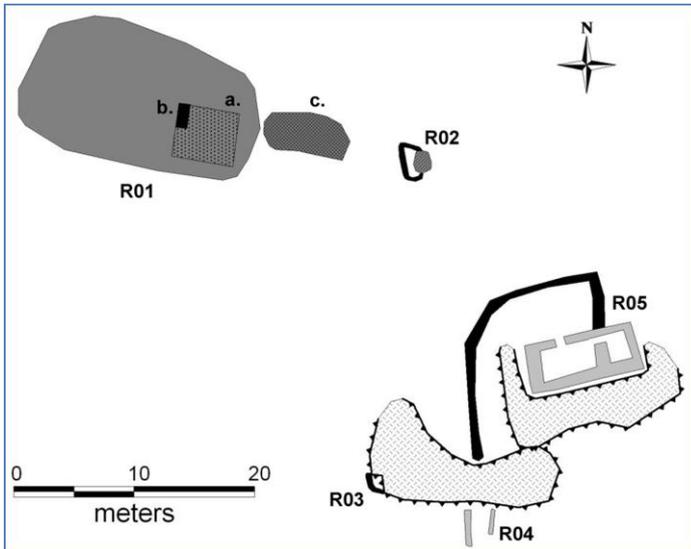
Fig.46 Survey plan of ruin 01-05 at E188.

Ruin 02 (fig.46): Small ruin, approx. 3,2x1m, built up against a naturally deposited boulder. The walls are built in stone (foundation for turf wall), preserved in 2-3 courses, c.30cm wide and rising c.30cm above the surface. If this is not a structure built during the excavation (a fireplace?), it is most likely a small enclosure for penning lambs/kids (i.e. a lambakró). Vegetated by grass and buttercup.

Ruin 03 (fig.46-47): Small ruin, c.1,6x1,4m, build against a steep cliff, thus forming a small enclosure, probably for penning lambs/kids (i.e. a lambakró). The somewhat collapsed stone walls (foundation for turf wall) are

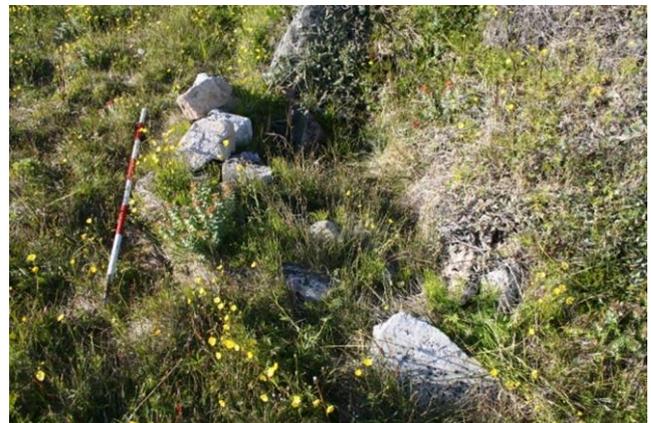
Fig.47 Ruin 3 seen from the S (Photo: C.K. Madsen 2010).

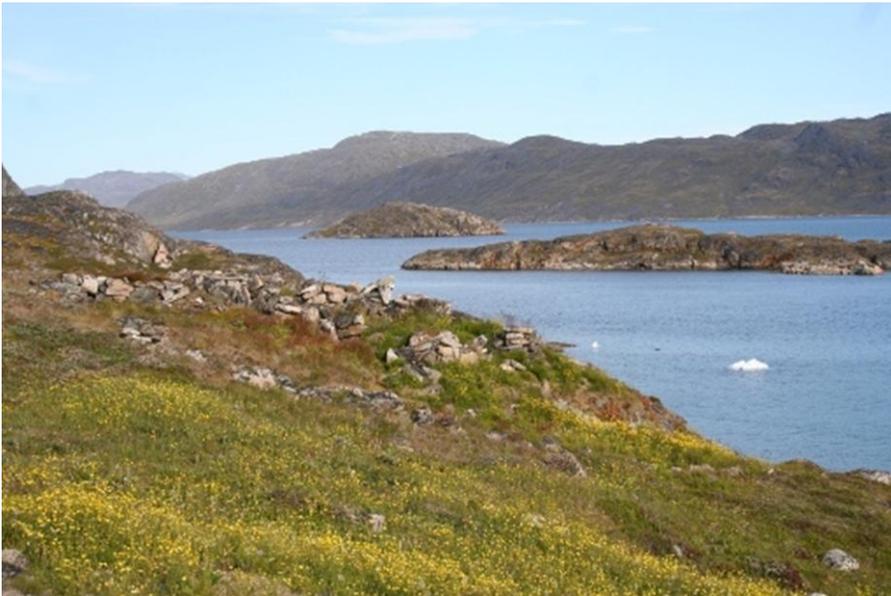
Fig.48 Ruin 5 seen from the W. Note the marked slope of the adjoining enclosure (Photo: C.K. Madsen 2010).

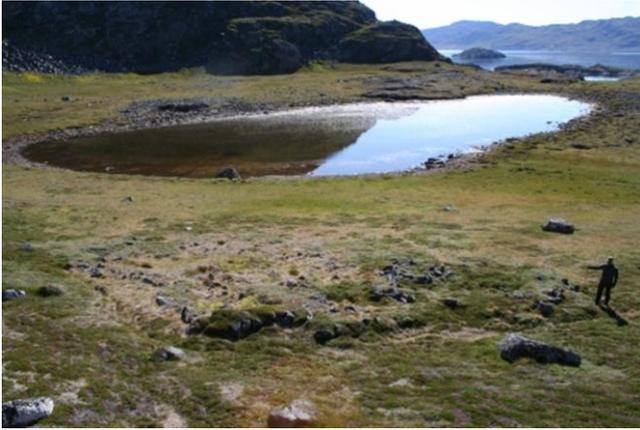
Fig.50 Ruin 06 seen from the NNW (Photo. C.K.Madsen 2010).

Ruin 06 (fig.49, 50): Very well-preserved and distinct ruin with several visible rooms. It is roughly rectangular, NE-SW oriented, c.23,9x10,5 and evidently built with turf walls with a stone core, c.80-120cm wide at the base and in some places preserved in up to 4 courses (ca.110cm). All the rooms and corridors open towards the grassy meadow and lake in the SE. In the SW is a wide opening to a room with two small, stone built compartments. Centrally in the ruin an opening to three compartments, one of which seems to lack an entrance, although otherwise clearly discernable. In the NE is an opening to a single large compartment. The ruin seems a likely stable/byre complex, but as noted by P.B. Heide, the structure bares a marked resemblance to the Støng longhouse and could thus be an early dwelling. However, the structure seems too well-preserved and substantial to be an early longhouse and there is no trace of midden, for which reason it must at least have been reused as/modified into a stable. The ruin is vegetated by grass, willow and crowberry.

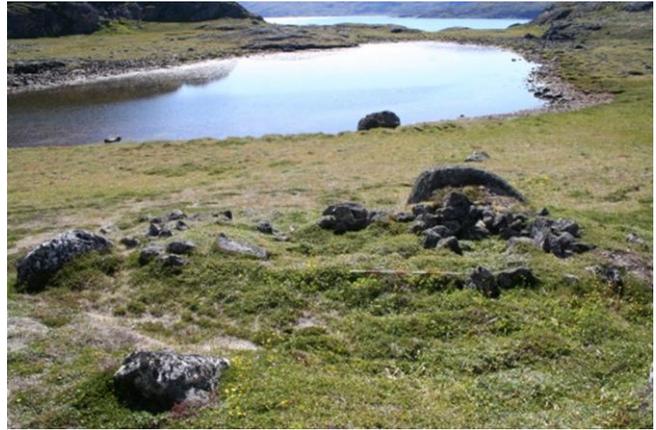
Fig.51 Ruin 07 seen from the NW (Photo. C.K.Madsen 2010).

Ruin 07 (fig.49, 51): Well-preserved rectangular, c.7,9x4,8m, NE-SW oriented turf/stone built house. The walls are 100-120cm wide at the base and preserved in up to 5 courses (c.110cm). Two distinct rooms are visible; a larger eastern with entrance to the S and a smaller western with no apparent entrance, but clearly with more stones in the wall (a natural deposited boulder forms part of the wall). Likely a sheeps/goats house with barn. The ruin is vegetated by willow, birch and crowberry.

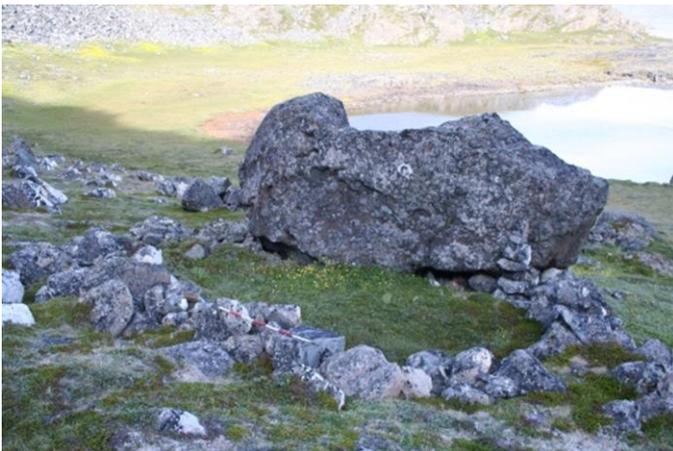
Fig.52 Ruin 08 seen from the NNW (Photo. C.K.Madsen 2010).

Ruin 08 (fig.49, 52): Well-preserved enclosure, c.7,8x5,4m, built up against a massive boulder. The remains of heavily built stone/turf walls, c.60-80cm wide, are preserved in up to 8 courses, c.150cm, though only in the southern corner near a c.40cm wide entrance to the enclosure and otherwise only standing 60-80cm. This wall must, based on the amounts of collapse stone, have had additional courses of turf. Inside the ruin grows crowberry, willow, buttercup and Roseroot. Additionally, a single light stone has been placed on top of the large boulder, possibly for visual effect (i.e. the enclosure can be seen from the opening of the valley).

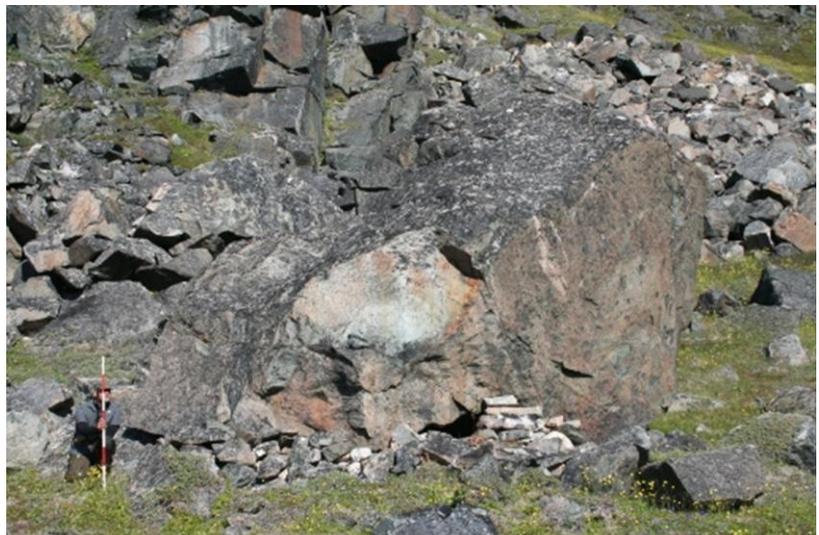
Fig.53 Ruin 09 seen from the NNW (Photo. C.K.Madsen 2010).

Ruin 09 (fig.49, 53): Shelter built under massive boulder. By erecting stone wall along the SW and NW openings under a large boulder, a completely sealed cave has been created under a boulder, measuring c.3x3m and c.80cm from floor to ceiling (at most). The entrance to the S is very narrow, only c.30-40cm wide. This is probably an animal shelter for goats/sheep.

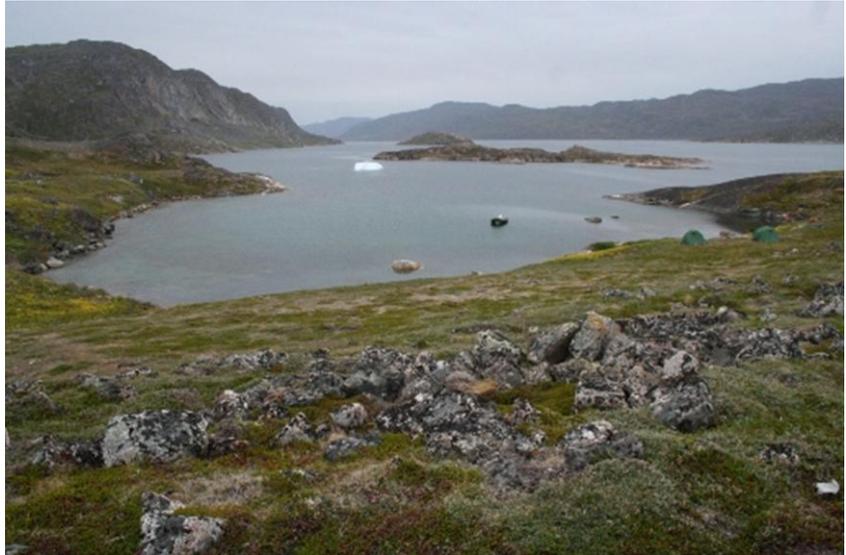
Ruin 10 (fig.46, 54): Somewhat uncertain ruin on the S side of the stream running to the cove. It appears as a roughly rectangular area, c.3,6x3,2m, with many stones rising c.30-40 above the surrounding terrain and, especially in the SW end traces of what could be walls foundations. It could be a natural formation, otherwise an outhouse of some sort. Between the stones grows crowberry.

Fig.54 Ruin 10 seen from the NNW (Photo. C.K.Madsen 2010).

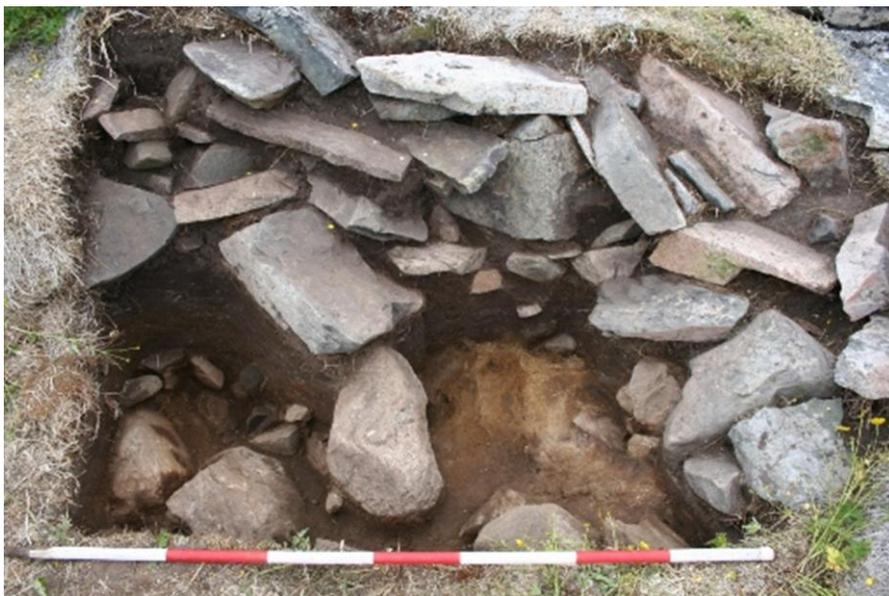
Fig. 55 The section in ruin 01 after excavation seen from the ESE (Photo. C.K.Madsen 2010).

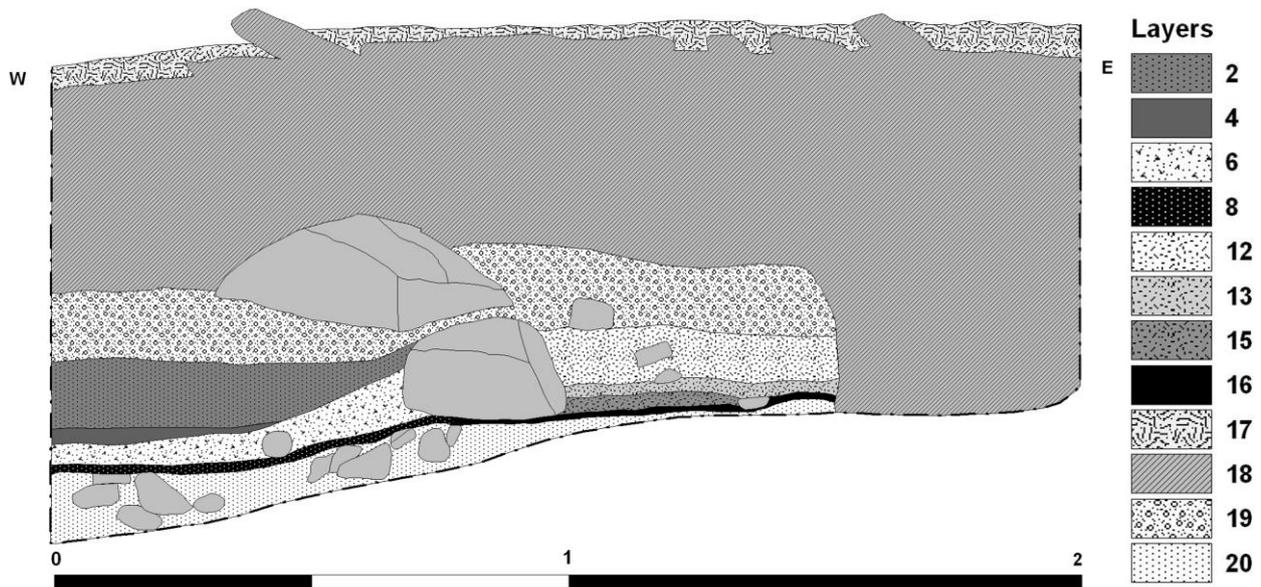
Fig.56 Scale drawing of 2m section P I.

Layer	Description	Interpretation
2	Layers of reddish brown to grey brown, roughly horizontal turf layers w. many collapse stones and specks of charcoal.	Wall/wall collapse?
4	Grey black silt (decomposed turf) with much charcoal and some burned/unburned bone.	Wall/wall collapse?
6	Heterogeneous brownish grey to reddish brown gravelly silt with specks of charcoal and a few burned bones.	Collapse/floor layer?
8	Brownish grey silt and fine grained sand with specks of charcoal and spots of red silt.	Original vegetation surface with clearing?
12	Heterogeneous dark brownish grey to red brown lightly sanded silt (decomposed turf) with specks of charcoal and a few burned bones.	Collapse/floor layer?
13	Heterogeneous dark brownish grey to red brown silt and fine grained sand with many specks of charcoal and burned bones (resembles 4&&).	Floor layer?
15	Heterogeneous grey brown to red brown silt with greyish turf spots, specks of charcoal, and burned bone.	Floor layer?

16	Blackish grey charcoal rich silt w. a few spots of reddish silt.	Original vegetation surface with clearing?
17	Growth layer with roots.	-
18	Stone collapse with fill of loose, homogenous silt with specks of charcoal and a few pieces of bone.	Collapse material (backfilling?)
19	Greyish to red brown silt with specks of charcoal, a few burned bones, and few collapse stones.	Collapse material
20	Naturally deposited, sterile layers deposited on top of gravel.	Subsoil

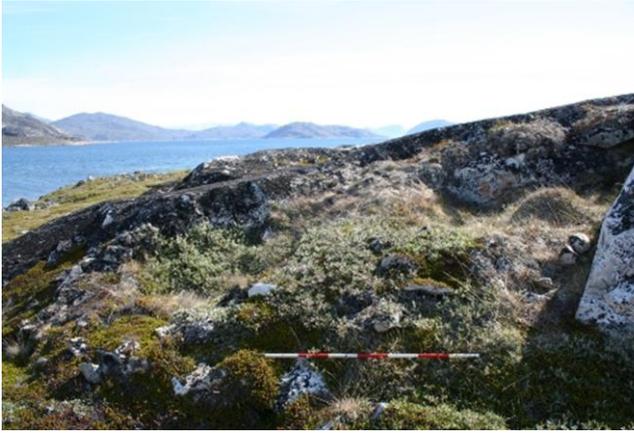
Fig.62 Ruin 01 seen from the WSW (Photo. C.K.Madsen 2010).

Ruin 01 (fig.61, 62): Small ruin built up against a low cliff ridge with steep sides, which form the E wall of the building. The walls are made of a collapsed stone/turf wall with a width of c.80cm at the base and preserved to a height of up to c.80cm. The structure is rectangular; c.4.,5x3m, oriented NNW-SSE and is located only 70-80m from the beach of the fjord. To small rooms are visible inside the ruin and in the SE corner, where the cliff forms a sharp angle, to stone slaps have been placed to form part of a roof. The ruin is vegetated by grass, willow, and crowberry.

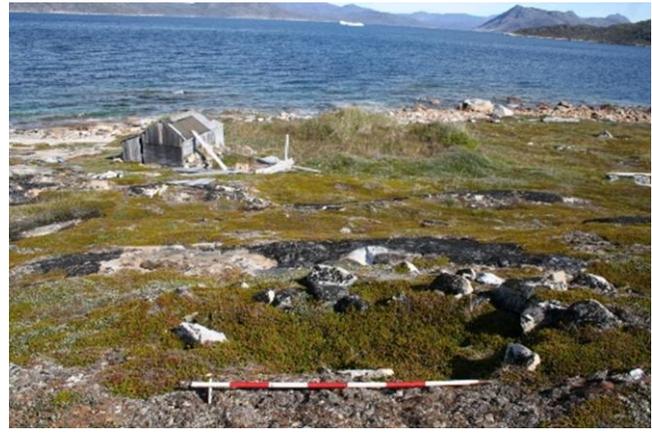
Fig.63 Ruin 02 seen from the S Note the “modern” fishing shed and 18th century sod house remains in the background (Photo. C.K.Madsen 2010)..

Ruin 02 (fig.61, 63): Small stone/turf built ruin built up against a low, naked cliff. The structure measures c.4,2x2,5m and the walls, c.80cm wide, rise up to 50cm above the surrounding terrain. One distinct room is visible. The ruin is vegetated by crowberry.

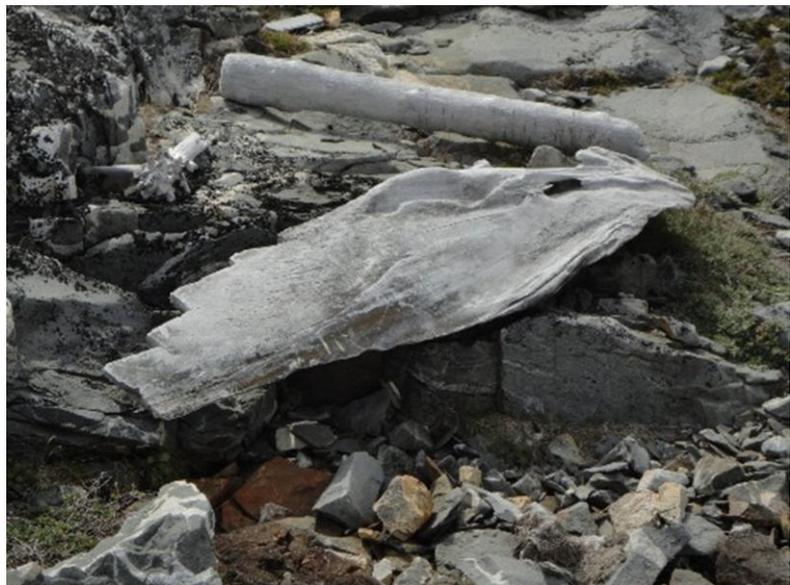
Fig. 64 Whalebone and driftwood by a large Inuit whaling site on Inartalik. The whale cranial bone has been cut into in order to extract the useful substance for e.g. tool making. The short cuts are app. 15cm long (Photo: P.B. Heide 2010).
