Norse Coastal Landscapes

Field report on surveys and excavations in the coastal area of Vatnahverfi Summer 2010

**The National Museum of Denmark,
Department of Danish Middle Age and Renaissance, Copenhagen, Jan. 2011**

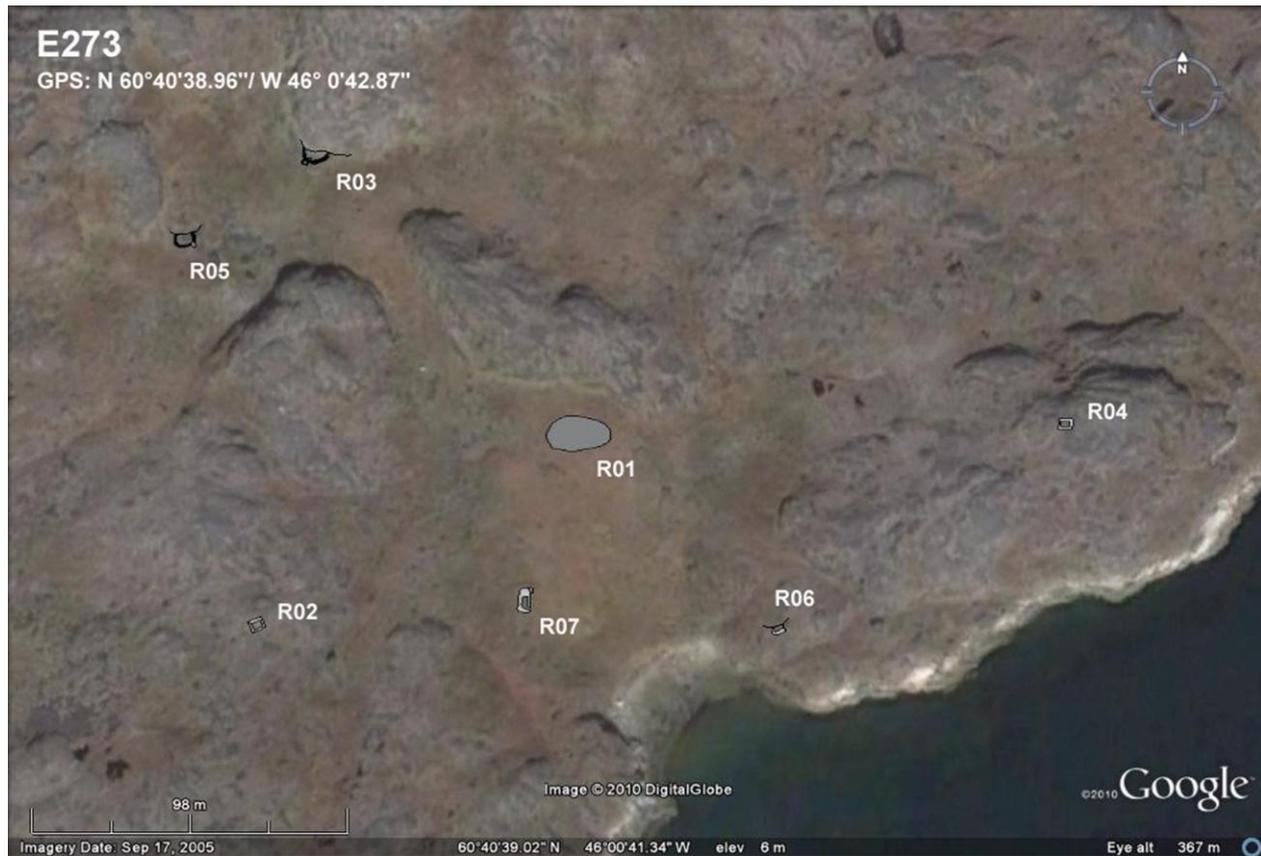
Fig.65 Survey plan of E273 on GoogleEarth© satellite imagery.

Site description: The ruin group is located only c.2,3km west of E188 on the Akia island. Here one finds a small, narrow inlet at the bottom of which is a perfectly sheltered stony beach providing excellent landing conditions. A grassy slope rises rather steeply from the beach and half way up is ruin 07 (at the only relatively level spot) and the top of the slope ruin 01, located just below a low cliff shelf. The 5 other ruins are scattered about this grassy slope. There are no signs of an actual homefield, only scattered patches of grass between the cliff riches. An interesting element at E273 is the fact that while there are only 7 ruins in all, two of these, ruin 04 and 02, seem to be well built dry-stone masonry houses, i.e. probable skemma's, which is also supported by their location on top of cliff knolls. While E273 could be a small farm, it is equally possible that it is a shieling facilitating the use of resources from the western end of the Akia island (see description), for which the ruin group is excellently positioned.

Ruin 07 (fig.65): Small and somewhat indistinct ruin of a small structure built against a cliff and measuring c.4,2x2,5m. The walls are c.50cm wide and rise c.20-30cm above the terrain. An entrance in the western gable is clearly discernable. The ruin is completely overgrown by crowberry and birch.

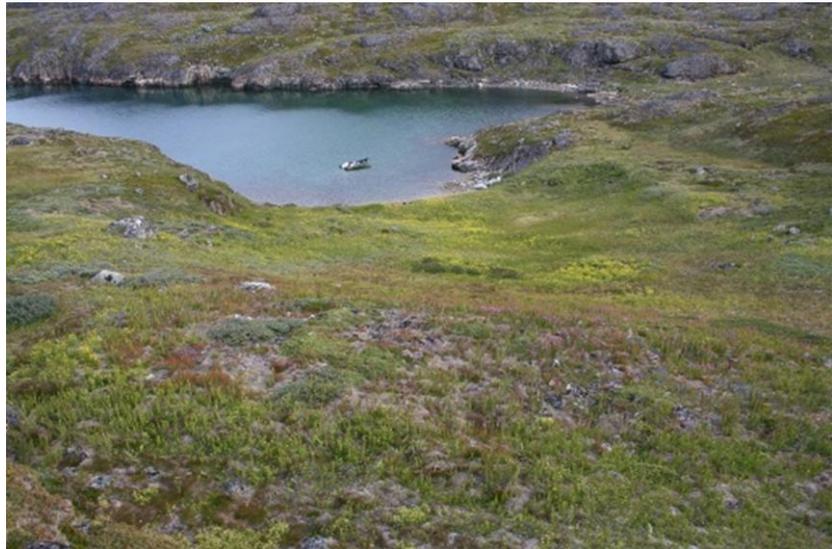
Fig.66 Ruin 01 seen from the N. The small gravelly beach at the bottom of the fertile slope is seen in the background (Photo: C.K.Madsen 2010).

Ruin 01 (fig.66): Very collapsed turf/stone built ruin, c.21x1m, undoubtedly a dwelling lying on a narrow, southern faced plateau on top of a grassy slope. To the north the ruin group is sheltered by a low cliff. The ruin is visible as a slight elevation in the terrain with many protruding stones with indistinct outlines of walls and rooms. Apparently the structure was slightly dug into the slope towards the north. The ruin is vegetated by grass, juniper and, noticeably, buttercup and purple flowers of unknown species.

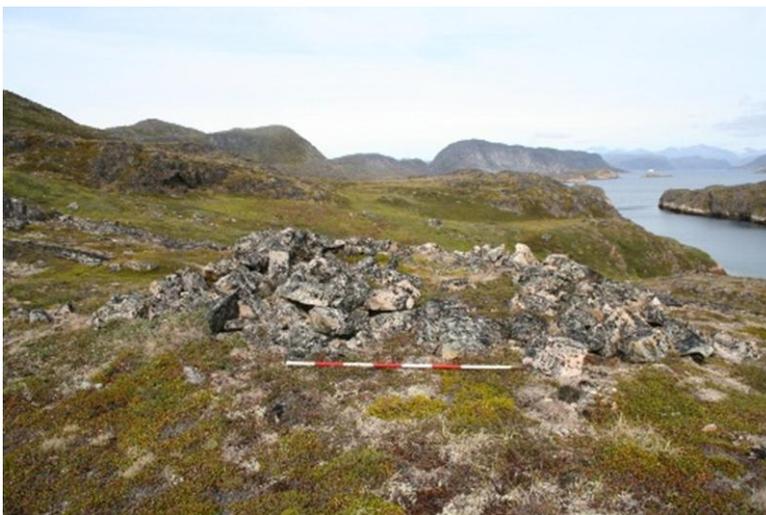
Fig.67 Ruin 02 seen from the W. Ruin 01 is located at the light green patch of grass beneath the cliff, top left (Photo: T.B. Jensen 2010).

Ruin 02 (fig.67): Ruin built in dry-stone masonry, c.4,4x3,9m, lying on an exposed cliff knoll. The walls have collapsed outwards, but in some places in situ walls, c.30-40cm wide, are preserved in two courses (c.40cm). Based on its location and construction, it is probably a skemma. Inside the walls grows crowberry, grass and birch. One stone has a rhizocarbon geographicum lichen of 9cm's.

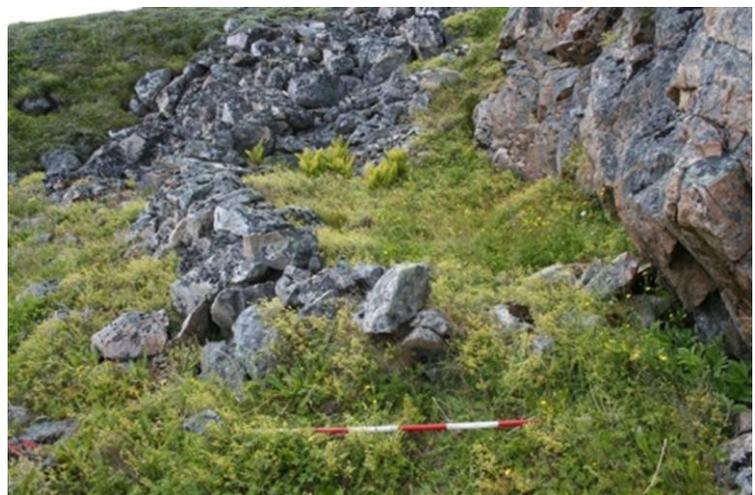
Fig.68 Ruin 03 seen from the E (Photo: T.B. Jensen 2010).

Ruin 03 (fig.68): Semicircular enclosure, c.8,3x3,4m, built against a vertical cliff wall and in the edge of a boulder field,

using stones from here in the construction, while some are naturally deposited boulders. The walls are preserved in up to 2 courses (c.50cm) and have been c.50cm wide. Inside the enclosure is a smaller, possible partition, maybe a lambakró. Another such is found outside the ruin, measuring c.1,6x1,4m. A possible entrance is seen in the NW corner. Inside the enclosure grows grass and Alpine lady's mantle.

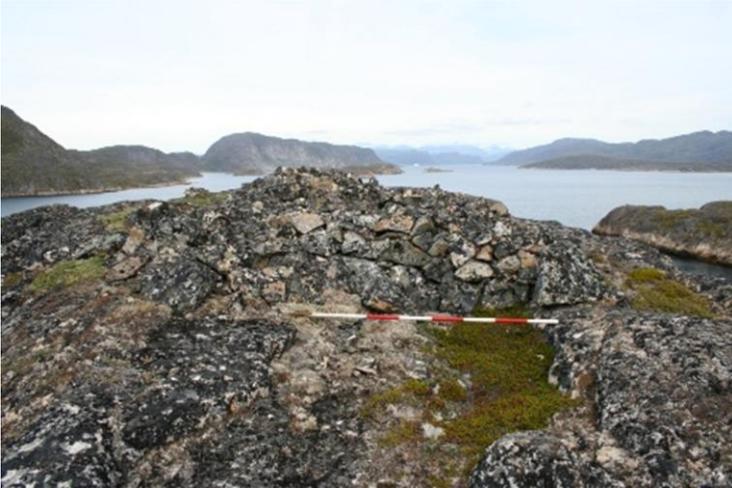
Fig.69 Ruin 04 seen from the W In the background fjord south of Akia (Photo: T.B. Jensen 2010).

Ruin 04 (fig.69): Well-preserved structure built in dry-stone masonry lying on an exposed cliff knoll with a view into the fjord. The ruin measures c.4,8x3,2 with box walls preserved in up to 5 courses (c.120cm) and 60-70cm wide. Especially the two gables are well-preserved, while the two long walls have collapsed outwards. Judging from the amount of collapse stone, the stone walls cannot have stood significantly higher than the c.1,2m, indicating that the rest was constructed in other materials. Based on its location and construction, it is probably a skemma. Inside the ruin grows willow, and on two or three stones, one sees rhizocarbon geographicum lichens of c.10cm.

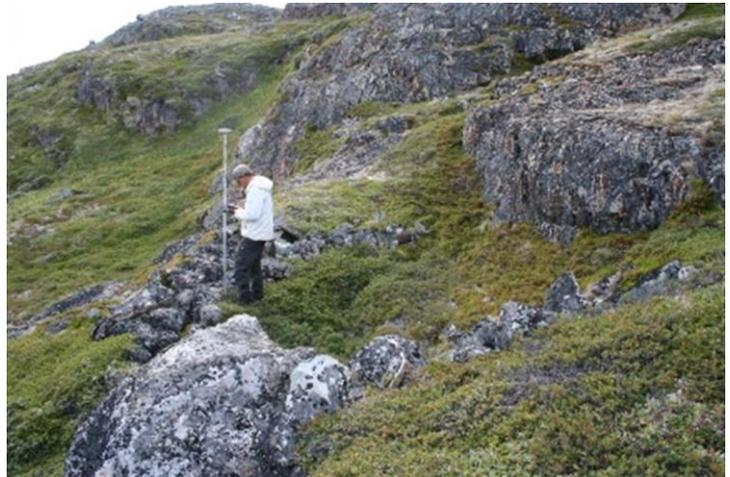
Fig.70 Ruin 05 seen from the E (Photo: T.B. Jensen 2010).

Ruin 05 (fig.70): On the plateau N of the dwelling, ruin 01, is another enclosure roughly similar, though smaller (c.6,8x3,8m) and more square in shape. It is built against a steep cliff to the N with stone walls c.60cm wide, preserved in up to 4 courses (c.1,2m) that, however, have mostly collapsed. Towards the S is a nicely preserved entrance. Inside the enclosure is vegetated by crowberry and birch.

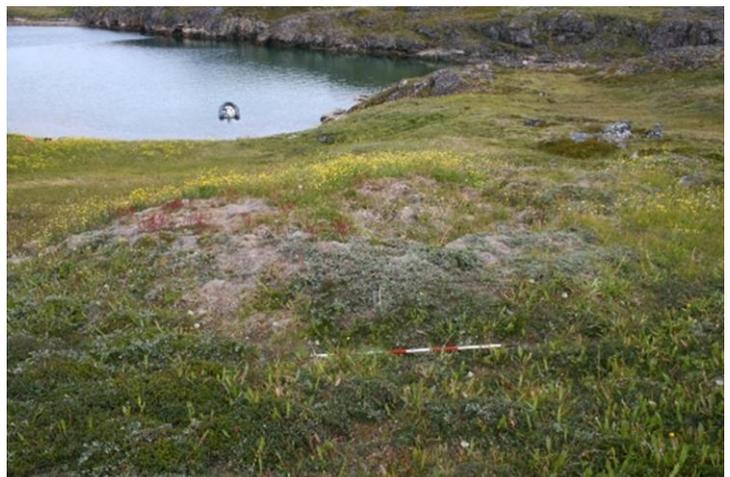
Fig.71 Ruin 06 seen from the NW (Photo: T.B. Jensen 2010).

Ruin 06 (fig.71): On a level spot just below ruin 01 are the remains of a turf/stone built structure, probably a small stable/byre. It measures c.7,6x3,8m. Though fairly collapsed, walls 30-40cm high and up to 1,2m wide are clearly visible. The same is a central room with a possible entrance in the SE corner. To the NE is pile of stones, either a addition or collapse stone. The ruin is vegetated by grass, buttercup, juniper and birch.

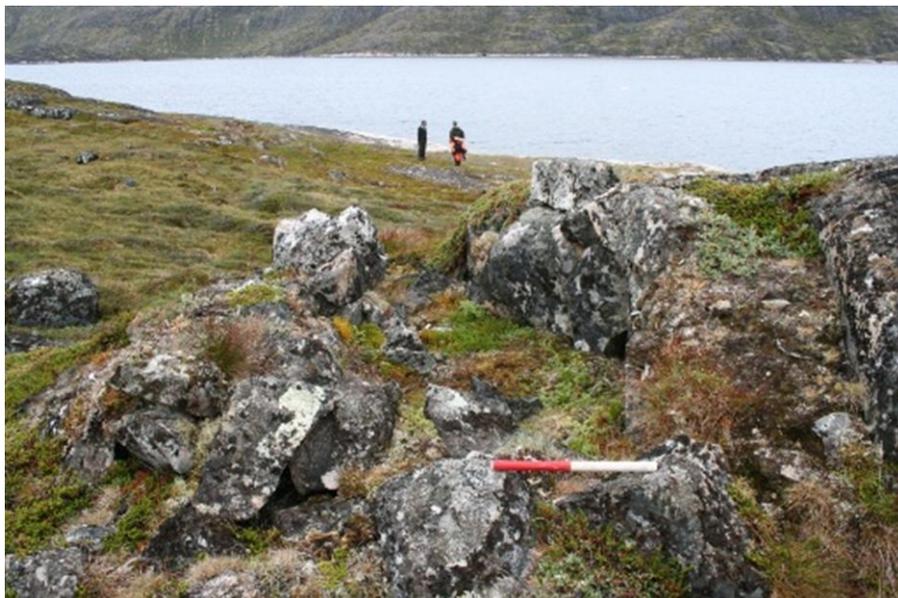
Fig. 74 The structure on the island of Qimatulivissuaq first interpreted as a possible pen, later identified as a likely large Thule-culture meat cash. In the background PBH is talking with our informative local host Arne (*Photo: C.K. Madsen 2010*).

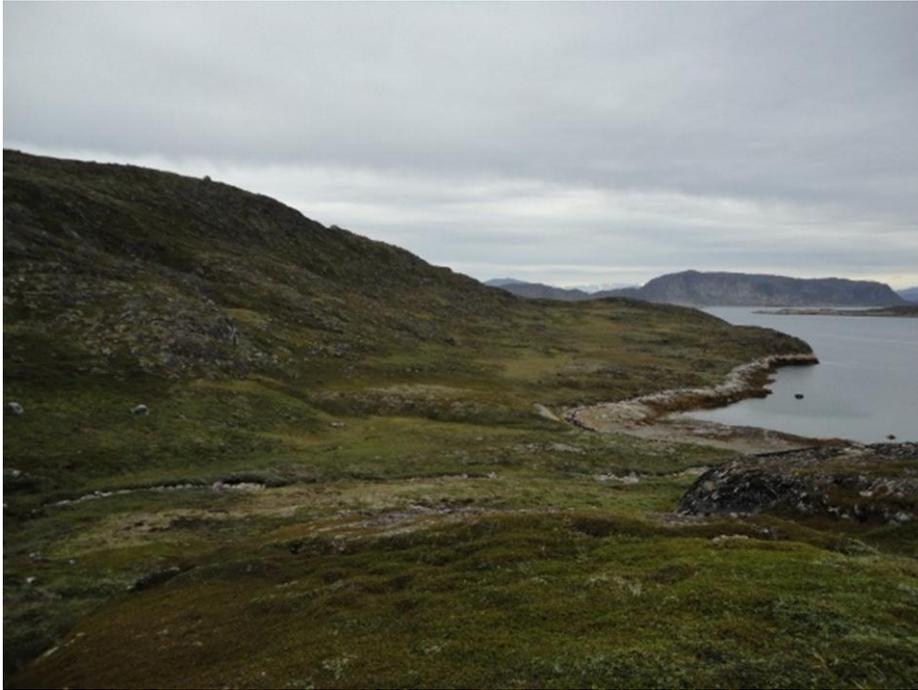
Fig. 75 The stony beach and grassy foreland at E274 seen from the WSW. The enclosure is located by the rocky outcrop to the left (Photo: P.B. Heide 2010).

Site description: On the south coast of the Island of Akia, just before one goes into the narrow straits separating Akia and Kangeq is a small bay with a stony beach, which provides easy landing (fig.75). Climbing the beach wall, one ascends up on to a small, gently sloping grassy foreland. Just a little ways to the right, near the fjord, is a few Thule-culture houses and other structures, including a well-built cairn (sea marker) that PBH has interpreted as likely Norse. Continuing along ENE along the beach, descend grassy patches are found among the

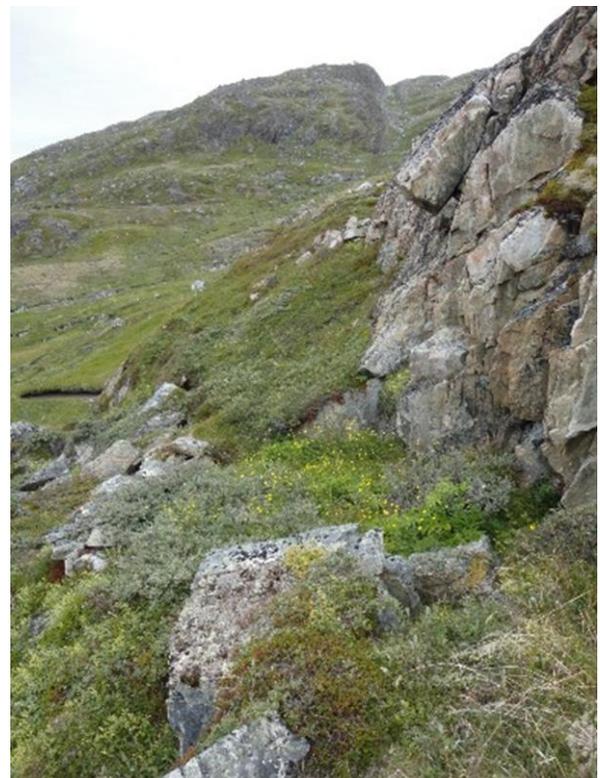
Fig. 77 Ruin 01 seen from the E (Photo: P.B. Heide 2010).

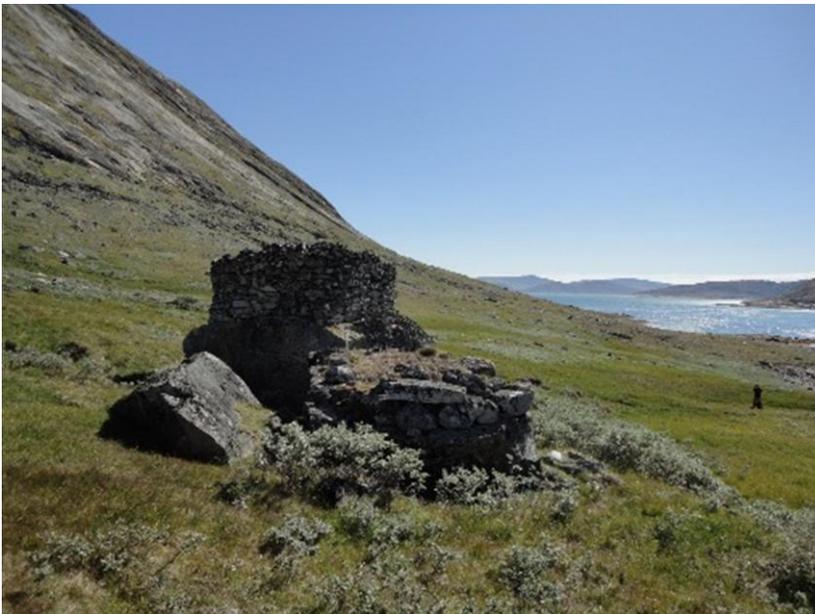
Fig. 78 The extremely well preserved skemma at E 80 (in front of it is a second, less well-preserved structure). The total height of the boulder and rock is app. 4m (Photo: P.B. Heide 2010).

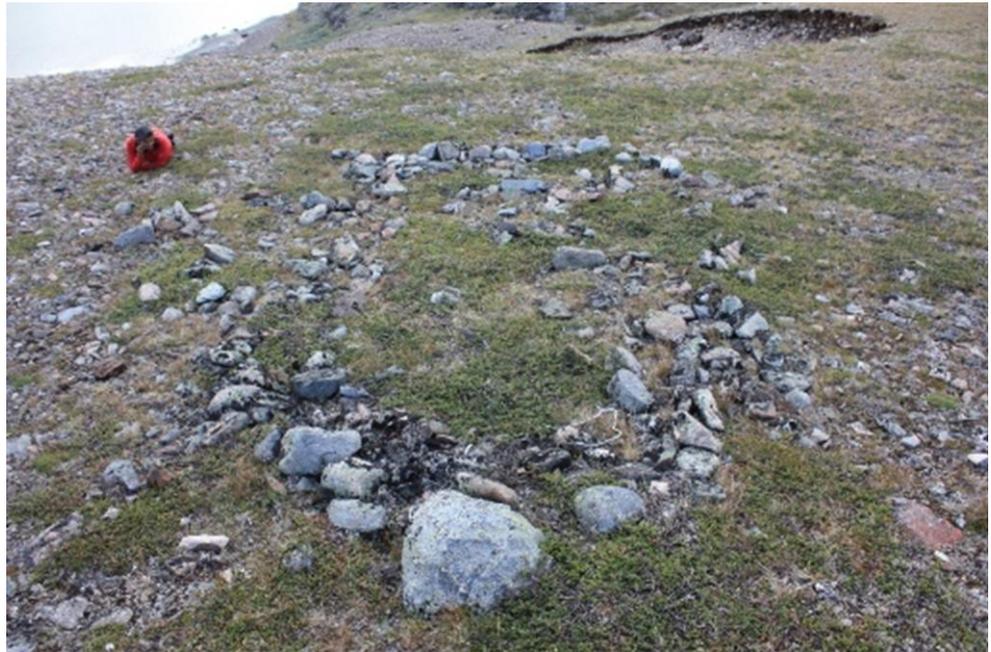
Fig. 83 Inuit/Norse ruin seen from the E (Photo: C.K. Madsen 2010).

Inuit/Norse ruin? (fig.83-84): At the edge of the gravel plateau west of the river, one finds an oblong ring of stones with a possible entrance on its S long side. This feature does not have the appearance of a Norse structure, but neither does it look like anything typical Inuit. In order to find out what this structure is, Museum director P.K. Knudsen and CKM did a 50x50cm test trench inside the structure just NW of the assumed entrance. Directly beneath the low vegetation of shrub were uneven layers of stones with a slight filling of silt, all looking natural. We thoroughly searched the outside of the structure for lithic debris, finding nothing as well.

Considering the odd shape of the structure, the uneven surface inside, and the complete lack of cultural material, it is very likely that this a natural formation, possible formed by frost action. On the other hand, the surrounding area displays no stone clusters of a like kind and is, in fact, very flat and uniform (fig.83), opting for the possibility that it might actually be a manmade structure.

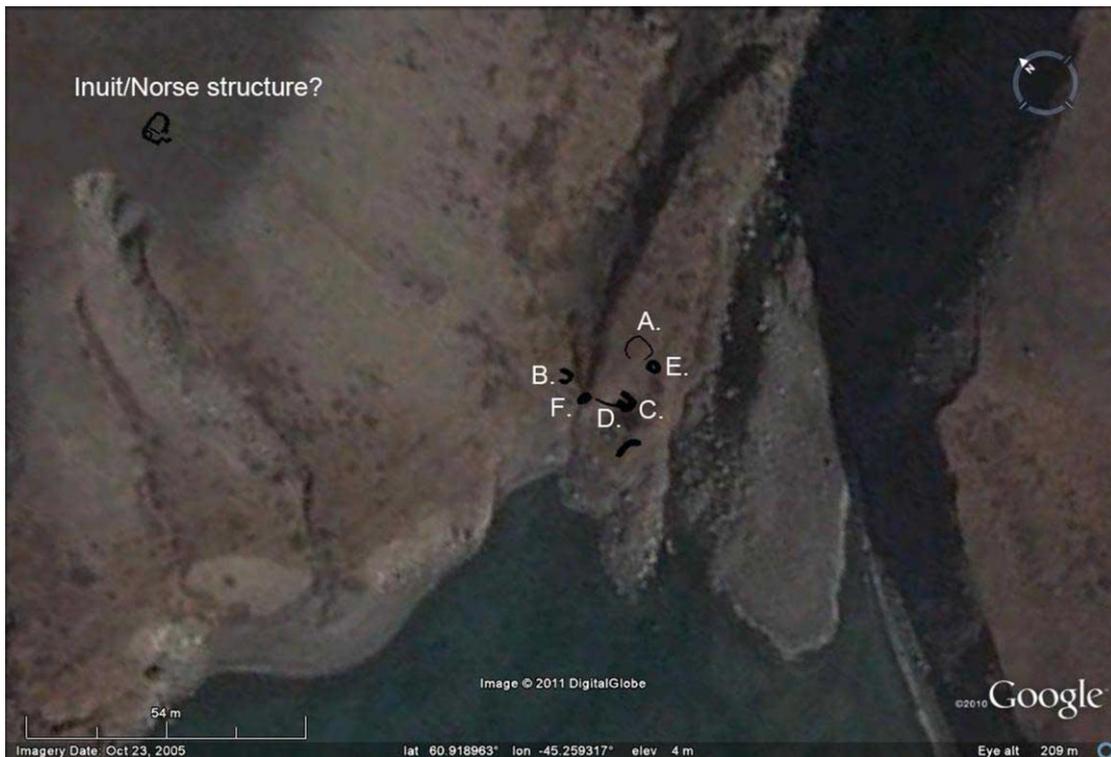
Fig. 84 Survey plan of structures near the river on GoogleEarth© satellite imagery.

Inuit ruins (fig.83): E64 and E209 are divided by a deeply cut ravine, where today runs a smaller river with excellent trout fishing. Towards the mouth of this river, it forms a small delta, which during the summer consists mainly of two branches, but the landscape morphology tells of times with considerably higher water flow. On a slightly raised gravel bank and running down into the nearby depression, one finds a number Inuit structures indicative of this rivers potential as fishing location (fig.83); A. newer tent ring, B.&C. horseshoe shaped stone built features, D. a stone built dike, E. Stone built meat cash, F. stone heap (possible structure). These structures are likely huts and structures used during fishing activities at the river.

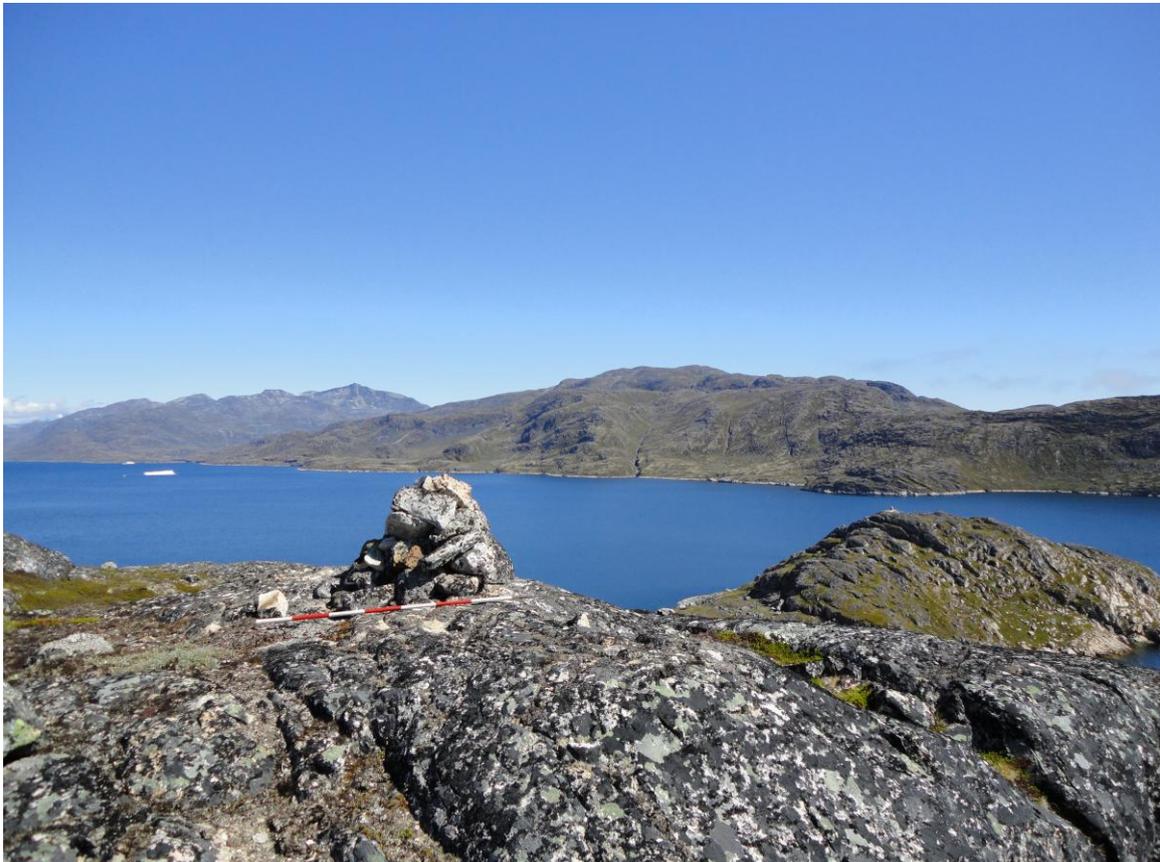
Fig.85 GUIDE 89 overlooking the fjords (Photo: P.B. Heide 2010).
