# OITIS

Field Report no. 2

Survey of Archaeological Remains at  
Svínanes, Reykhólahreppur, Iceland

2011

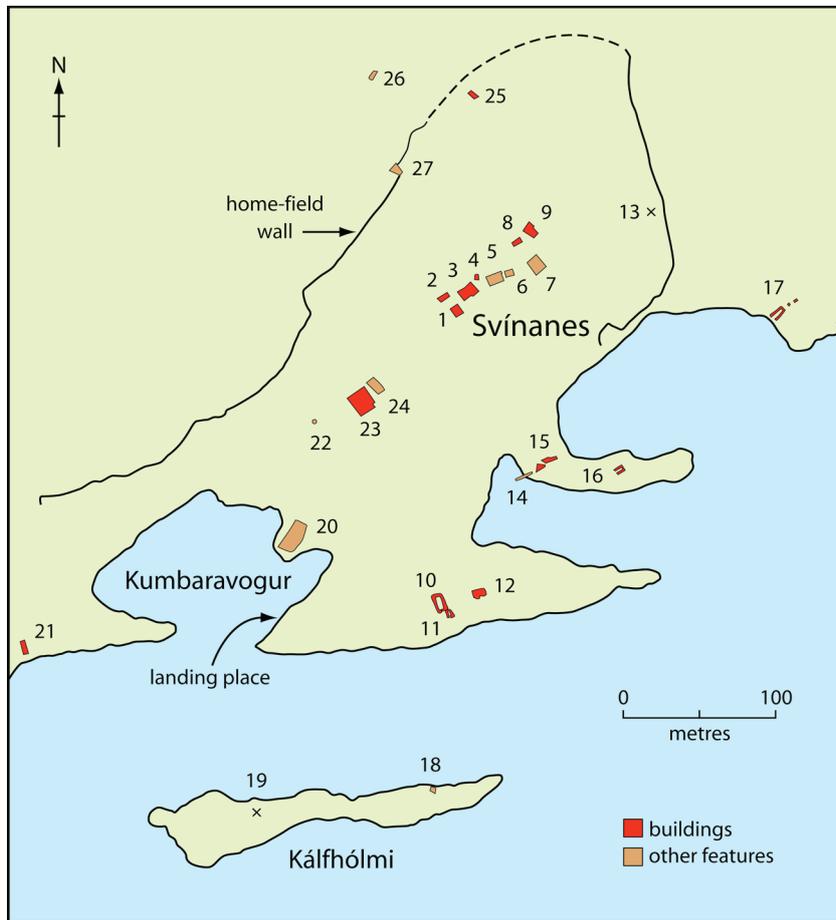
**Illus. 3** Sites recorded at Svínanes farmstead, recorded during the survey in 2007

The site was surveyed with a Leica 1200 GPS using a reference station and a rover to record a series of positions on and around the remains. This method fixes the positions not only in relationship to one another, but also provides a latitude and longitude value for each point accurate to within about 10mm. The home field boundary and high-water mark of the coast were also recorded (Illus 3-4). Brief notes and photographs were made of each site.

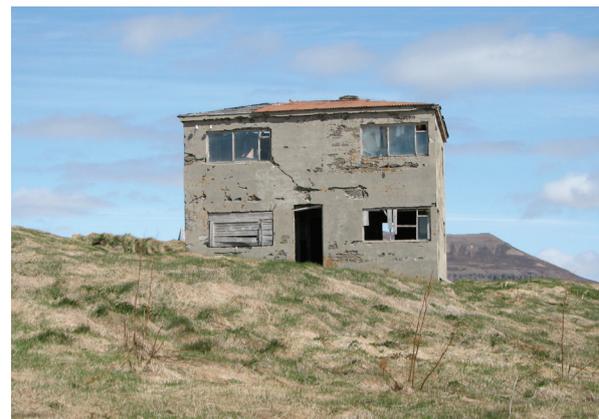
**Illus. 5** Farmhouse from the west in 2007

The farmhouse is a two-storey concrete building constructed in 1943 just a few yards to the east of the site of the earlier house. The earlier site is not readily apparent. According to oral history the earlier building was new when the farmstead was visited by a priest from Flatey in about 1850. The interior of the concrete farmhouse is now derelict, although many of the wooden fittings still survive (Illus 5-7). The corrugated iron roof has been partially blown off by the wind and the concrete structure has suffered from some frost damage.

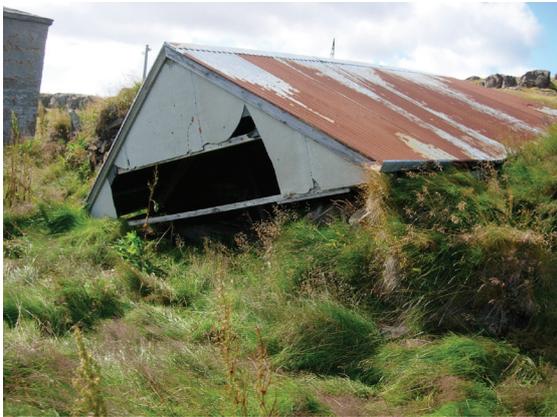
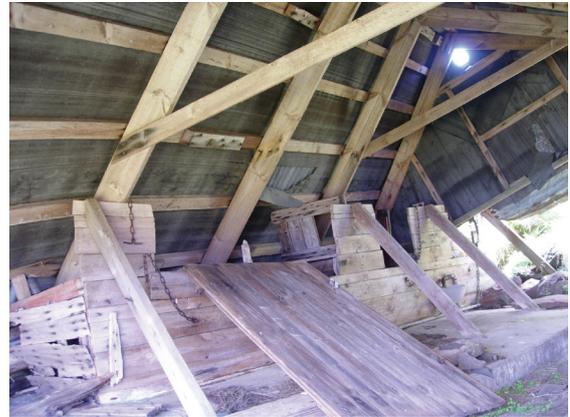
*Illus 8, 9* The partially collapsed structure of the cow house

Two conjoined turf-walled buildings lie to the east of the farmhouse. The nearer is the earliest standing building and was perhaps built about 1900. It was used latterly for smoking meat. The one adjoining it was built in 1954 as a cow house (Illus 8-9). It has a concrete floor and timber mangers and accommodated three cows. It was constructed on the site of an earlier cow house which dated from 1901.

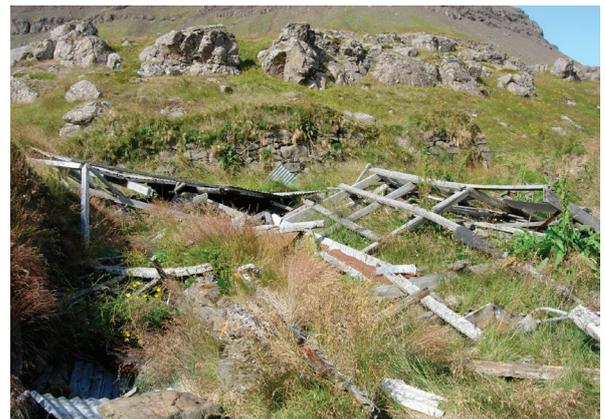
*Illus. 10* Dairy and tractor shed

A dairy and temporary tractor shed were constructed of timber and have now been entirely blown down (Illus 10).

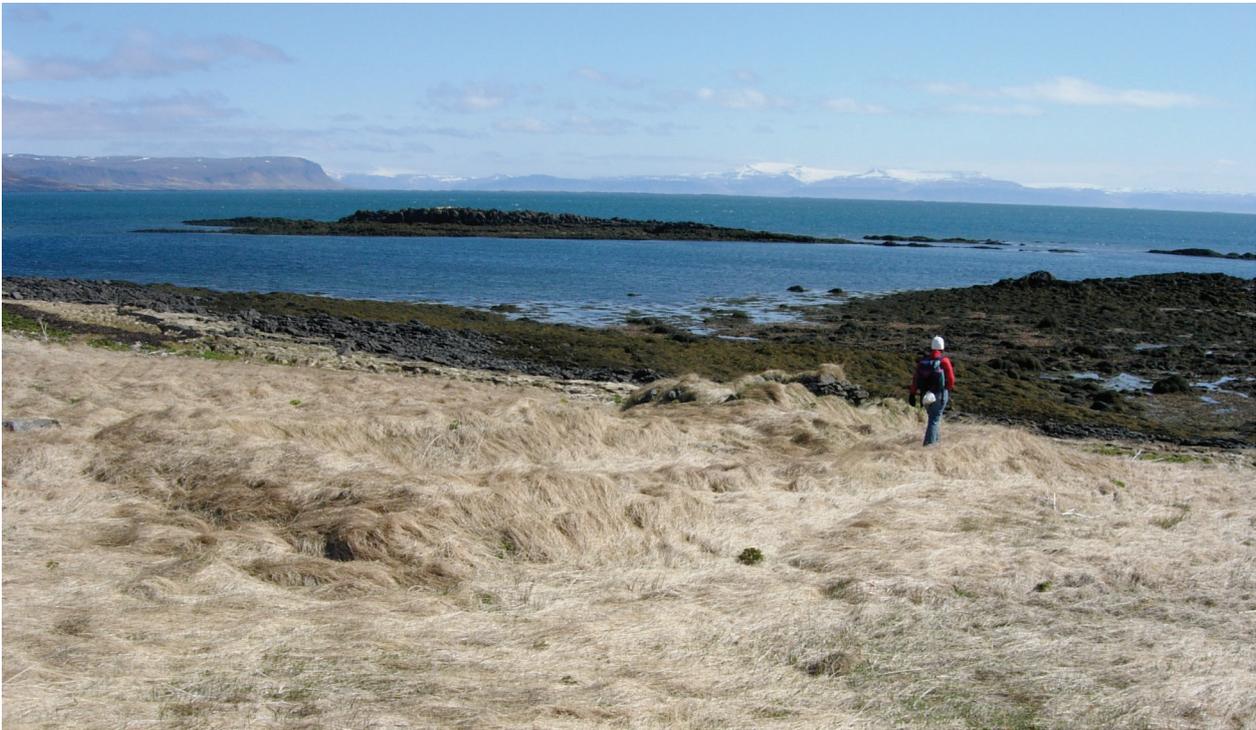
*Illus. 11* The ‘German building’ – a large turf-walled building associated with Hanseatic traders

External measurements: 13.1m by 7.6m. Internal measurements: 9.4m by 3.5m.

A rectangular turf-building lies on a gentle slope a short distance from the sea (Illus 11). The entrance is to the south facing the sea. There is some evidence that the walls of the building were faced with stone, although it is so overgrown that this is impossible to confirm. There is some damage or possibly a second entrance on the east wall near the south-east corner.

The identification of this as the ‘German building’ is traditional and it is said that the building served to store goods for traders. The building is of unusual width and is also notable for being built on a slope, which would have been difficult if it had been a house, though, of course, it would not precluded its use for animals. The name of the adjoining cove, *Kumbaravogur*, is notable since this means the ‘cove of the cogs’. A cog was a common type of European trading vessel. The traditional identification and the place-name provide supporting strands of evidence that this building was associated with foreign trade. Cut into the south side of the building is Site 11.

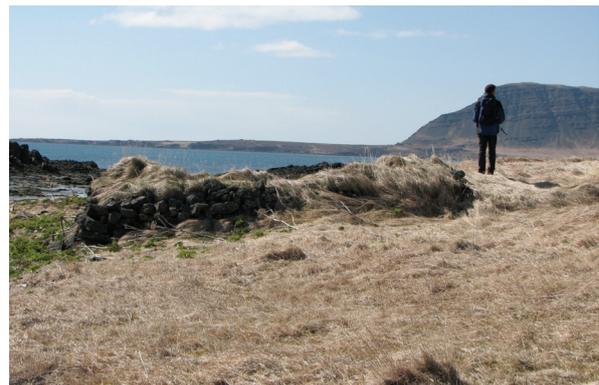
*Illus. 12* A turf-walled building used for storing the possessions of the farm-labourers looking west

External measurements: 6.9 m by 4.1 m. Internal measurements: 4.0m. by 1.5m.

A small building is cut into the south-east corner of the German building, and is probably later (Illus 12).

The walls have internal and external stone-facing with a earthen core. The entrance which lies to the south is now very narrow, but it is possible that it may have originally been across the full length of the building. Before the abandonment of the farm, it was used for storing the possessions of farm labourers.

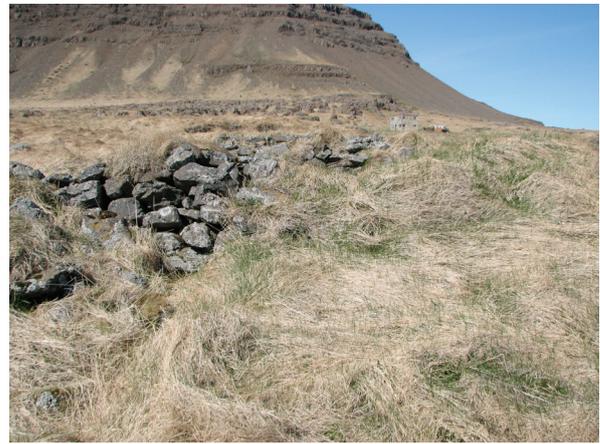
*Illus. 13* Smithy, later tractor building with blocked doorway

External measurements: 8.9 m by 6.6 m. Internal measurements: 5.4m. by 1.7m.

A short distance to the east of Sites 10 and 11 is a turf building with stone-lined interior on the eastern half of the north wall (Illus 13). It was used as a smithy by Bergljót’s grandfather who died in 1917. The door to the south was subsequently blocked

with stone and the west wall removed to provide shelter for a tractor. Subsequently that wall was replaced. The earlier usage of the building is also implied by the name of the headland, Smiðjutangi.

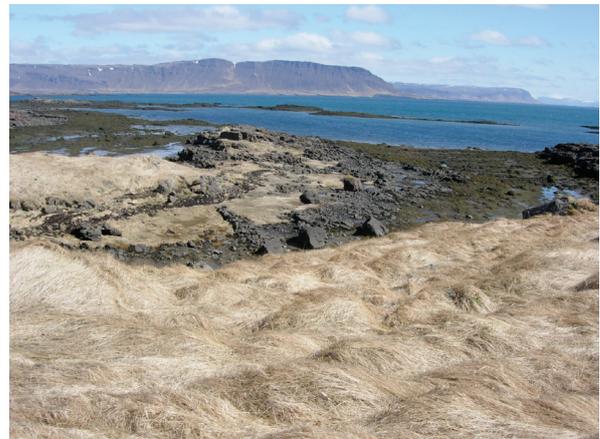
*Illus. 14* Inlet showing the breakwater and nausts. Beyond these on the headland is the fish-drying building (16)

A series of maritime structures were recorded near to the shore to the east of the farmstead. The inlet to the south-east of the farm was used for keeping fishing boats by Bergljót's father and the head of the bay is partially protected by a small stone breakwater (14) (Illus 14-15). The smaller of the nausts lay to the south-west and was used in winter for keeping boats when there was ice on the fjord, according to Bergljót (Illus 16). It could have only accommodated a small boat. It is marked only by a shallow depression. The larger naust has stone-edged walls supporting the base of a turf-building. It appears to cut a further naust to the east which sat on the edge of the cliff.

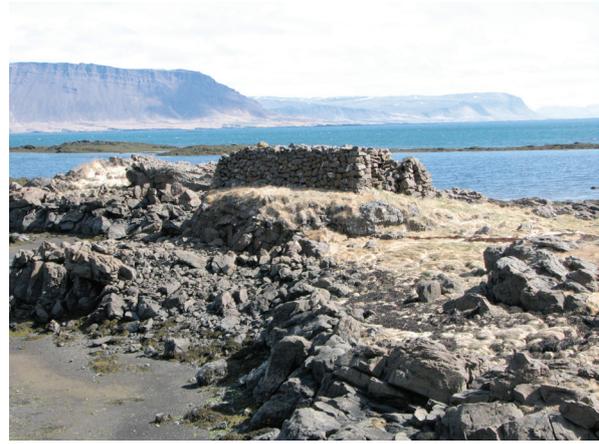
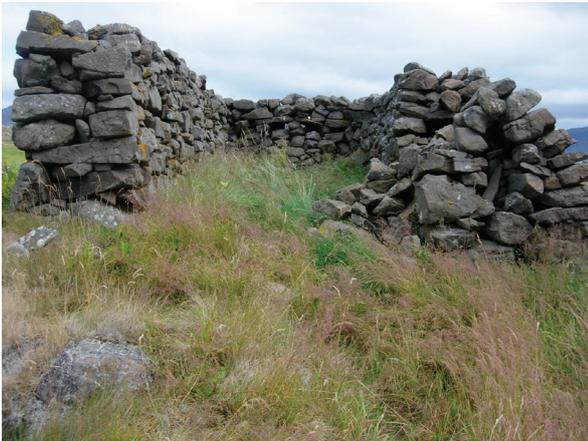
Drystone buildings were commonly used for drying and storing dried fish in the past (Kristjánsson 1985, 289-96). A drystone-building on the exposed headland south of the farmstead was used for this purpose (Illus 17-18). The building is orientated west-east with the door to the west and three small apertures in the east wall to allow wind to blow through. The walls are about 1 metre thick and barely coursed. There is some evidence for rebuilding on the south side where there is some poor, uncoursed work. The wall at the east end is thinner than the side walls and there is some evidence that it has been rebuilt.

Illus 17 Fish-drying building, view from the west

Illus 18 Fish-drying building, views from the west and south-west

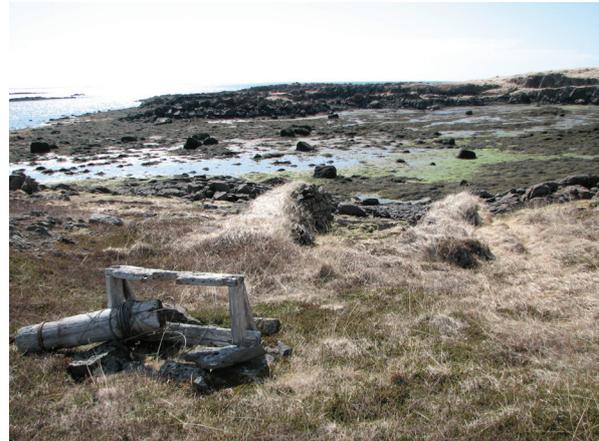
Illus. 19 Capstan and beyond it the stone-walled naust building

A large, well-built naust faces the third bay, to the east of the farmhouse (Illus 19-20). It was built with drystone, barely coursed walls and has a clear ramp leading to the water. Bergljót says that boats were hauled up on whale-bone runners. There is a timber capstan with steel cable to the east of the naust and beyond that a further setting, evidently for an earlier capstan beyond it

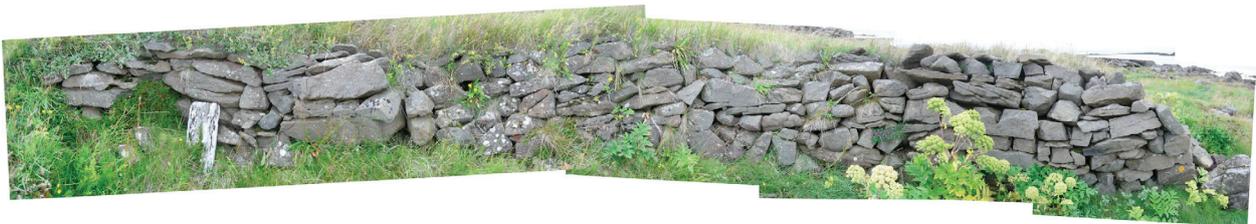
Illus. 20 Pseudo-orthophoto of the south-east side of the wall of the naust showing different types of walling, suggesting periods of reconstruction and repair

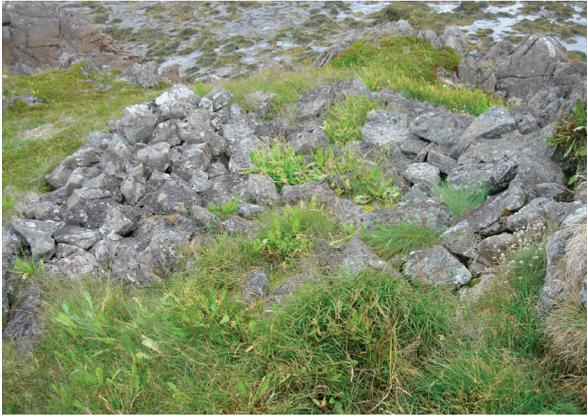
*Illus. 21* Hide or fold on Kálfhólmi

The first of the islands sites occupies a natural horseshoe of rocks and is a small enclosure or hide

(Illus 21). Bergljót suggests that it may have been a hide for shooting foxes venturing near the farm and eating eider ducks. Alternatively, it may have been a small fold. Above the structure is a cairn of stone.

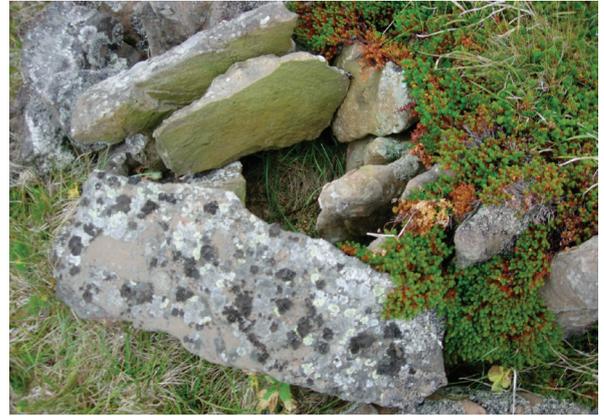
*Illus. 22* Eider duck nesting box

A second structure recorded was a small nesting box for eider duck recorded towards the west end of the island (Illus 22).

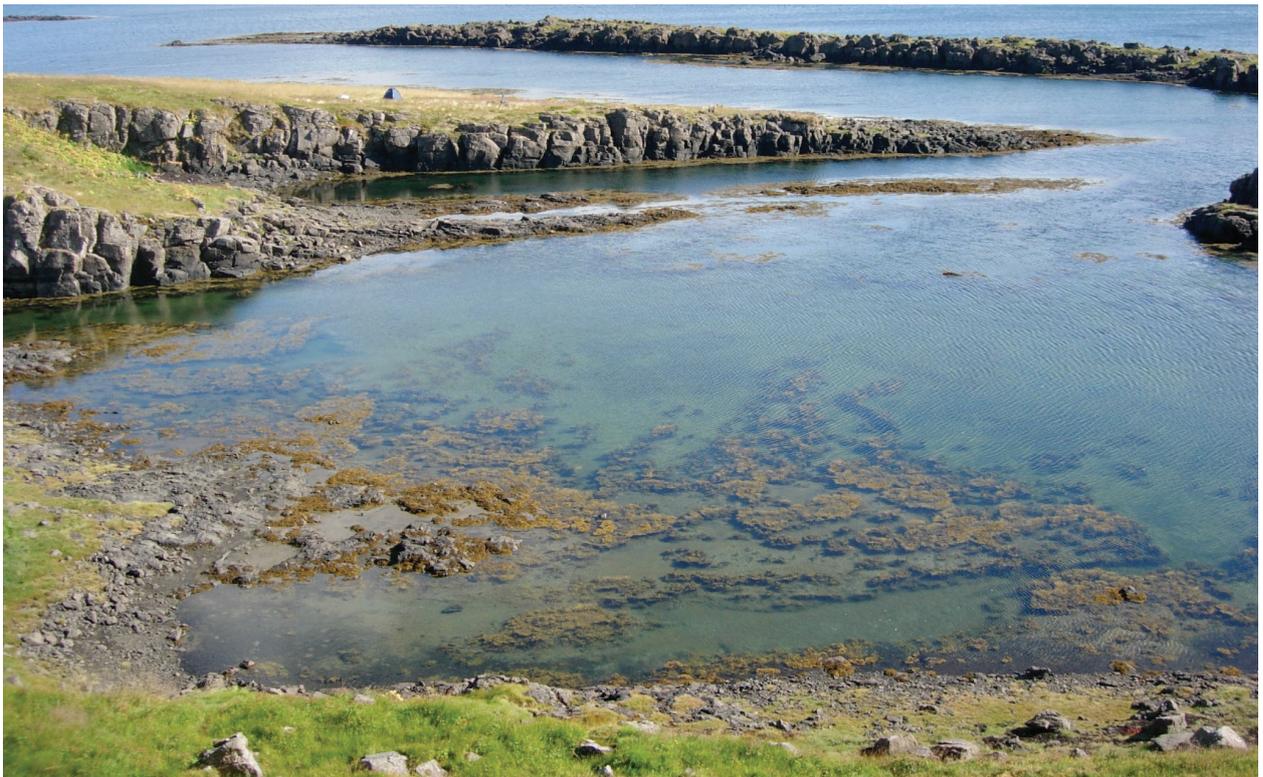
*Illus. 23* The bay at Kumbaravogur with the landing place on the far side and the reef of Kumbaratangi just emerging from the water

The main landing place at present is the bay of Kumbaravogur where a natural wall of rock provides a useful point against which boats can be brought up (Illus. 23), and is a convenient point for loading and unloading vessels (Illus. 24). However, the bay does not provide a deep-water landing and at low tide is almost empty. The entry to the bay is difficult for larger ships, so it is doubtful whether it would have provided an anchorage for cogs or other vessel types. It may be significant that the ‘German house’ does not face this bay.

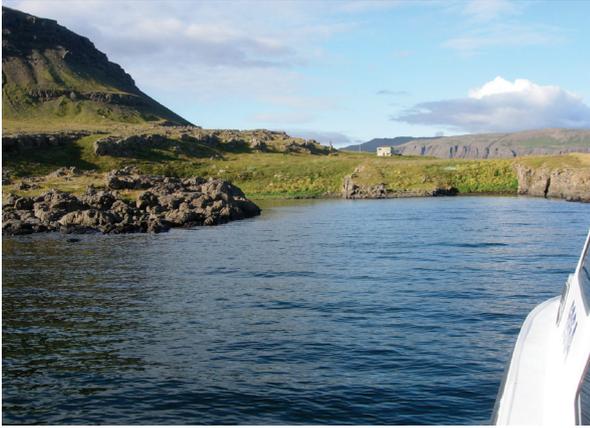
*Illus. 25* The enclosure of Svínabæli projects into the bay at Kumbaravogur. The landing-place is on the right-hand side of the bay out of the picture. The farmhouse is visible in the far distance

This large enclosure stands on a sharp slope directly above a reef (Kumbaratangi) exposed at low tides in the inlet of Kumbaravogur (Illus 25). The enclosure relies partly for its boundaries on the ridge of rock. It takes its name from the pig enclosure which Geirmundur was supposed to have established at Svínanes after the settlement of Iceland (*Landnámabók*, 58-59). It is surrounded by an earth bank on the west and north sides, and a stone wall on the east. A further earth bank prevents any animals from escaping over the low cliff towards the sea to the south. No entrance was recorded.

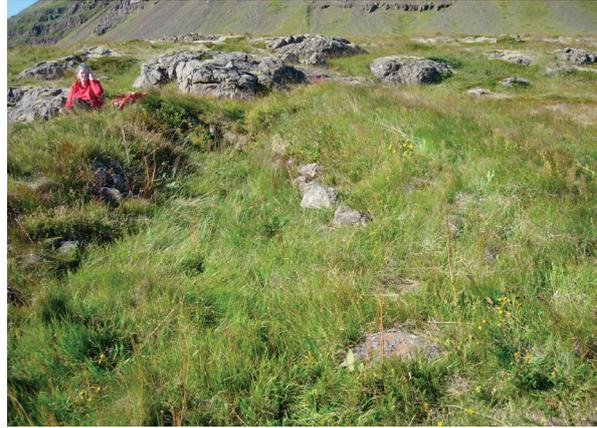
*Illus. 26* The naust on the south-west of the farmstead, showing Bergljót Aðalsteinsdóttir on the left-hand side

A further naust lies to the west of Kumbaravogur. It has stone-faced internal earthen walls. There is a hole at the north end for a cable to haul up boats (Illus 26).

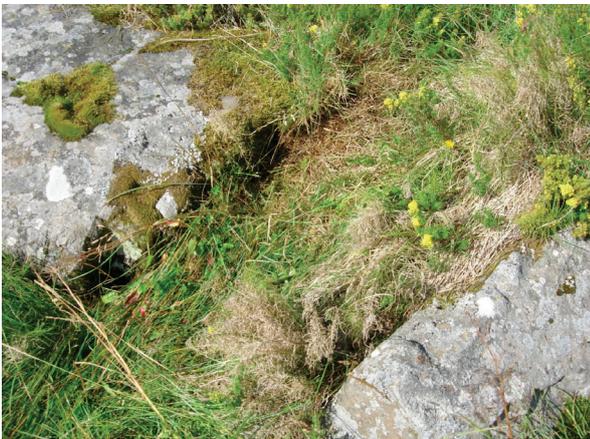
*Illus. 27* A hearth used for preparing wool for cloth

Two large adjoining stones mark the position of an outside hearth used for washing the wool for cloth-making (Illus 27).

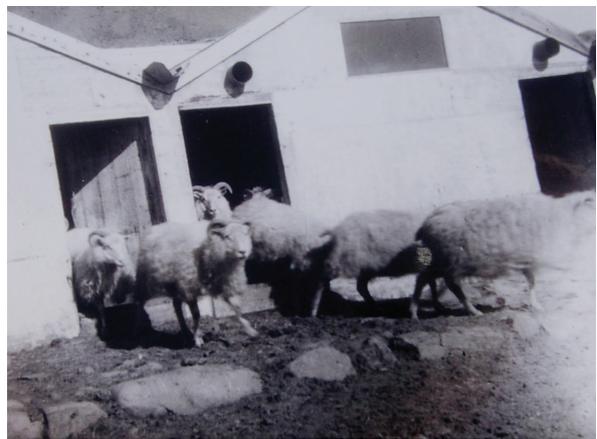
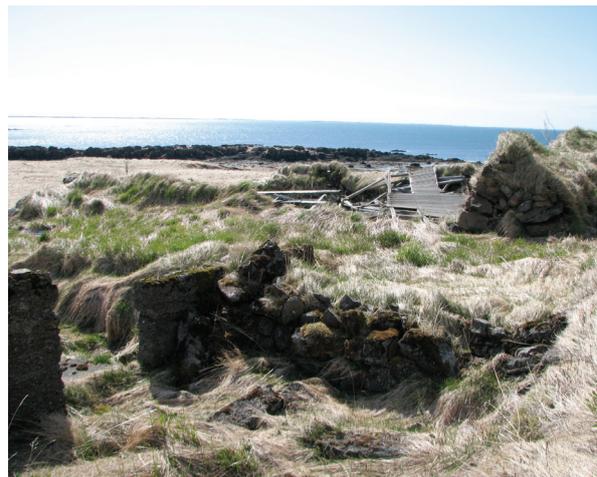
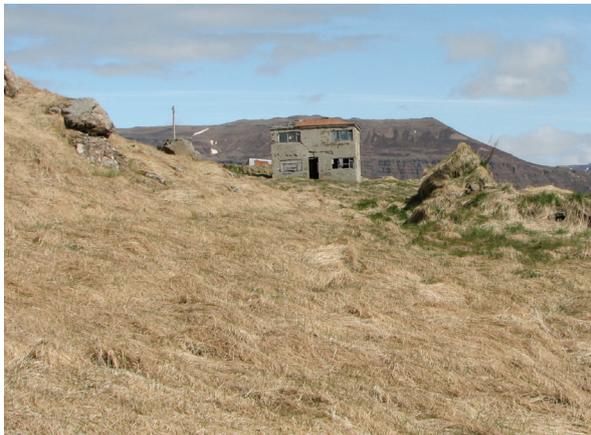
*Illus. 28* Photograph from the 1950s showing the sheep house

*Illus 29* Ruins of the sheep house and hay store

*Illus. 30* Ruins of the sheep house and hay store

The farm at Svínanes kept a flock of 200 sheep in the 1940s. The sheep house was built between 1948 and 1950 with stone from the old farmhouse (Illus 28-30). The north wall is better built than the east wall. It was constructed in a combination of concrete and stone which was experimental and not entirely successful. The hay was kept in a storehouse to the north, the roof of which is just visible in Illus. 28 and more clearly apparent in the cover illustration.

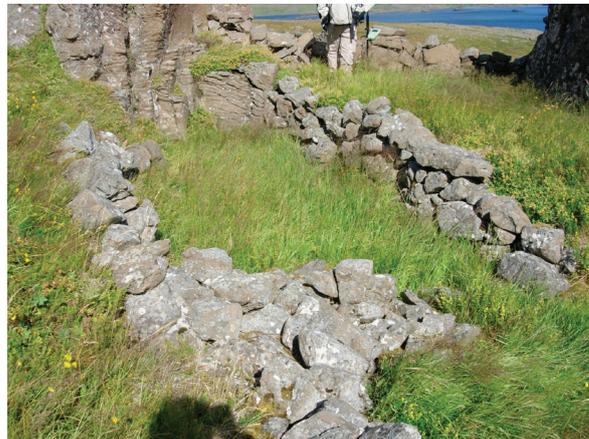
*Illus. 31* Sheepfold under the mountains for ewes

There was a sheepfold (26) under the mountains where the ewes were kept immediately after lambing and it was perhaps 200 to 300 years old (Illus 31). A later sheepfold was constructed next to the home field wall (27) (Illus 32).
